# College Avenue Chlorine Contact Tank

innovative solution for structural repairs of a live potable water concrete contact tank

by Giampiero Mendola CEng CWEM MCIWEM

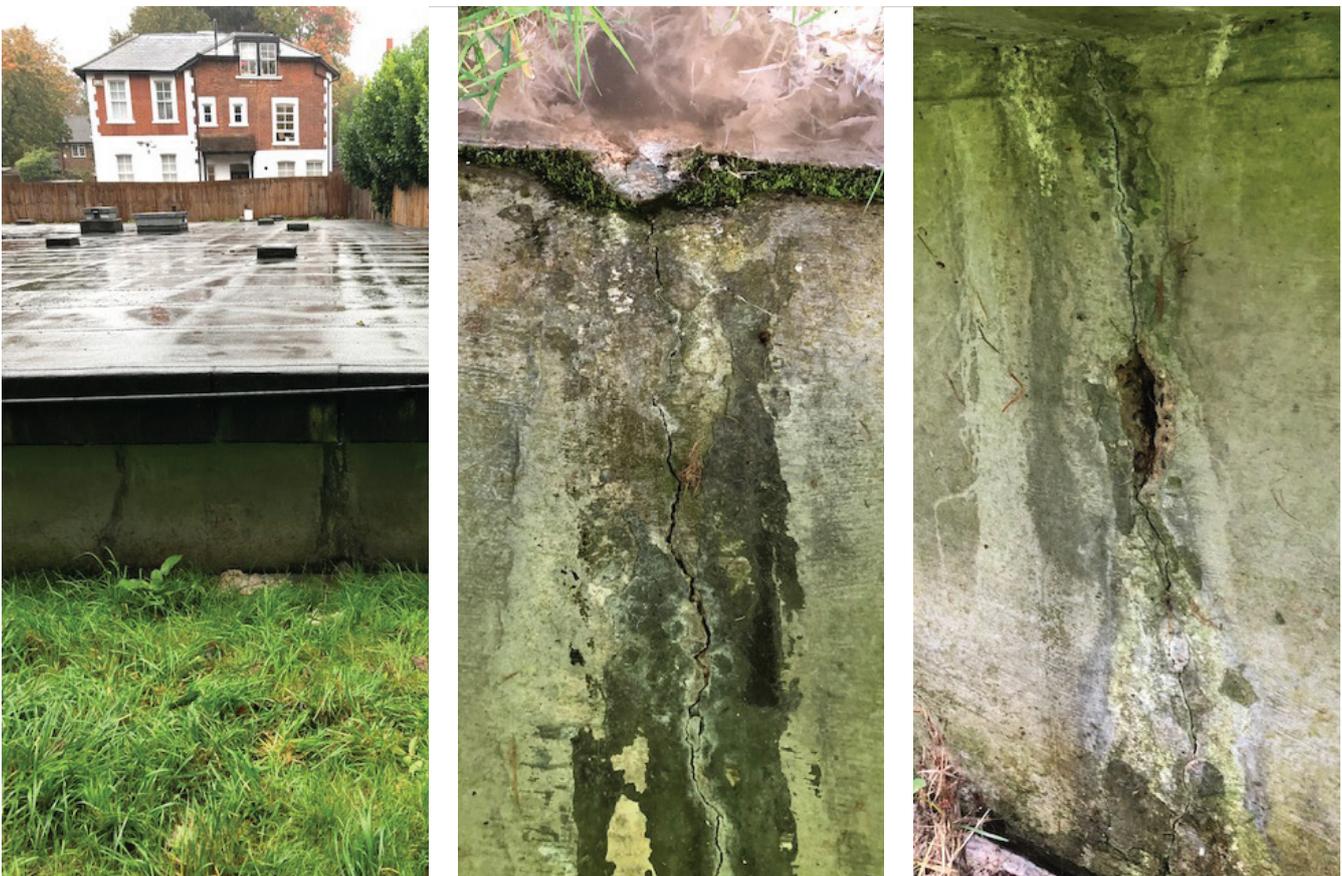
Photographs of leaking cracks observed in November 2019 - Courtesy of South East Water

In November 2019 external leaks from the western concrete wall of the contact tank were observed. The condition of the structure caught the immediate attention of site production managers. While a long-term project to replace the tank with a new permanent UV treatment plant had already been identified by South East Water, a short-term repair solution was urgently needed.

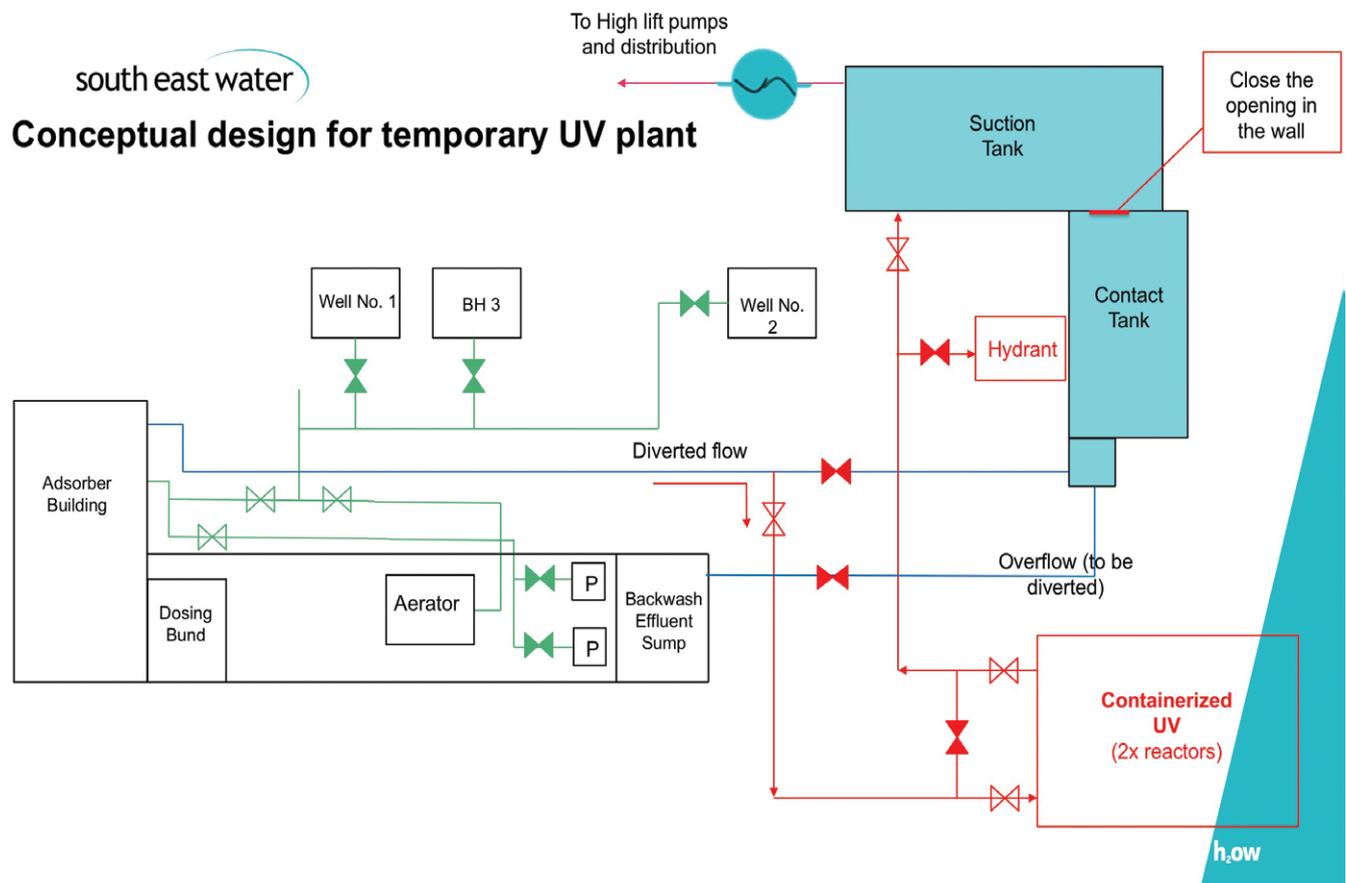
- **Option 1: Temporary containerised UV plant:** A temporary containerised UV plant solution was considered, as this treatment process would make the existing contact tank redundant while repairs could be undertaken. The study concluded that this option was not practicable nor cost effective due to the little space available for a hired containerised UV plant and the extensive electro-mechanical and civil enabling works that this solution would have required.

Conceptual design for a temporary UV plant- Courtesy of South East Water

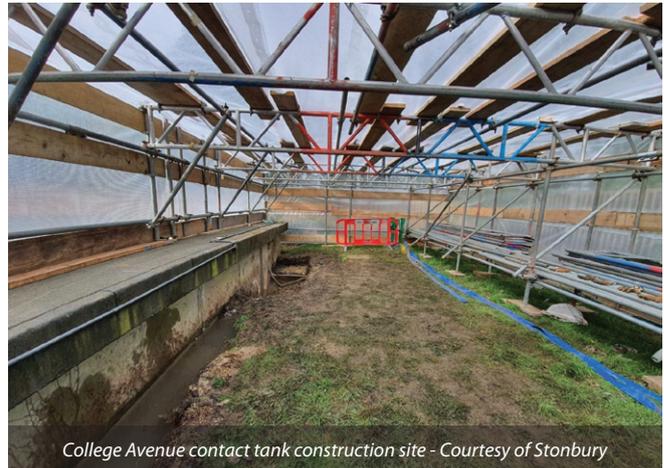
College Avenue contact tank construction site - Courtesy of Stonbury

Careful structural testing on the concrete wall in conjunction with a temporary works design was undertaken to establish if the original design and the condition of the wall could cope with the removal of the surrounding backfill to the tank. This was an important consideration as the repairs to the wall were to be done on the reservoir at full to top water level. In order to limit any excessive structural loading on the wall during the repair works, Mason Clark recommended that the cracks being repaired were only exposed locally by excavating ground around a crack to a maximum width of about 2m.

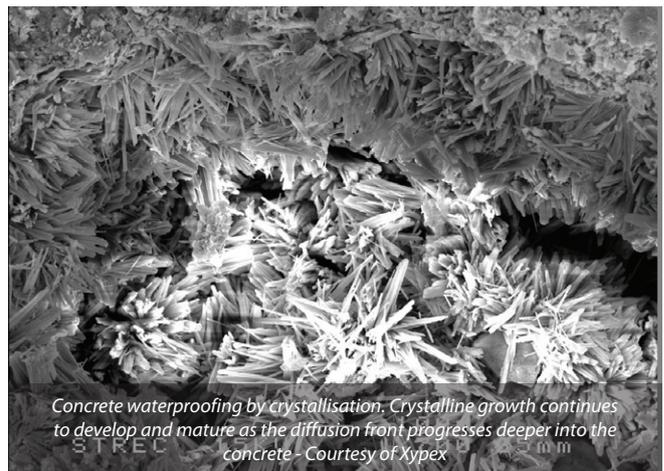
- **Option 3: Application of Xypex (preferred solution):** The preferred option was to complete the repair using Xypex products. These are specially formulated portland cement, finely graded sand and active proprietary chemical compound, that by means of diffusion fill the cracks with an impermeable crystalline structure which renders the concrete structure waterproof. The advantage of Xypex over other methods of repair was its ability to stop leaks in structures that are weeping, or even actively flowing, through concrete structures while the repair is undertaken live i.e. in this case with the reservoir full and operational,

Concrete waterproofing by crystallisation. Crystalline growth continues to develop and mature as the diffusion front progresses deeper into the concrete - Courtesy of Xypex

and all in compliance with the strictest water quality safety regulations as enforced by the DWI. Xypex was an ideal choice in these specific circumstances, as unlike other products, it did not require heating, dehumidification, wet vacuumed or drag dried surfaces. On the contrary, the manufacturer's instruction for use (IFU) specified the use of water to be regularly applied during and post application to help the formation of the crystallisation process, which was conveniently available from the leaking cracks.

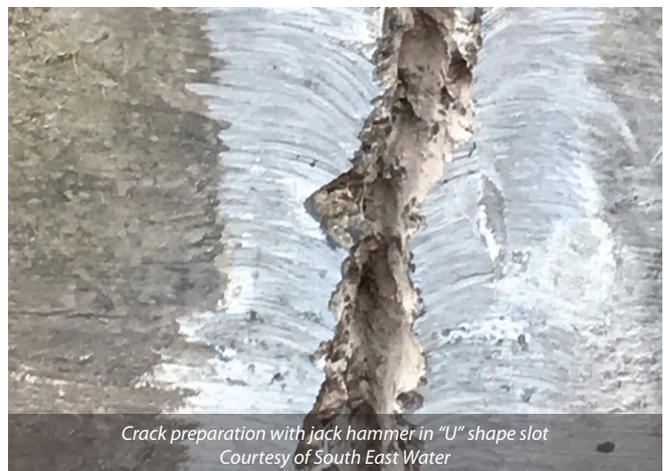
Crack preparation with jack hammer in "U" shape slot  
Courtesy of South East Water

The repair works involved around twenty specific predefined steps including materials' mixing, crack cleaning and preparation with jack hammer in a U shape form, placing of a bleeder hose into the cavity, stemming the water flow with Xypex Plug and Patch and then repair using a dry packing method, and slurry coat applications of Xypex Concentrate finally followed by the installation of strain gauges for future structural monitoring.

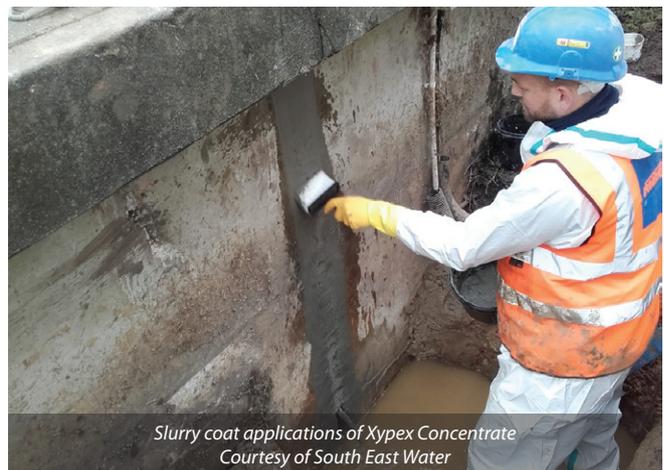
Slurry coat applications of Xypex Concentrate  
Courtesy of South East Water
