# Testwood Water Supply Works

## capital maintenance scheme and large scale refurbishment of the rapid gravity filters in Southampton

by Charles Tinsley IEng MICE

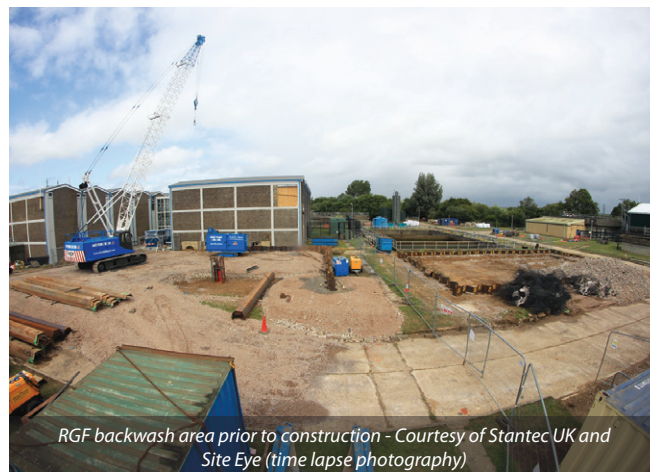
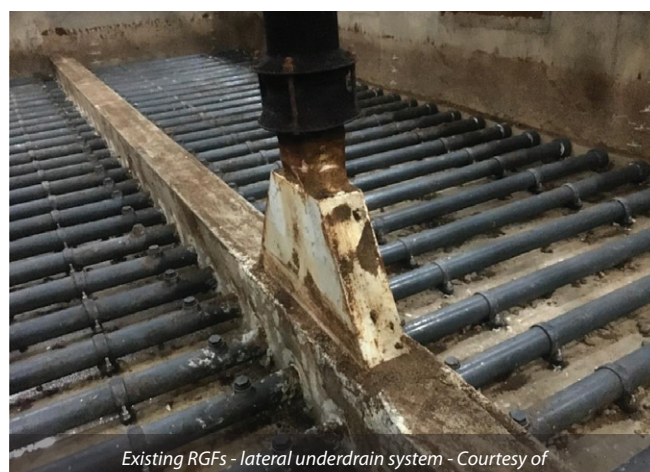
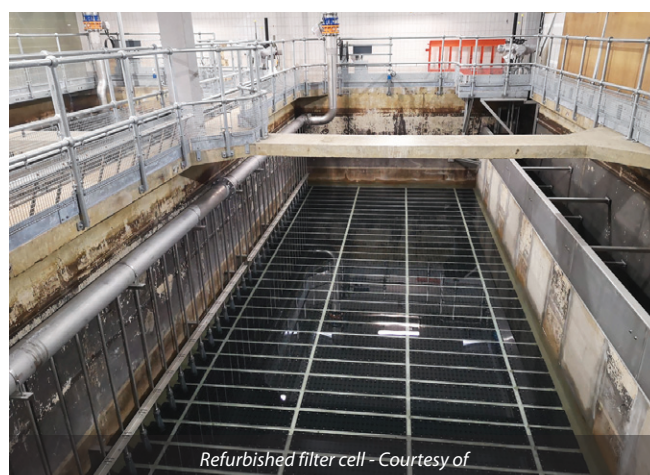
'Crash decks' were installed under the roof soffits, allowing works to progress on the filter cells underneath simultaneously. However, upon removal of media it was determined that most of the existing lateral underdrains were asbestos cement, therefore the area

had to be isolated and sealed, to allow a specialist contractor to remove them. Once civil demolition works were complete, work progressed on; increasing the height of the existing backwash weir, replacement of the existing penstocks, installation of the Leopold XA underdrain system and modifications to the access metalwork.

Making these changes has provided an increased depth of media and an increase in L/d ratio, to meet Southern Water specifications. The increased weir height will enable a combined air and water wash, once the new clean backwash pumping station is commissioned, further improving process efficiency.

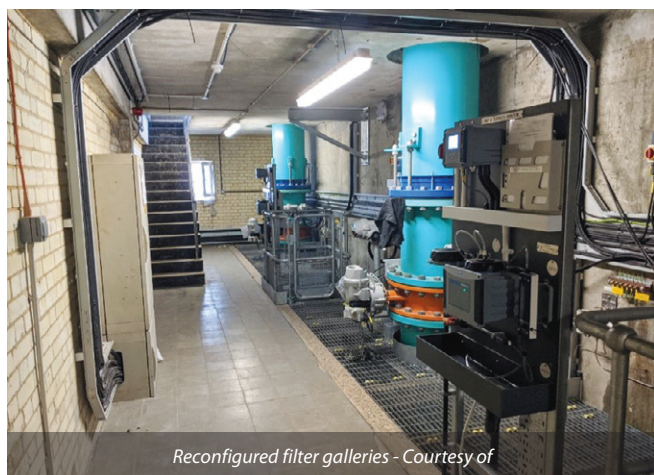
Reconfigured filter galleries - Courtesy of

The existing filter outlet pipework manifolds were located in a gallery, and critical valve actuators were only accessible via a ladder into an enclosed area. As modifications were required to the manifold to allow a new, larger backwash inlet main, improvements

were also made to these existing valves by bringing the actuators up to the higher platform level significantly improving operational safety for Southern Water staff.

As part of the pipework modifications, a run-to-waste facility was incorporated by using the existing backwash main. The existing main can continue to be used for backwashing until the new backwash tank is commissioned. Careful consideration was made to the phasing of the refurbishment works, which required close collaboration between the designer, contractor and operational staff. Extensive use of Microsoft Hololens technology was utilised to allow visualisation of solutions in situ and to identify clashes. Identifying these issues at an early stage significantly reduced risk to programme during construction, and enabled the team to stay on track for completion prior to regulatory output date.

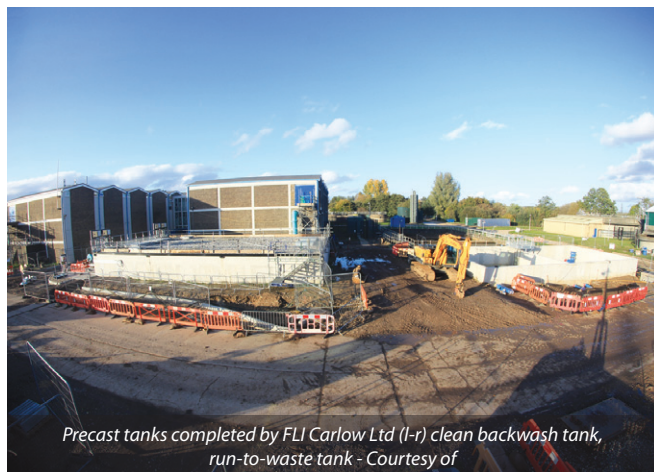
Precast tanks completed by FLI Carlow Ltd (l-r) clean backwash tank, run-to-waste tank - Courtesy of

Construction of the new backwash tank began in late 2019, and comprises a dual cell precast concrete tank, which provides 600m<sup>3</sup> working volume with an overall footprint of 20.0m x 12.6m. This provides sufficient partially treated water for two consecutive backwashes plus an additional 10% volume in accordance with Southern Water specifications. The pumps are submersible with all control equipment above ground adjacent to the tank to minimise the need for below ground access. The new feed to the tank is taken from the existing filtered water outlet main which combines filtered water from RGFs 1-8. On the feed to the backwash tank there is a control valve to manage a maximum take-off of 10% of forward flow to prevent issues with the disinfection process downstream.

A key Southern Water driver for AMP6 has been Design for Manufacture and Assembly (DfMA), therefore the design looked at options available at an early stage. To optimize the volume available within the given footprint on site, a rectangular shape was preferable, and was therefore a good candidate for modular precast concrete wall sections. FLI Carlow Ltd were engaged via Trant, and design progressed collaboratively. Keeping pipework penetrations to a minimum, and making them simple and linear minimised the amount of work required on site.

Along with the backwash tank, a run-to-waste tank has been included within the design to reduce the impact from post-backwash turbidity spikes. The design of this tank was again delivered with precast in mind collaboratively with FLI Carlow.
