# Thames Tideway Tunnel - Falconbrook PS

## Industry first: Jet grouting against a live Thames Water asset

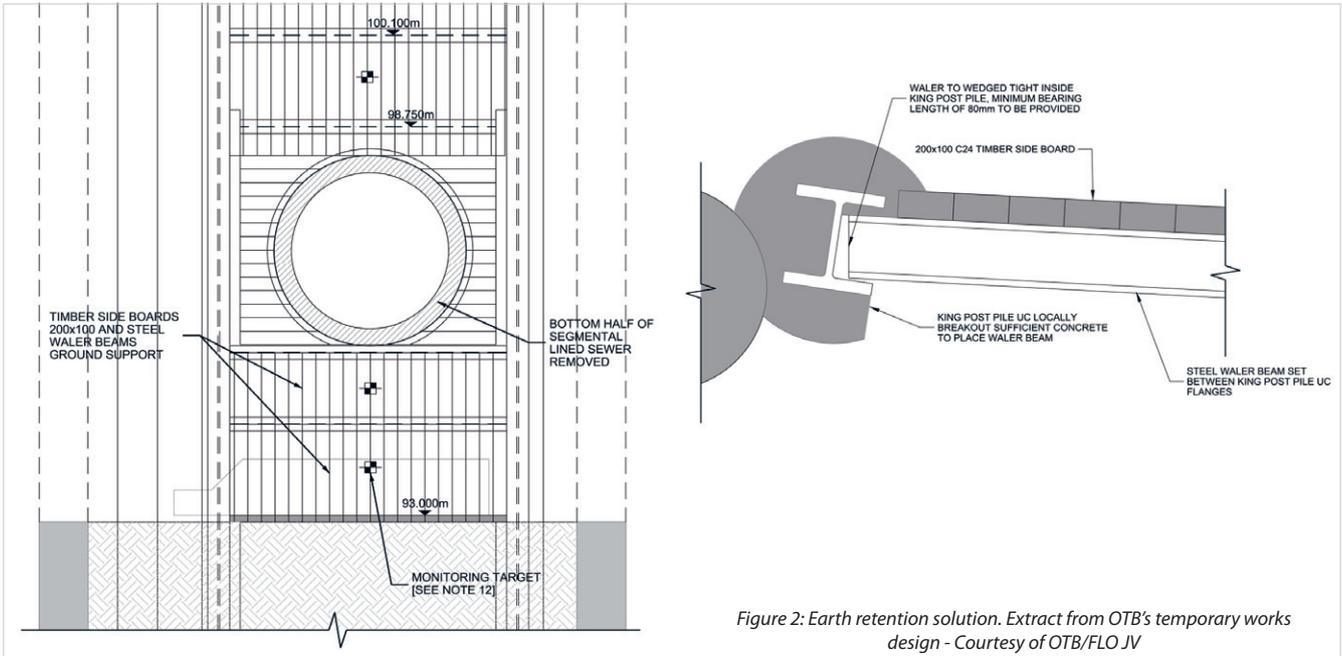
Figure 2: Earth retention solution. Extract from OTB's temporary works design - Courtesy of OTB/FLO JV

The interception chamber is a reinforced concrete (RC) substructure, through the centre of which runs the live Low Level 1 Relief Sewer (LL1RS). The LL1RS is considered a highly critical asset in the Thames Water Utilities Limited (TWUL), servicing numerous boroughs from the south west of London. In order to construct the RC box, temporary works secant piles were necessary to be installed as earth retention and water cut-off. As aforementioned, this LL1RS is a live sewer and therefore must be kept operational throughout the construction of the chamber. This necessitates the need for a different earth retention design in the local areas through which the sewer enters and exists the IC RC box, as piles cannot be bored through the live sewer. The solution that evolved for these localised areas was the installation of timber sideboards, supported via steel walers spanning between universal column sections that have been cast within the secant piles. The typical arrangement can be seen in Figure 2 (next page).

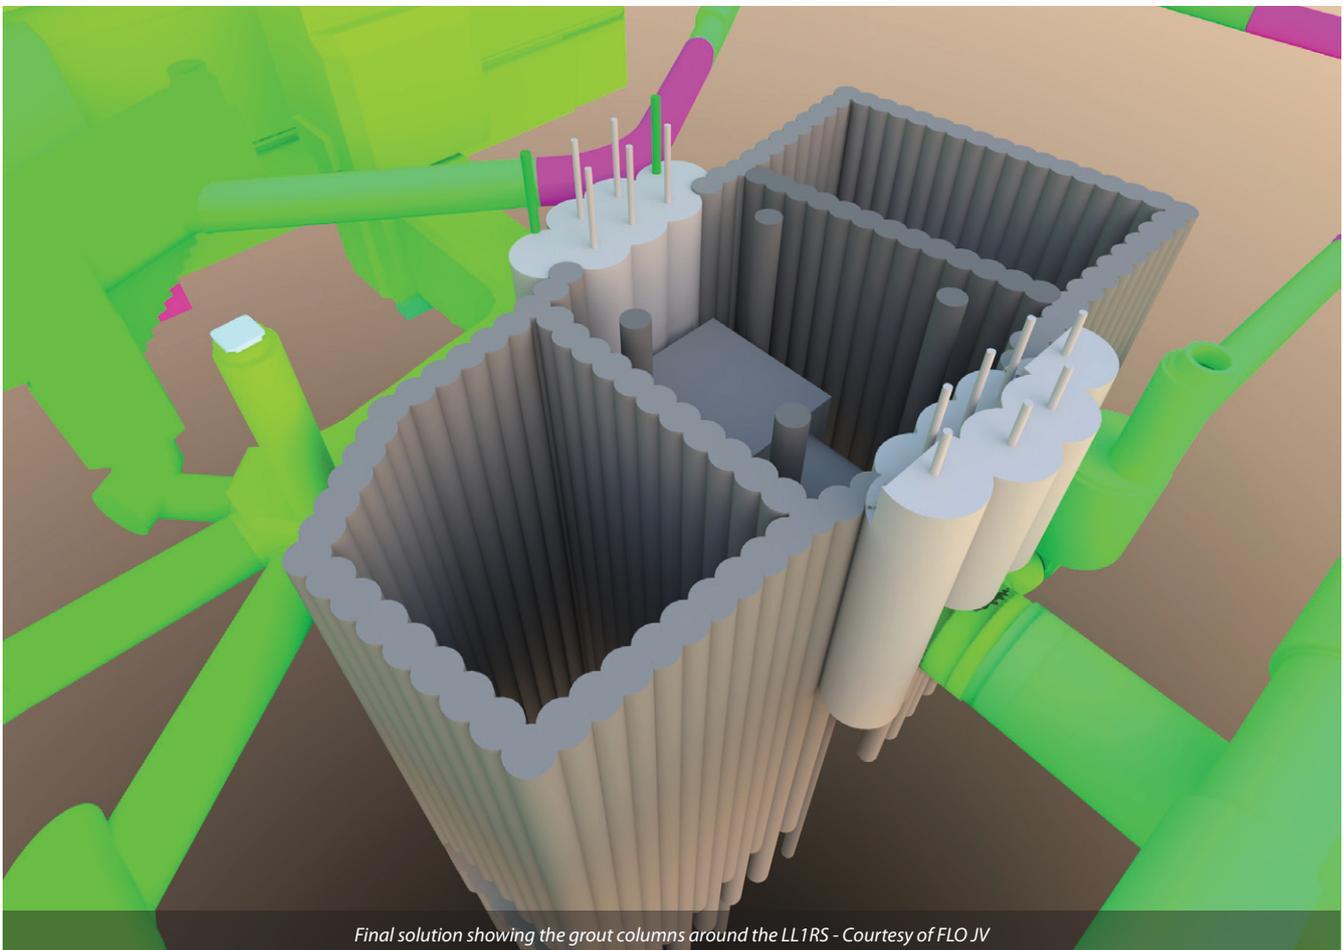
Final solution showing the grout columns around the LL1RS - Courtesy of FLO JV

With the increased confidence provided by both FLO's improved understanding of the asset and the outcome of the trial, FLO and their subcontractor were able to propose a solution consisting of 14 interlocking grout columns; seven at the north and seven at the south side of the IC.

Each set of seven would be formed in two rows and would interlock with the existing secant piles. The columns would be of varying diameters of between 1.6m and 1.8m. The depth of the columns varied due to the position of the column around the LL1RS; the columns that were installed down the side of the LL1RS were installed in the London Clay strata located 7.5m beneath the existing ground level.

When forming the columns over the LL1RS, this offset would cause an excessive untreated area above the sewer which could result in ground stability issues in the future. To reduce the area of the untreated section, a specialist nozzle was procured from Germany that has a reduced distance from the drill head to the nozzle whilst also having the ability to be angled down at 15°. This solution was essential in reducing the untreated areas above the sewer.
