# Hingston Down Reservoir

## fast-tracked project to provide resilience of supply

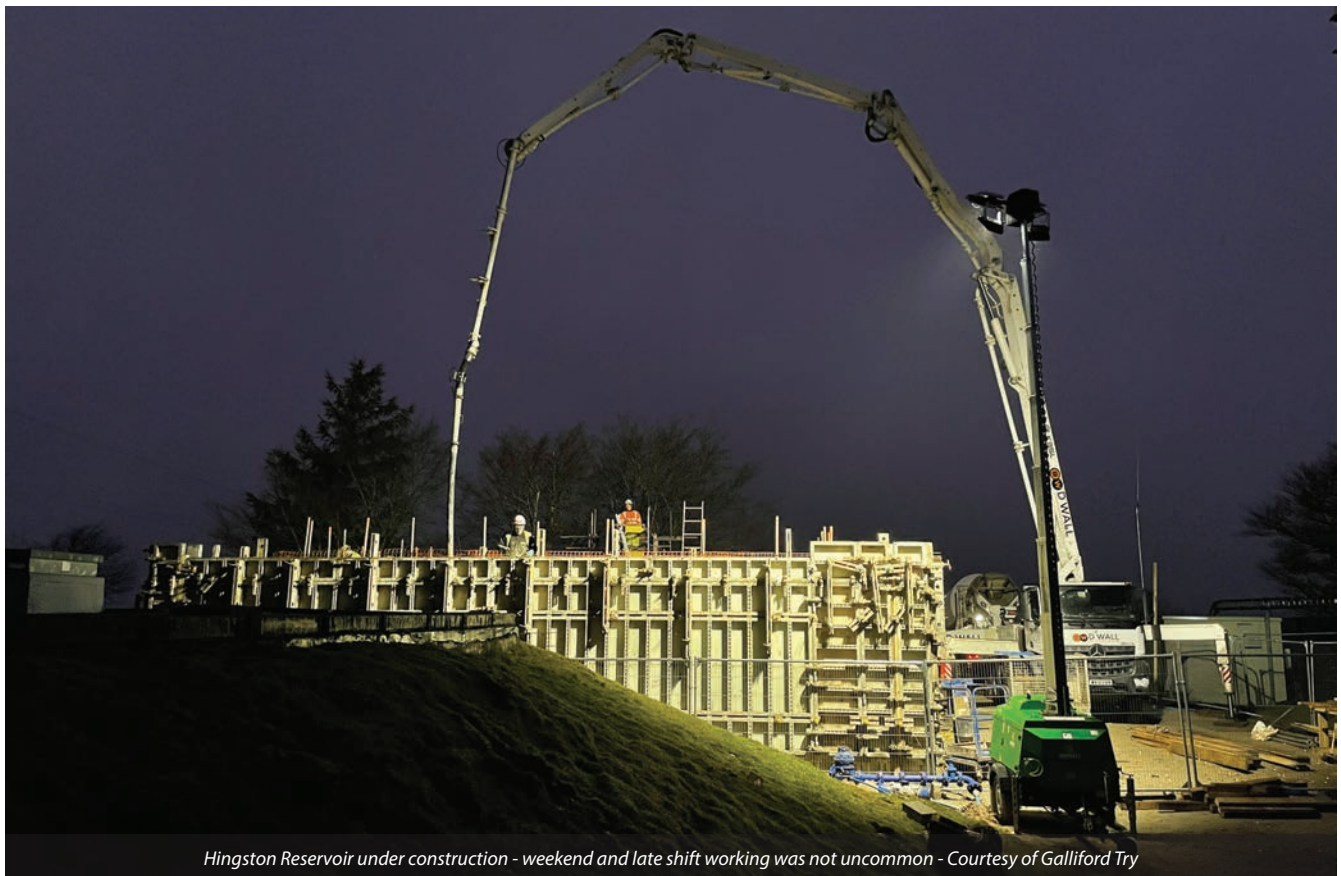
*Hingston Reservoir under construction - weekend and late shift working was not uncommon - Courtesy of Galliford Try*
