# Ise Valley Sewer Rehabilitation

## temporary overpumping solution facilitates CIPP re-lining using ultraviolet and water cure techniques

by Anglian Water's @one Alliance

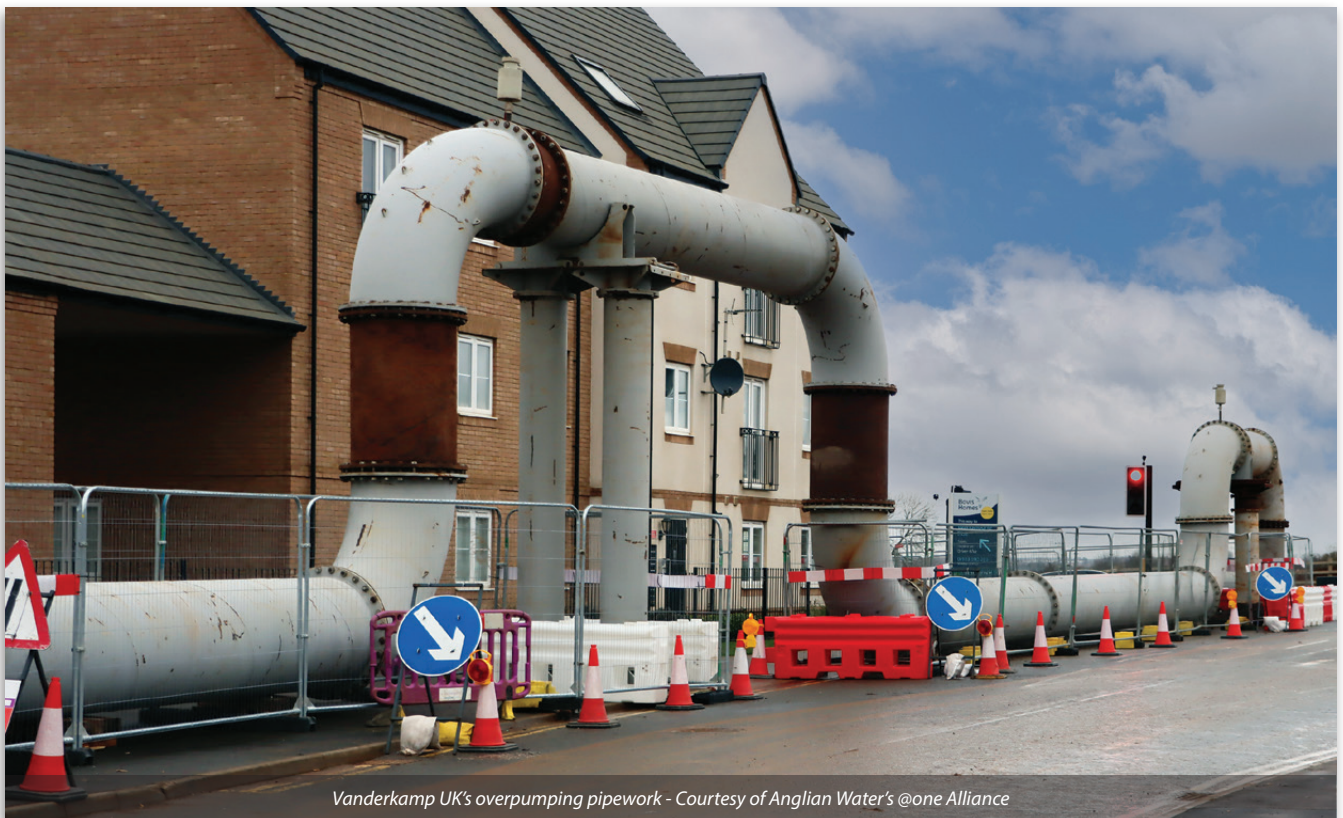
Vanderkamp UK's overpumping pipework - Courtesy of Anglian Water's @one Alliance

Utilising contacts across the @one Alliance's supply chain, specialist overpumping contractor Vanderkamp UK was contracted to provide a temporary bypass in short order. The teams decided on a 1m diameter pipe to give the equivalent flow of the existing twin 700mm diameter pipes to avoid reducing pump capacity.

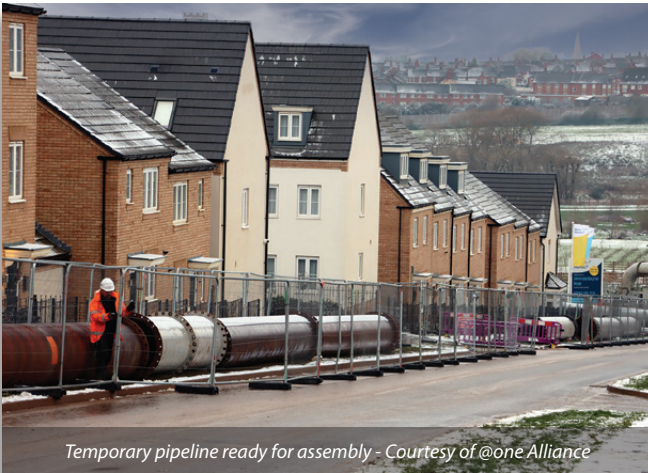
Temporary pipeline ready for assembly - Courtesy of @one Alliance

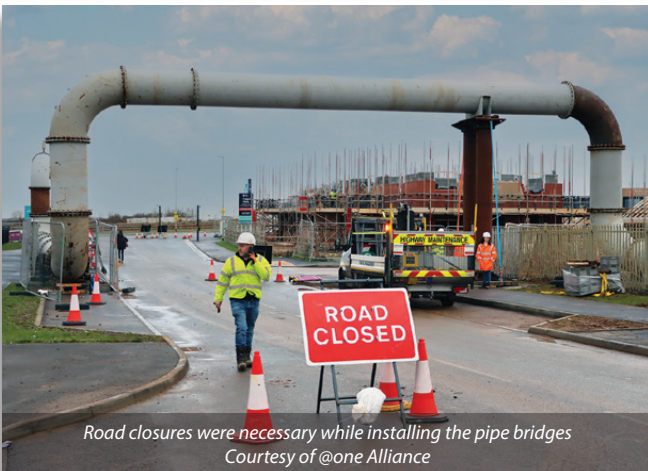
Road closures were necessary while installing the pipe bridges  
Courtesy of @one Alliance

Due to the new housing development, it was not possible to follow the route of the existing mains and care had to be taken to ensure the bypass pipework would not interfere with a permanent solution or the ongoing operation of the pumping station. A route along Driver Way and Irthlingborough Road was selected which included several pipe bridges in order to allow unrestricted customer access. Emergency road closures were agreed with both the local property developer and North Northamptonshire Highways to safely install the pipework.

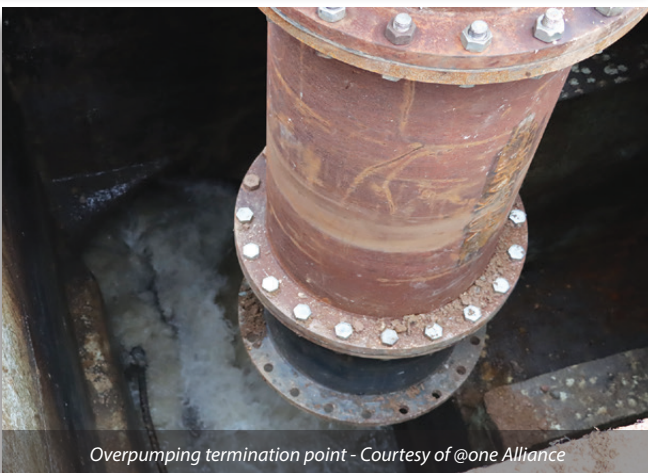
Overpumping termination point - Courtesy of @one Alliance

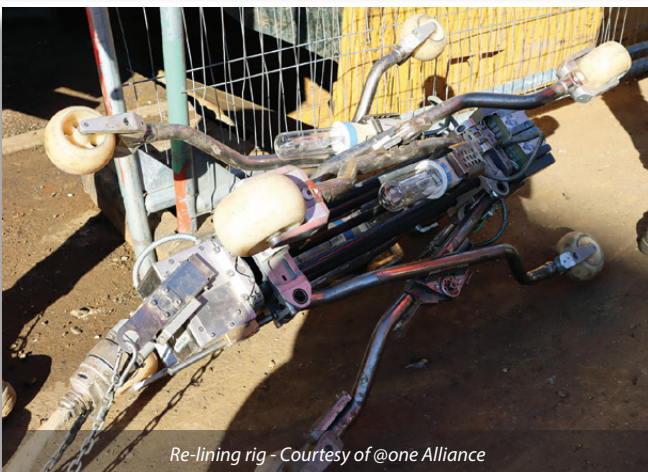
Re-lining rig - Courtesy of @one Alliance

Rehabilitation of the existing mains using specialist pressured cured in place pipe (CIPP) liners was selected. Framework supplier OnSite Central Ltd installed the liners using a combination of ultraviolet and water cure techniques to suit the challenging pipe conditions. Aware of the time constraints, OnSite Central Ltd worked with the project team to ensure the liners were delivered promptly from IMPREG GmbH in Germany, and that installation gangs were available to work extended shifts to ensure the challenging programme was delivered.

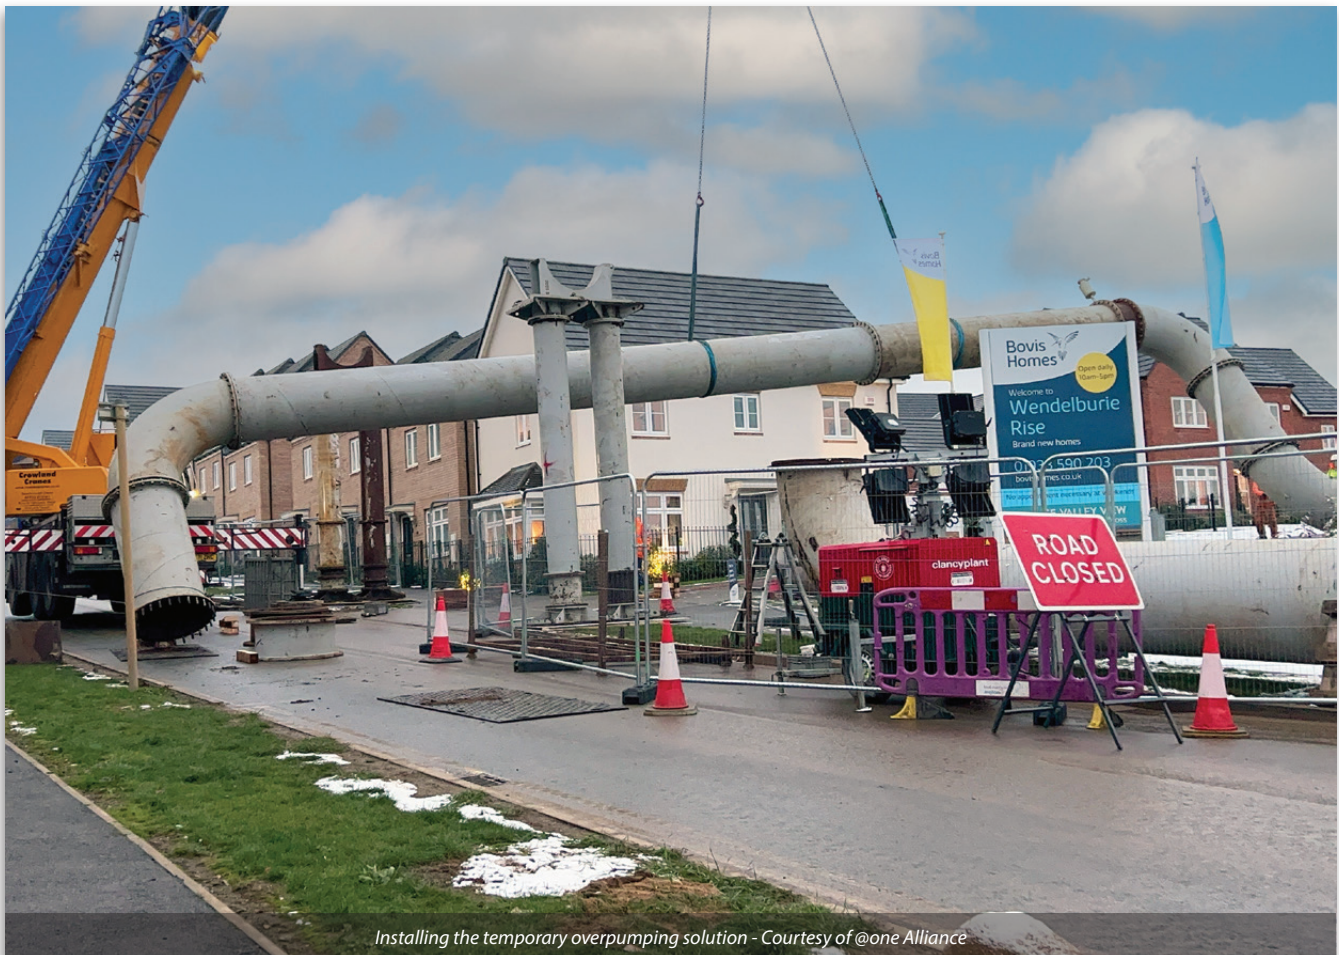
Installing the temporary overpumping solution - Courtesy of @one Alliance
