Toplers Hill Water Tower

refurbishment of a 90-year-old potable water storage tank in Bedfordshire without compromising water quality

by Anglian Water's @one Alliance

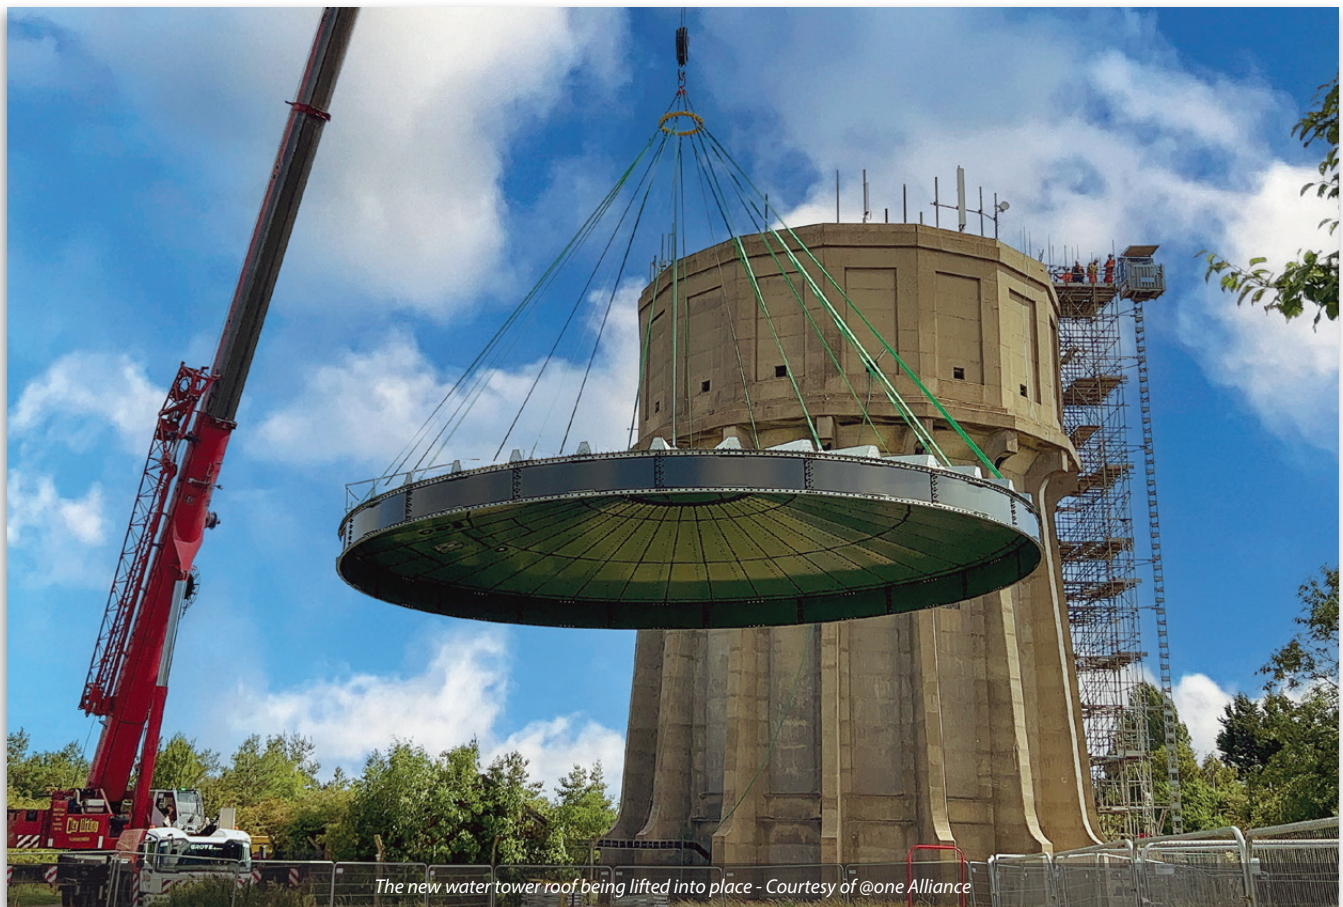
The new water tower roof being lifted into place - Courtesy of @one Alliance

Roof replacement: The leaking tank roof was removed by crane by Hayes GFS Ltd and dismantled this on site. This was replaced with a new glass lined steel structure provided by Permastore and installed by Hayes. The top section of the walls had been identified as heavily corroded, so was cut away and prepared to receive the new roof arrangement. Using a crane from Cadman Cranes Ltd, the new tank roof was lifted into position onto the existing structure.

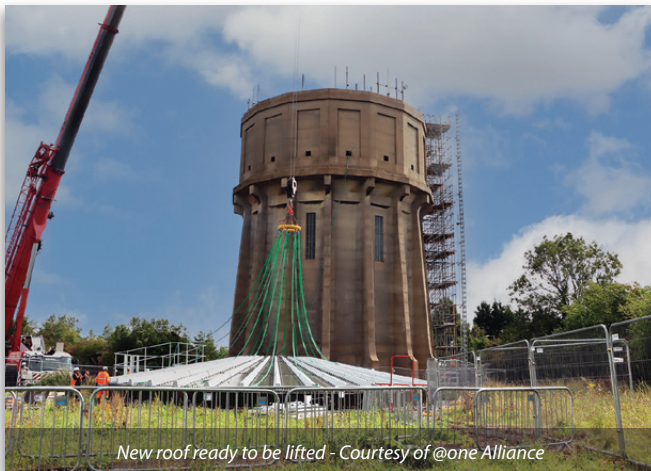
New roof ready to be lifted - Courtesy of @one Alliance

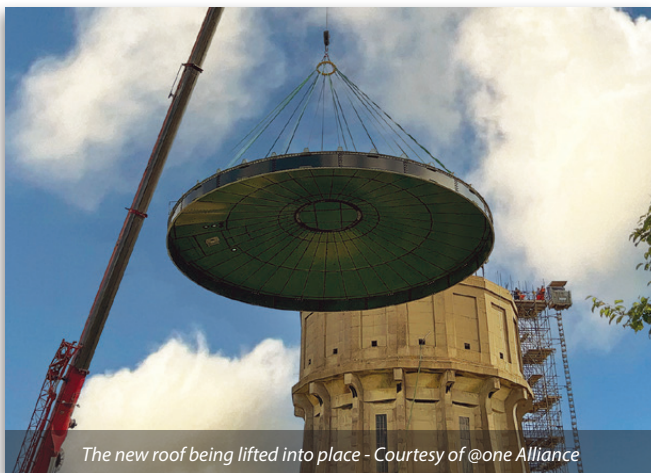
The new roof being lifted into place - Courtesy of @one Alliance

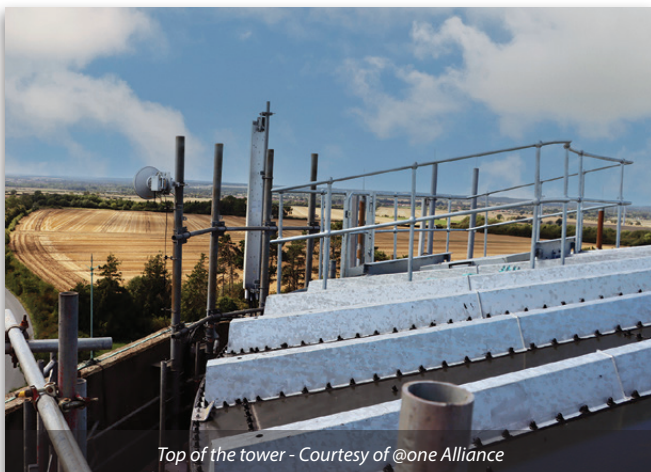
Top of the tower - Courtesy of @one Alliance

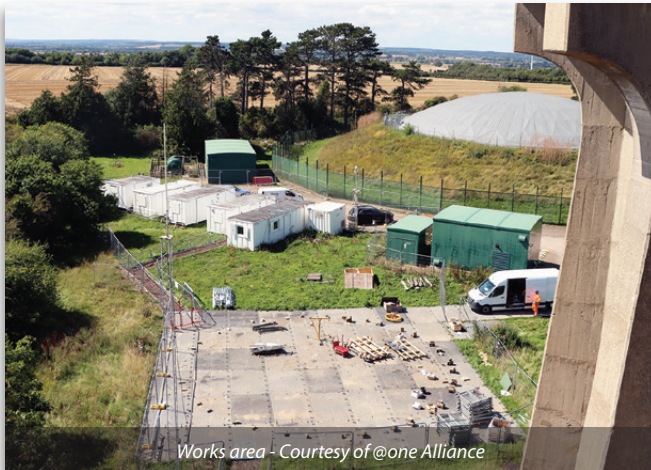
Works area - Courtesy of @one Alliance

Crane pad and lay down area: Whilst the scaffold was being installed, Claret Civil Engineering designed a crane pad to facilitate the old roof removal and new roof installation. A separate levelled roof dismantling/assembly area was created nearby and covered with track matting.
