# West Hallington Reservoir

## design and construction of two 700mm diameter siphons for reservoir draw down

by Peter Bell

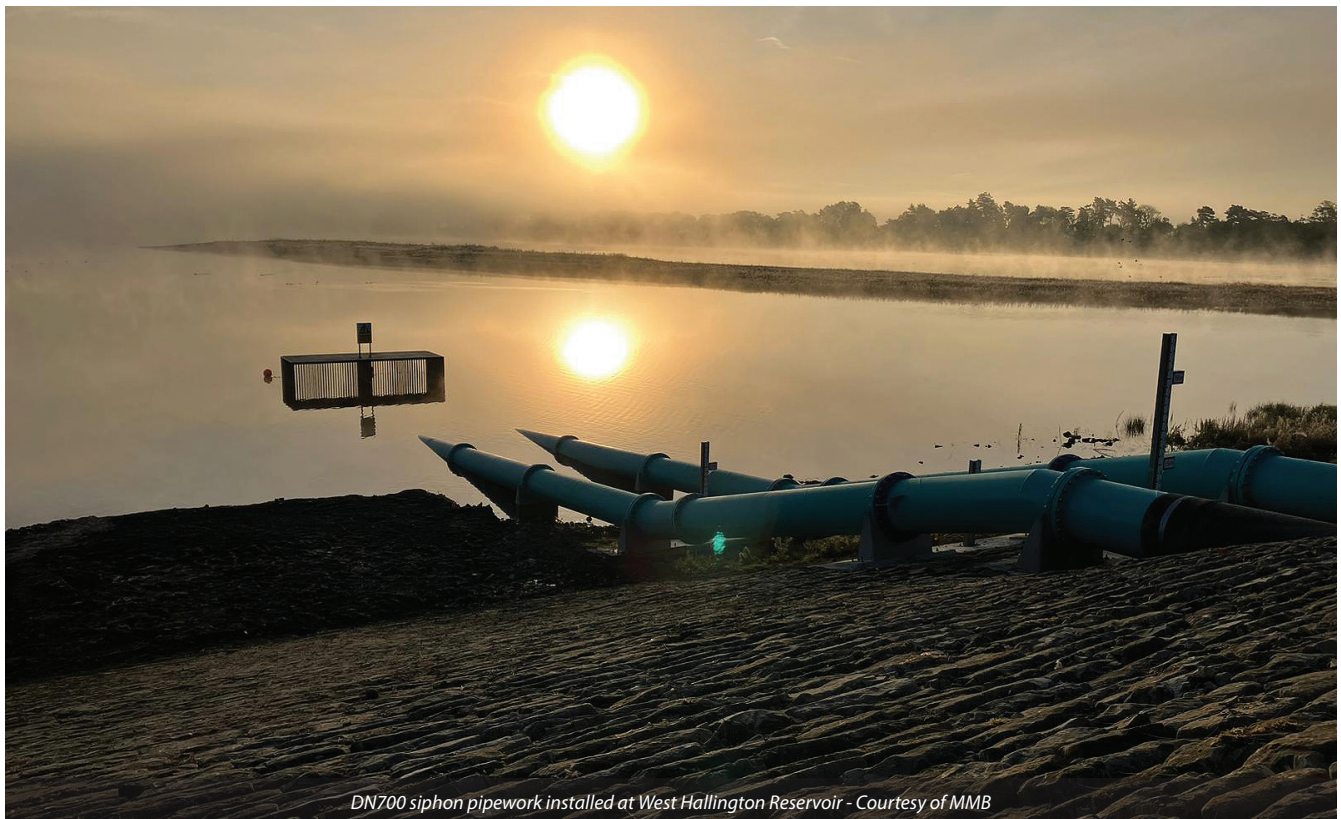
DN700 siphon pipework installed at West Hallington Reservoir - Courtesy of MMB

Mott MacDonald Bentley (MMB) developed a design solution which utilises two 700mm diameter siphons on the west embankment to operate at a combined flow rate of 3.2m<sup>3</sup>/s. The new siphon pipeline, alongside a temporary pump arrangement and the existing scour pipes, will meet the required drawdown capacity. The siphon flows will be conveyed across a stretch of adjacent field which NWG has purchased. The flows will then either percolate to ground or gravitate to the Coal Burn and eventually to the River North Tyne.

**Pipes and thrust restraint:** Hoops stresses within the DN700 mild steel siphon pipes were checked and a DWI Regulation 31 coating specified. The stainless steel pipe supports were analysed for bending and shear and concrete thrust blocks were designed for the system test pressures. The pipe wall thickness was reduced from 10mm to 8mm as an efficiency. The pipework arrangement drawing was uploaded into the federated model in BIM360 to check for clashes and when installed on site was found to fit perfectly.

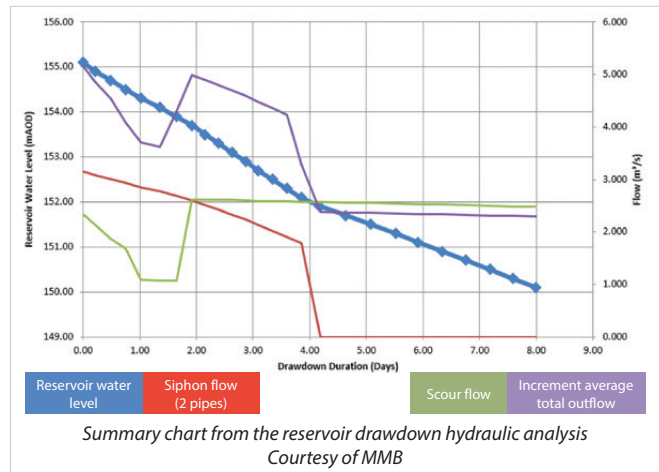
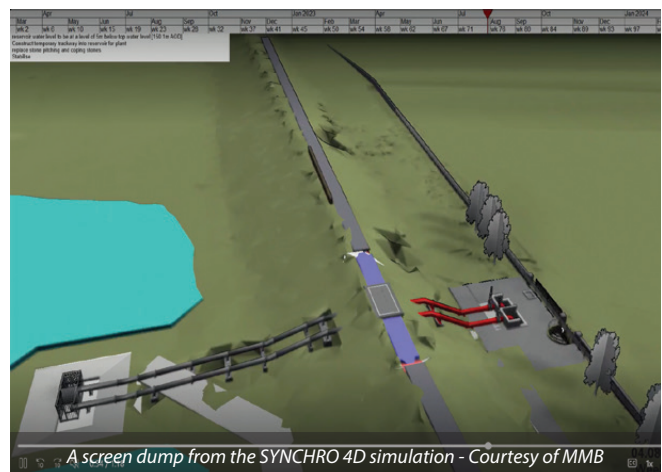
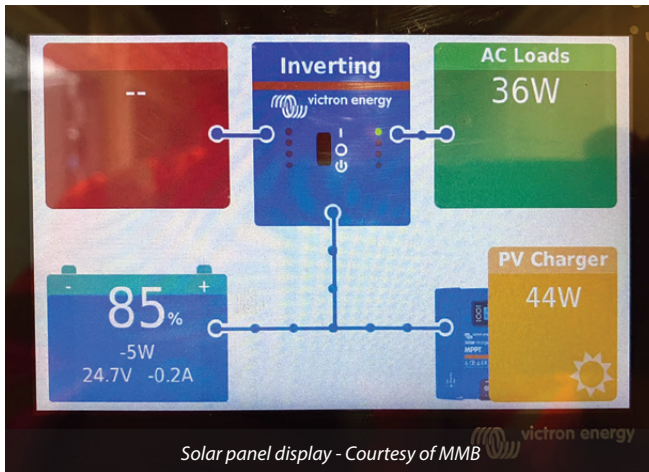
**Synchro 4D:** MMB chose SYNCHRO 4D from Bentley Systems during the latter stages of the design process. SYNCHRO 4D is software that enables MSP/P6Programme to be linked with a Revit model and to run a construction simulation. The simulation highlighted a number of pinch points when materials must be delivered or when water levels must be lowered or raised and helped drive efficiencies. SYNCHRO 4D was also useful for explaining the construction process to the client, to site operatives and to visitors.

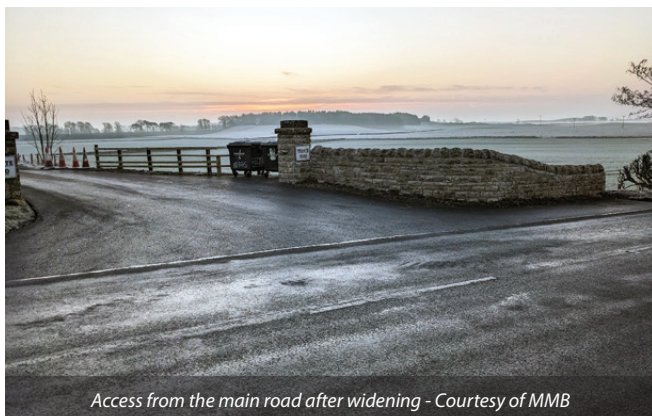
Access from the main road after widening - Courtesy of MMB

Northumbrian Water is very keen on creating community projects and "leaving a legacy". MMB widened the access from the main road and provided three passing places as the access route is used by both residents and members of the fishing club.

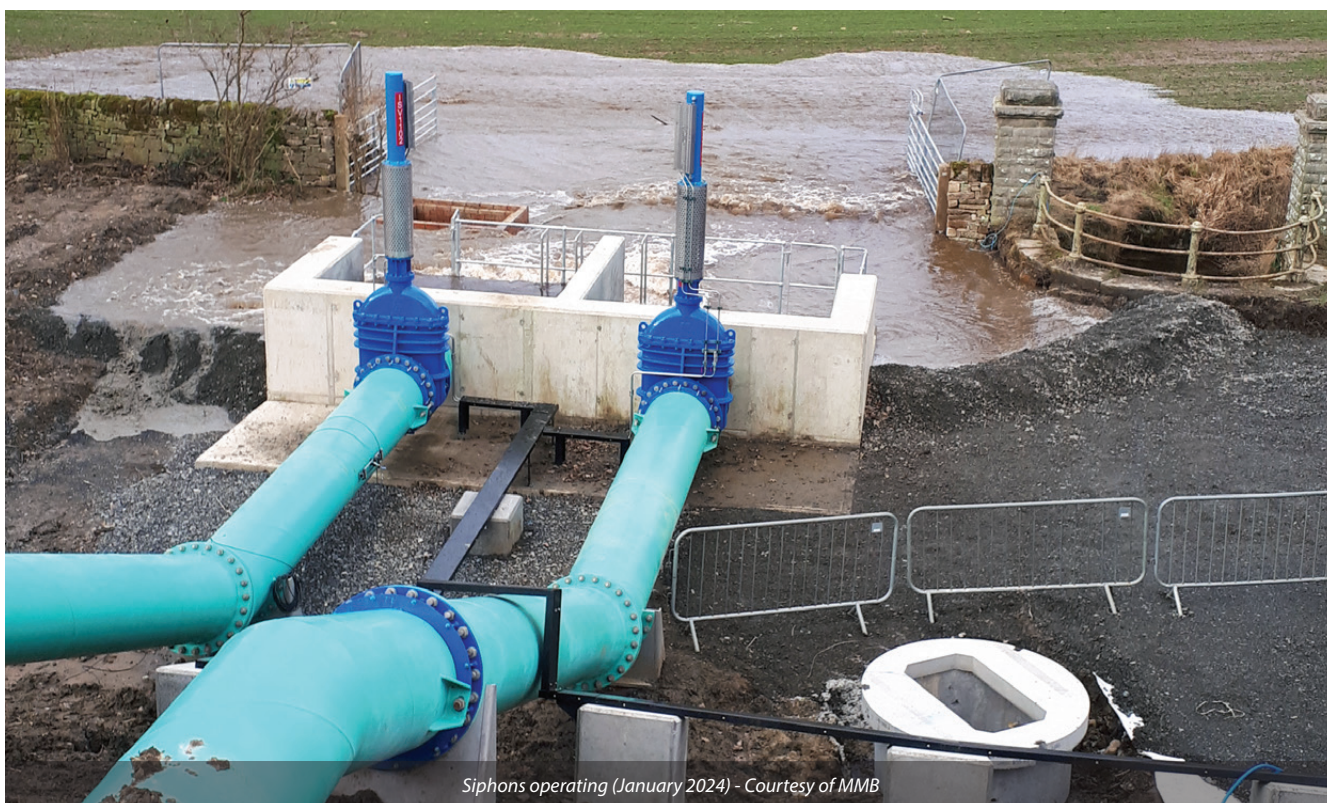
Siphons operating (January 2024) - Courtesy of MMB

The siphon is designed to operate above a water level of 152.5m AOD and to self prime above a level of 154.1m AOD (TWL = 155.1m AOD) and so the All Reservoirs Panel Engineer (ARPE) requested that during the testing and commissioning stage, MMB should demonstrate the following:

- That the siphon can be primed between the water levels 152.5m AOD and 154.1m AOD.
- That the siphon can self-prime above a water level of 154.1m AOD.
- That the Full Supply Level of 155.1m AOD can be achieved.
