Dunside Reservoirs

the removal of two reservoirs from the Reservoir Act

by Louise Methven & Charlie Gallagher

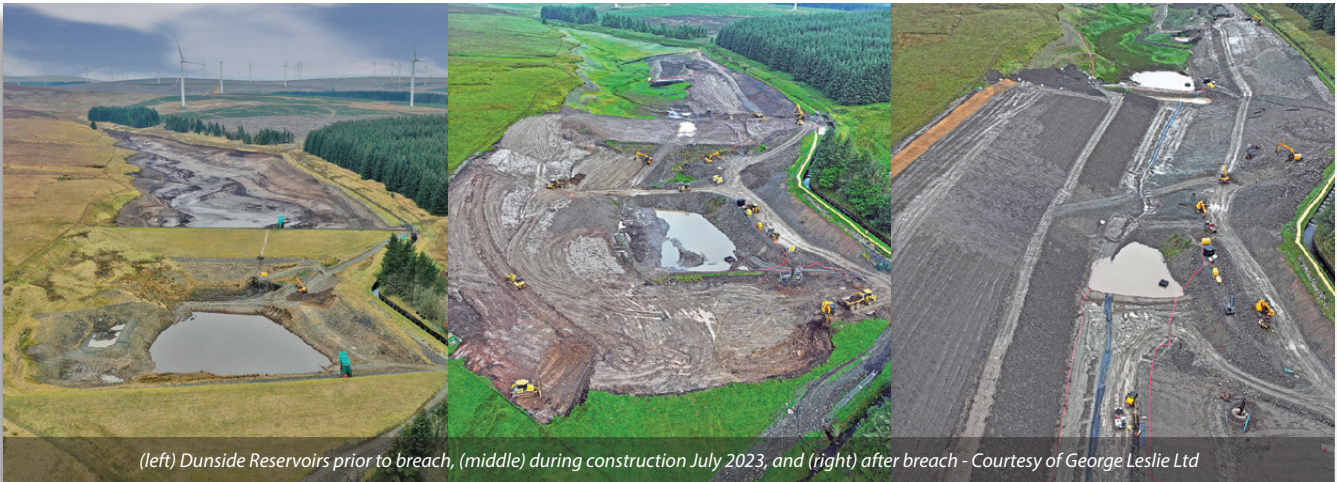
(left) Dunside Reservoirs prior to breach, (middle) during construction July 2023, and (right) after breach - Courtesy of George Leslie Ltd

- Breach cut through the Dunside upper embankment (down to the original watercourse level). Work to be undertaken in a specified sequence.
- Breach cut through the Dunside lower embankment (down to the original watercourse level). Work to be undertaken in a specified sequence.

- Creation of a meandering channel through the base of each embankment, following the alignment of the original watercourse from historic drawings.
- Grouting of the outlet pipes through both embankments.

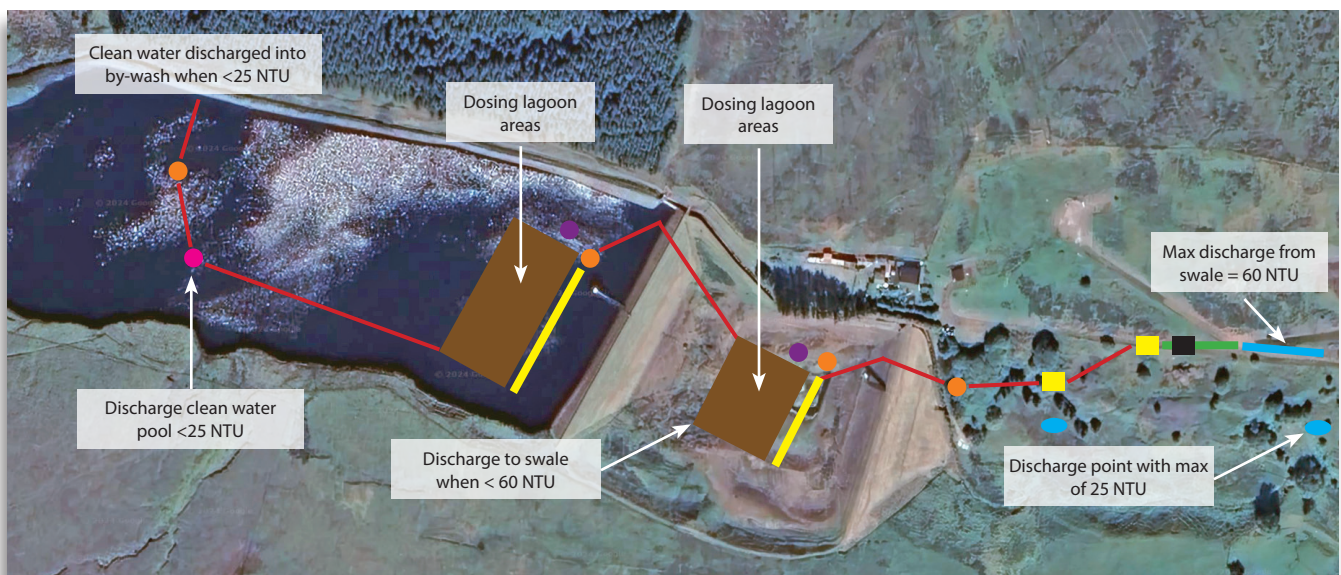
Water management plan layout - Courtesy of George Leslie Ltd

- Swale
- Bagging
- Clay bund
- QP33 dosing unit
- De-silters and/or settlement tank
- 8" or 4" pumps
- Murlac bagging
- Ditch lined with visqueen and sedimats along route
- Incoming water dammed to reduce water to Upper Reservoir
- Silt netting

A Water Management Plan, detailing an extensive regime of settlement lagoons and swales, filtration through matting and bags, and finally lagoon flocculation using QP33 was developed and implemented prior to any release of water to existing watercourses.

QP33 is an organic coagulant, which is supplied and installed by Taytech Environmental Ltd. This coagulant is a primary chemical used in suspended solids settlement. At the time of writing (August 2024) QP33 was the only flocculant chemical approved by SEPA.

Sediment filter bags from Murlac Land & Marine Environmental Solutions are made of a 90 micron non-woven high strength (400 gsm) geotextile, which catch silt, sediment and oil, whilst releasing clean water. The Murlac sacs were connected to the de-silters to catch any finer silt before discharge.

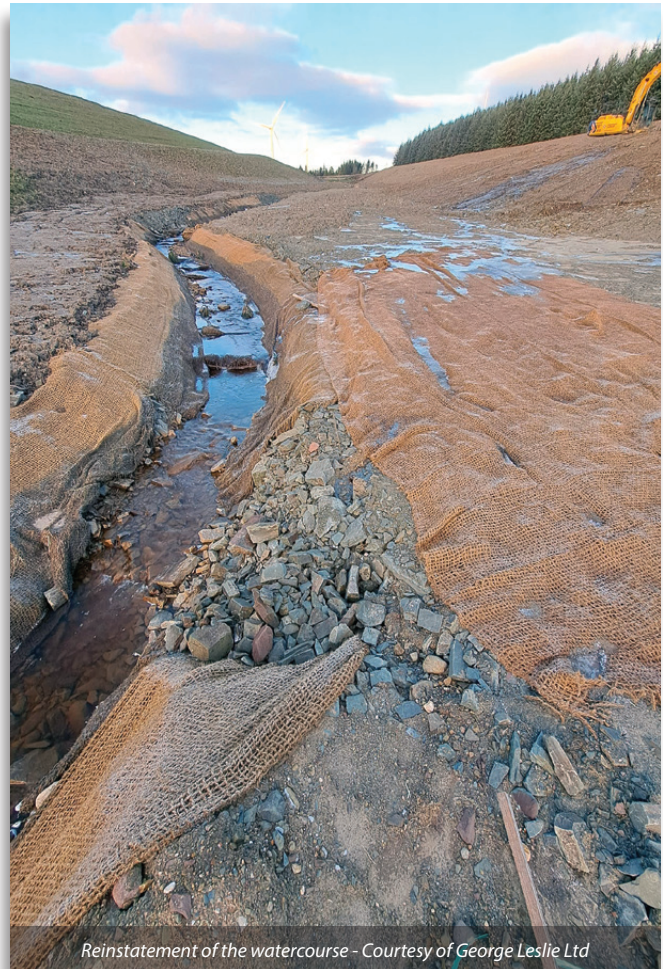
Reinstatement of the watercourse - Courtesy of George Leslie Ltd

Following the earthworks being completed, the formation of the watercourse was carried out. Hydro-morphologists from Mott MacDonald and SEPA had consulted historical maps, from prior to the original dam construction.

George Leslie Ltd was tasked with reforming the watercourse as closely as possible to the original course to replicate the sinuosity to appear more natural and less engineered. Prior to flows being gradually re-introduced over a prolonged period, coir fabric was installed temporarily on the burn banks to minimise scouring whilst vegetation growth took place.

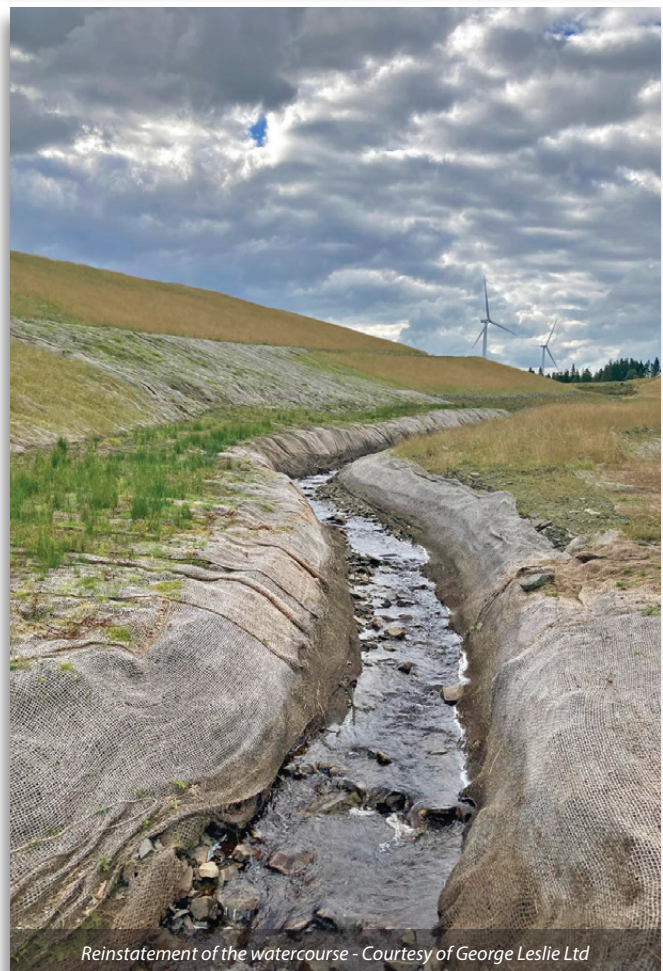
Reinstatement of the watercourse - Courtesy of George Leslie Ltd
