Llyn y Fan Fach Reservoir

Grade II listed structure that underwent refurbishment to address safety concerns in the draw-off tower and spillway

by Alasdair Handley CEng MEng, Amy Jones MEng & Simon Fisher

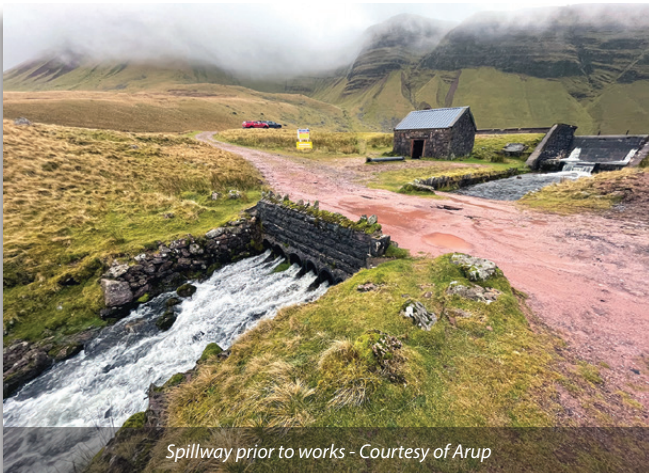
Spillway prior to works - Courtesy of Arup

The proposal was to fully replace the lower spillway with a precast structure capable of passing the 1,000 year (design) and 10,000 year (safety) flood events for the Category B dam. The wall heights were designed to contain the flows including full USBR freeboard. In order to maintain cultural heritage of the existing spillway, the spillway was lined with stonework.

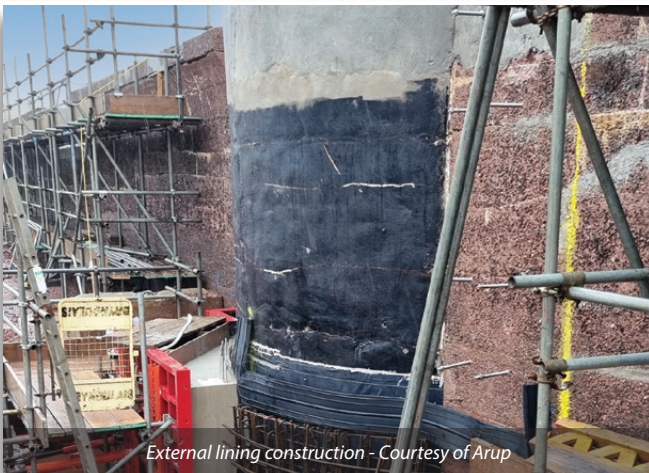
External lining construction - Courtesy of Arup

The site team utilised Filcor 90 expanded polystyrene shuttering from Cordek Ltd to make the external repairs to the drawdown

tower and dam face. This innovative shuttering solution used the output from 3D surveys to fabricate the intricate curvature of the existing tower and corbel detail and then mold the shuttering off site, allowing delivery to site in manageable sections. Given the location of the dam, the at times poor weather conditions the site team faced, traditional timber shuttering would not have been able to form the shape of the tower.

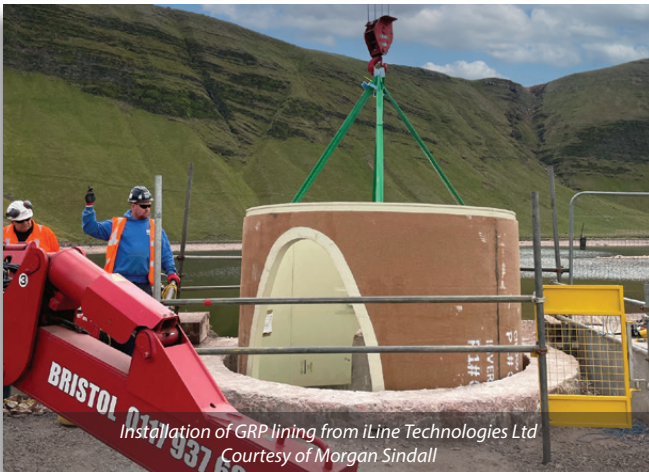
Installation of GRP lining from iLine Technologies Ltd
Courtesy of Morgan Sindall

1. A glass reinforced plastic (GRP) liner that is flexible enough to accept the thermal strains of the existing dam wall elastically, whilst being strong enough to resist the hydrostatic loading from the reservoir. The GRP liner is also designed to withstand the environmental conditions within the tower as it is the primary means of preventing water ingress to the shaft. Arup worked closely with the supplier, iLine Technologies Ltd, to guide their design and verify it met the requirements.

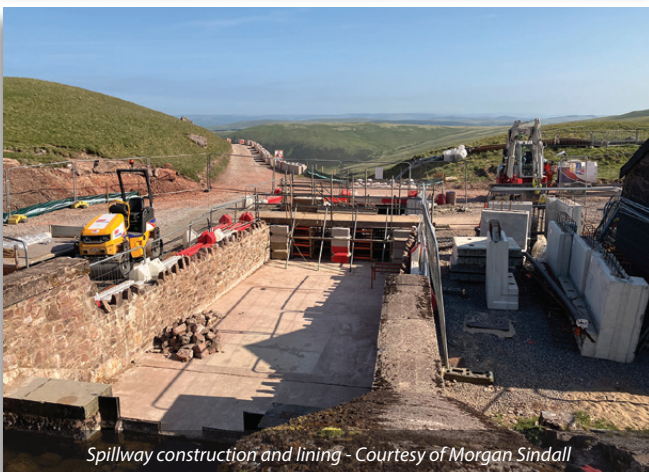
Spillway construction and lining - Courtesy of Morgan Sindall

A significant constraint was the low clearance and low capacity bridges on approach to the site. This restricted the size of plant that could be transported and in turn, the size of components that could be handled. Therefore a large number of precast concrete units were required to make up the spillway structure with a considered and minimised use of in situ stitches. Another example where this constraint influenced delivery was that the tower required GRP sections with a 2.7m internal diameter being transported over a 2.4m wide bridge. The rings were therefore formed in half sections and assembled in situ.

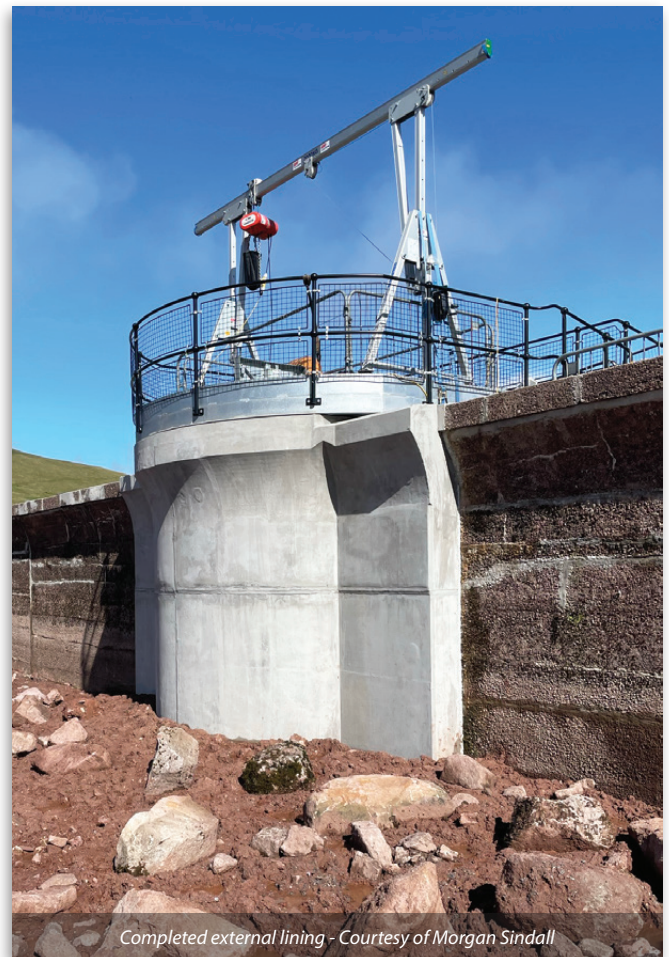
Completed external lining - Courtesy of Morgan Sindall

2. The existing cracking to be raked and filled with a flexible sealant. The sealant allows the cracks to continue to move. It is shrouded from UV radiation and temperature effects by a new façade to extend its working life.
3. A new reinforced concrete wall on the upstream face of the tower to structurally replace the cracked valve tower wall. This wall is made of two leaves cantilevering from the dam walls with a movement joint down the middle. This structure will also insulate the cracks and their repairs from environmental effects as well as being the first line of water ingress defence with a waterbar around its perimeter and waterproofing admix.
