# Red Doles CSO

## refurbishing an existing combined sewer overflow that had reached the end of its asset life

by Pamela Ajayi & Kruti Makwana

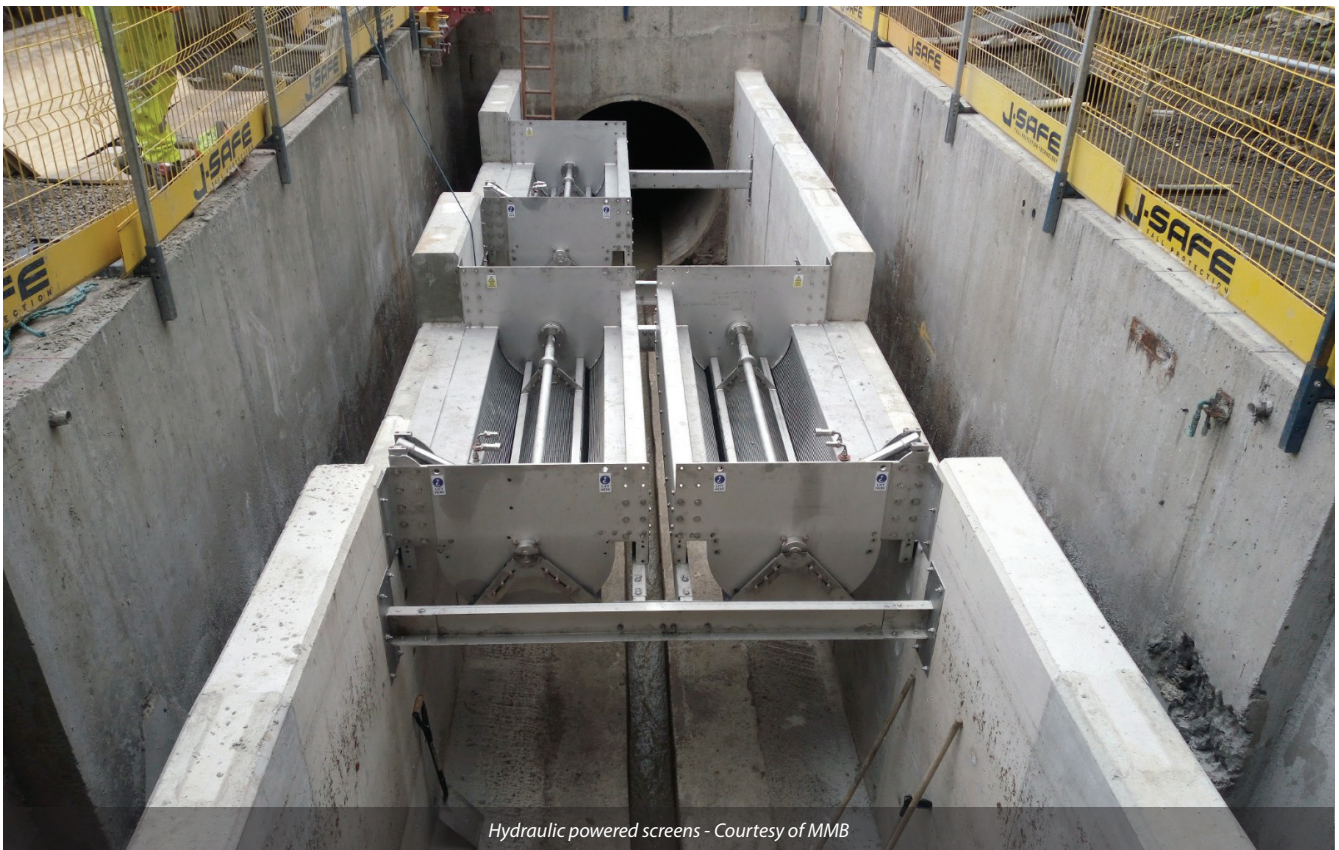
Hydraulic powered screens - Courtesy of MMB

Mott MacDonald Bentley (MMB) was instructed by Yorkshire Water to undertake the refurbishment of the existing CSO chamber, which involved installing three new 2.5m hydraulic screens from Eliquo Hydrok along with associated electrical components. Structural modifications to the chamber were necessary, including the removal of the existing concrete weir wall and roof slab, installation of new precast weir walls, re-benching of the existing chamber, and installation of a new precast cover slab to enable installation of the three new screens. Additionally, the project required the removal of a brick control building, disconnecting the power supply, and installing two new security-rated GRP kiosks for hydraulic power packs and a control panel along with a new power supply.

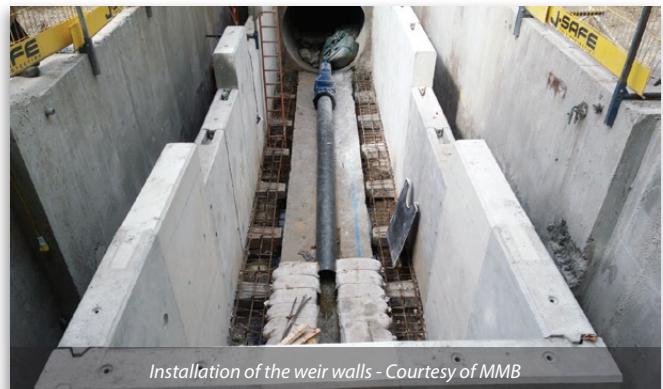
Installation of the weir walls - Courtesy of MMB

MMB adopted a Design for Manufacture and Assembly (DfMA) approach throughout the modification of the CSO. Precast concrete weir walls with infill stitches from FLI Precast Solutions were used for the new weir walls; suitable for the new screen arrangements and providing quality and time savings compared to traditional in situ installations. The screens, which were manufactured off site, could be lifted and bolted into place, reducing assembly on site within the chamber. Finally, the cover slabs were specially manufactured to fit the unique chamber size, providing self-supported slabs with the necessary maintenance and inspection openings.

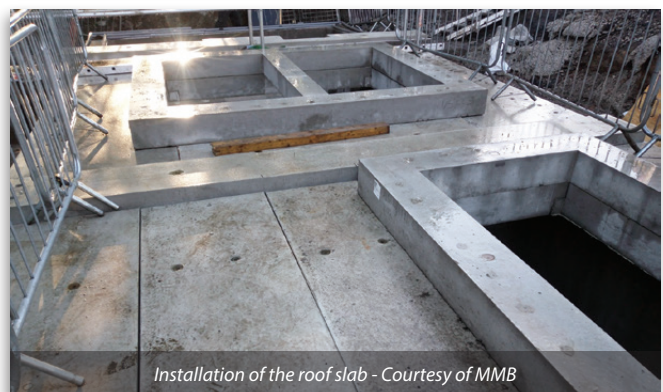
Installation of the roof slab - Courtesy of MMB
