Cadney Reservoir

repairs to cracks and joints at a key reservoir to restore structural stability by preventing water infiltration and reducing the risk of leaks or failures

by Anglian Water's @one Alliance

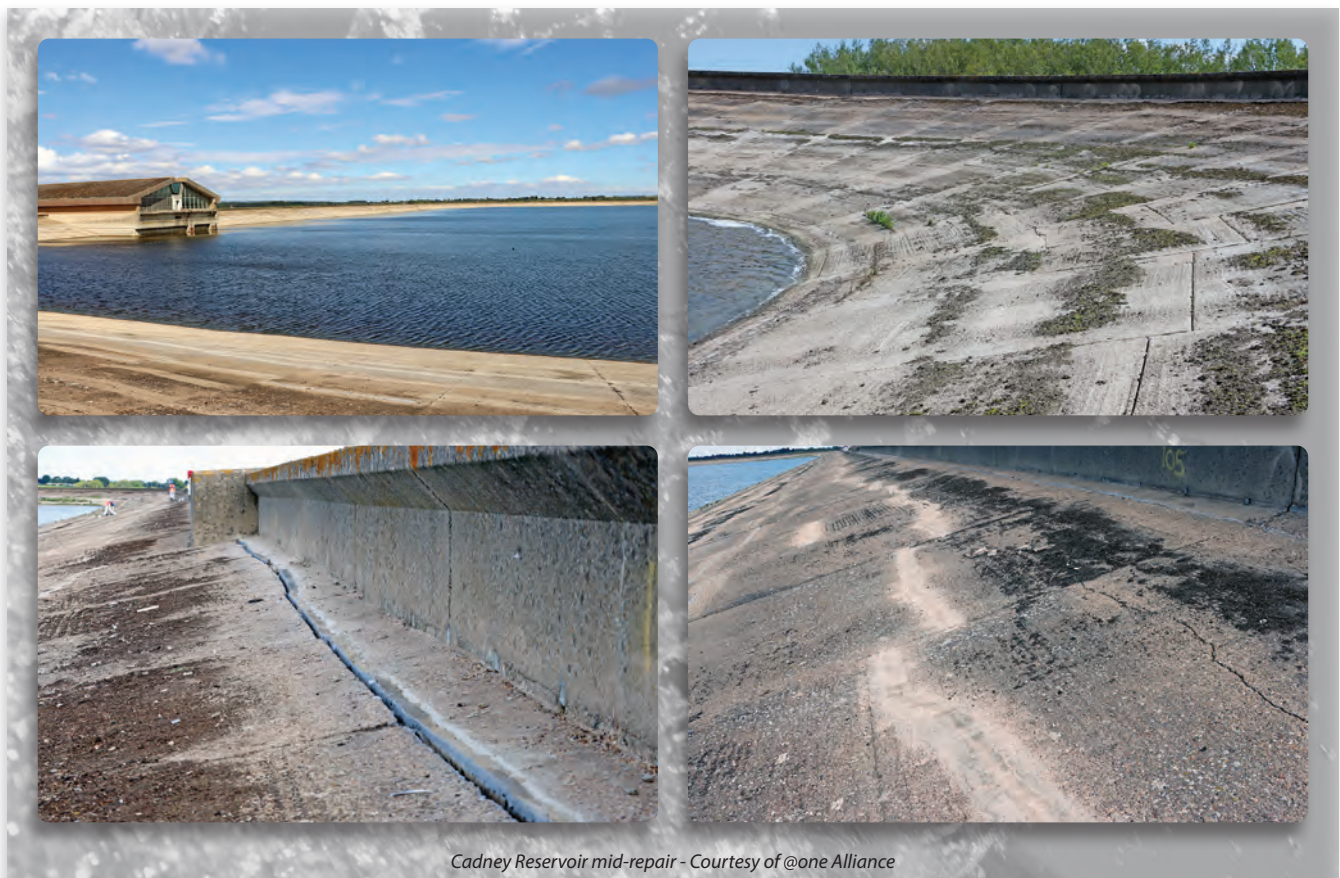
Cadney Reservoir mid-repair - Courtesy of @one Alliance

Surveys of the revetment identified potential for release of gravel from cracks and construction joints greater than 10mm in width between bottom and top water levels. The repair strategy was to prevent water ingress, and subsequent release of gravel, via sealing of cracks and joints, whilst retaining potential for movement in construction joints.

Approximately 6935m of the embankment required repair. Construction joints greater than 10mm in width required sealing to prevent further water ingress whilst still permitting movement (in line with their original purpose). Joints were filled with SikaSil® DW sealant from Sika; an approved product for use in drinking water applications. The business worked closely with Sika to ensure that the significant quantities of sealant required were available

Cracks in the precast concrete slabs between 10mm and 40mm in width were also addressed utilising Sikasil® DW. Prior to sealant application all surfaces were primed using Sika's primer product. For instances of cracks in concrete revetment exceeding 40mm in width, repairs were completed utilising NATCEM® 35 from Natural Cement, a repair mortar approved for use with drinking water applications. Ahead of application, loose concrete was removed and cracks 'straightened' via disc-cutting to aid application of repair mortar. As with the application of Sikasil® DW all repairs were completed in line with the product curing requirements, utilising temperature logging to confirm compliance.
