Langford Weir Fish Pass

reconnecting rivers: the construction of a dedicated fish and eel pass on the River Blackwater to re-connect river channels

by Stonbury Ltd

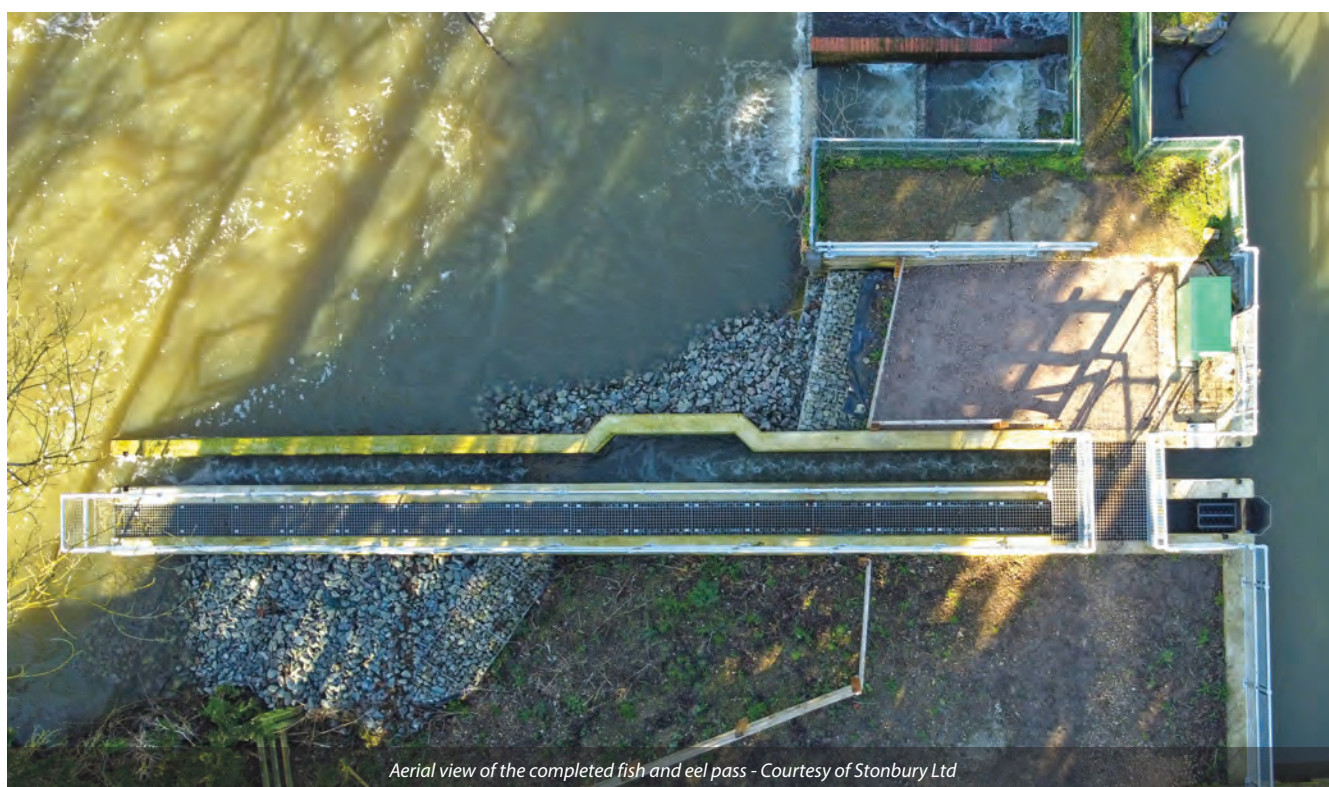
Aerial view of the completed fish and eel pass - Courtesy of Stonbury Ltd

To complete the pass, the team lined the inside of the channels with bespoke Larinier fish baffles and tiles suitable for eels and elver. On the eel side, GRP mesh flooring was affixed on top of the channel. A handrail was installed around the structure to allow safe access for operatives to maintain the pass and remove debris, and a debris deflector was installed at the head of the eel pass to reduce debris entering the system.

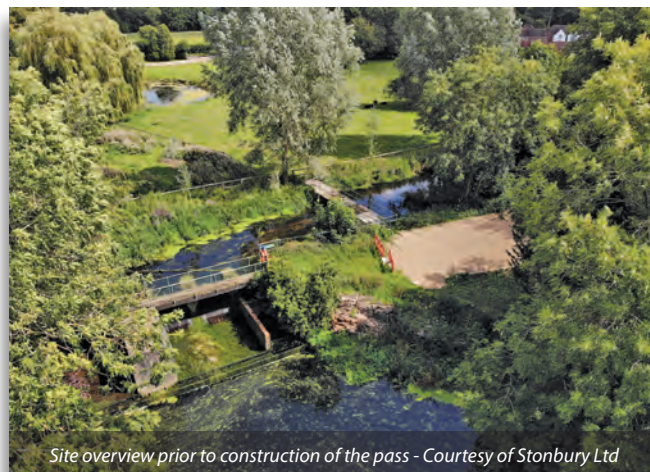
Site overview prior to construction of the pass - Courtesy of Stonbury Ltd

The River Blackwater splits into two channels at Langford Weir. The main River Blackwater flows westwards over the weir to a pond and continues to its confluence point with the River Chelmer, at Beeleigh, just north of Maldon Golf Club. Flows around the Langford Mill intake are conveyed in an eastern Blackwater channel to Beeleigh. The site is in a designated Conservation Area.

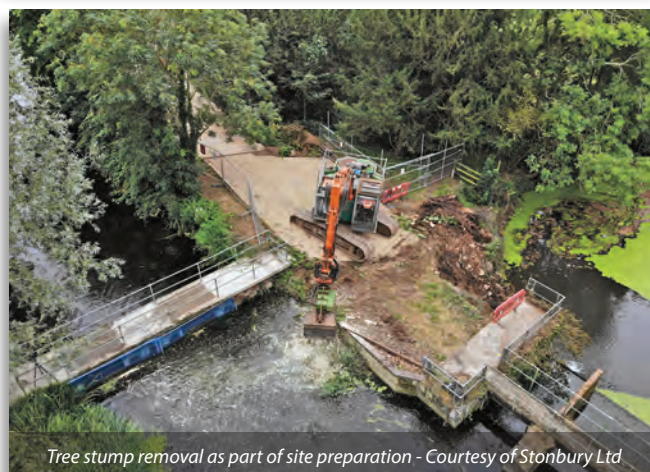
Tree stump removal as part of site preparation - Courtesy of Stonbury Ltd

As the site is in a conservation area which has a high potential for archaeology, the programme methodology included special measures to avoid breaking ground unless it was essential. Therefore, to install a safe access route to the working area, timber bog mats were laid to create a firm access road without excavating the ground. Suppliers with a specialist machine were mobilised for the removal of two large tree stumps that were obstructing the location of the new pass.

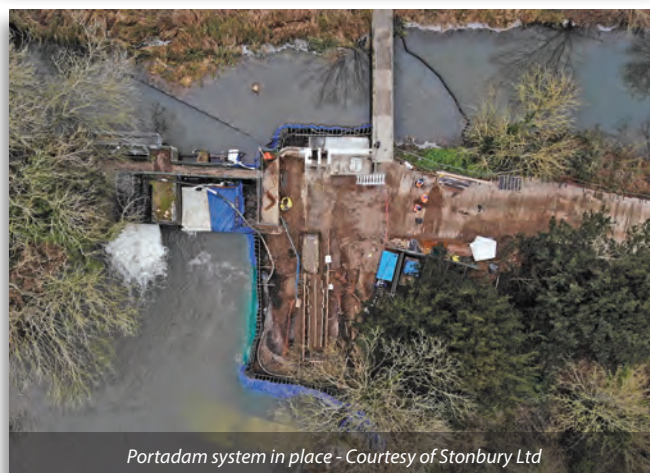
Portadam system in place - Courtesy of Stonbury Ltd

To dewater the site and create a dry working area, a temporary Portadam system from OnSite Central Ltd was installed. One dam was installed on the river side at the top end of the pass, and a second in the pond at the lower end of the pass. Temporary pumping was used to drain the area behind the Portadams and maintain drainage throughout the programme. Once the working area was dry, a piling mat was laid to allow access for the installation of steel sheet piling to prevent water from undermining the pass structure and provide additional foundation support.

Second, persistent heavy rain led to multiple major flood events which breached the Portadam and forced the team to reset the site and reinstate the working area before recommencing work. This was successfully managed by monitoring river and rainfall data to identify opportunities to reset and pump the area dry.

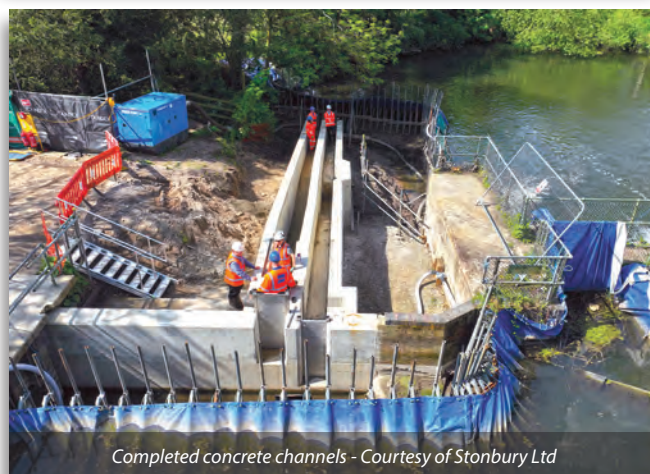
Completed concrete channels - Courtesy of Stonbury Ltd

concrete to create the main pass structure which included both fish and eel channels, a resting pool part-way up the fish pass, and cut-outs for stop logs and the new camera monitoring system.

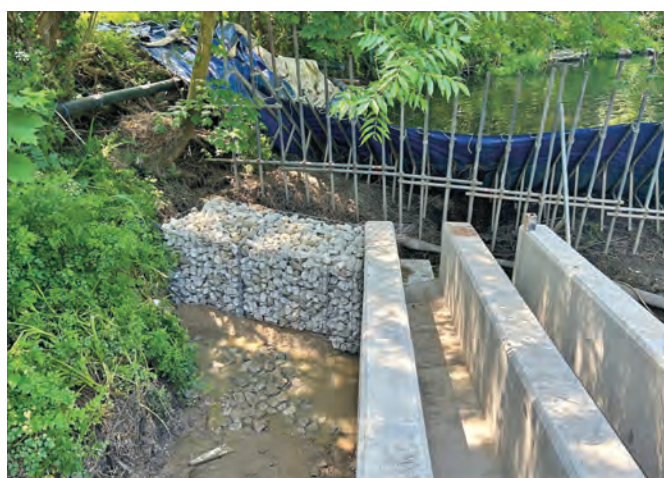
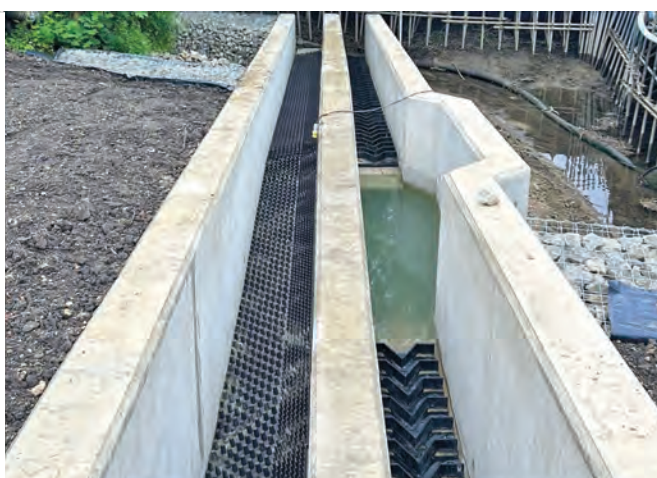
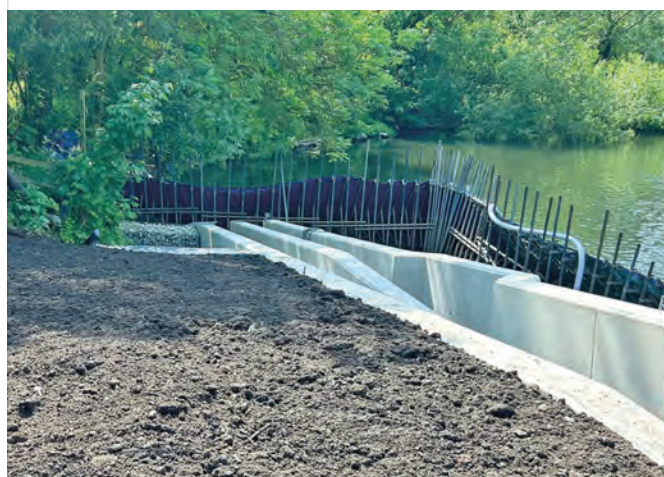
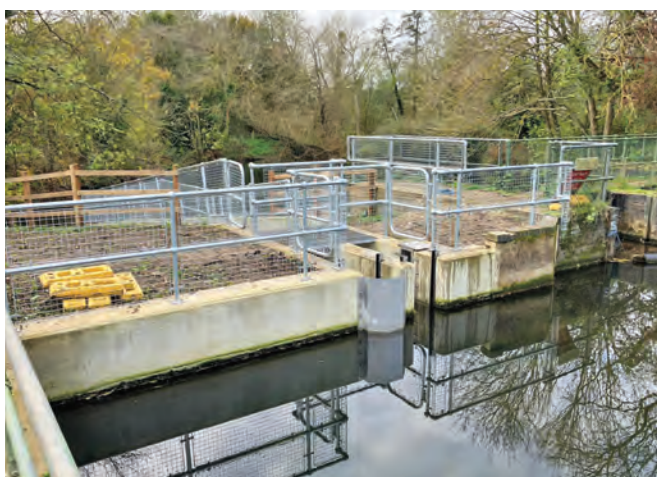
Construction components; clockwise from top left: Gabion baskets, specialised fish and eel tiles, soil reinstatement, and safety railings - Courtesy of Stonbury Ltd

After casting the concrete pass structure, the team installed an engineered wall on the river side of the structure and gabion baskets on the pond side to support the bank and backfilled behind the baskets with clean stone. The lower gabion on the southern side (nearest the bank) was placed to prevent pooling in what would otherwise be a 'dead end' for the fish and eels looking for a way into the pass. The banks and ground around the structure were then reinstated with the previously excavated material.
