Gowerton WwTW Sea Outfall

Dŵr Cymru Welsh Water outfall rehabilitation to alleviate pollution in a SSSI and designated shellfish water

by Lee Galsworthy BSc (Hons) & Matt Unsworth BEng (Hons) CEng MICE

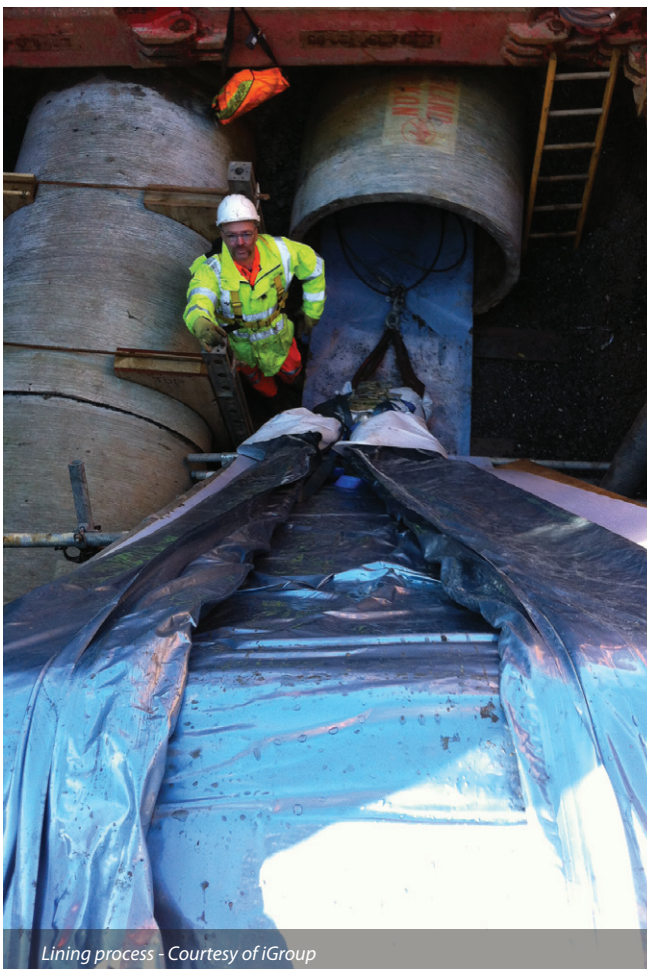
Lining process - Courtesy of iGroup

On locations where the existing pipes were in particularly poor condition, where water ingress or potential sharp edges of pipe may have resulted in damaging the liner, a plastic pre-liner was installed. Once the liner was in place, packers were installed to seal the ends and the whole liner was inflated to 250 millibar to achieve

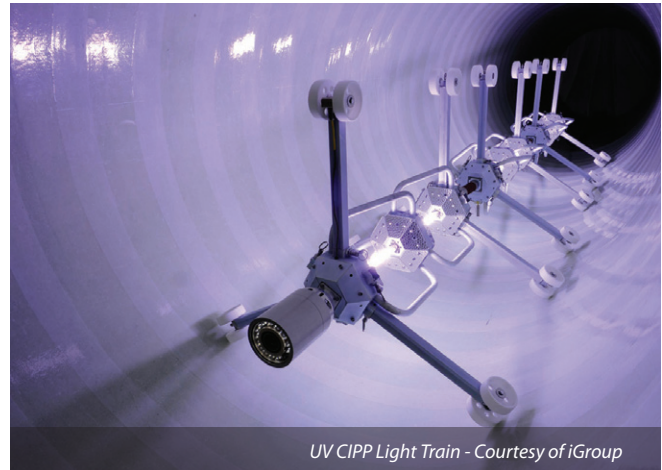
UV CIPP Light Train - Courtesy of iGroup
