Tunstall Reservoir

design & construction of the repairs to the lower part of the spillway, abandoned siphon recommissioning and the infill of a tunnel

by Borja Aguilar CEng MICE

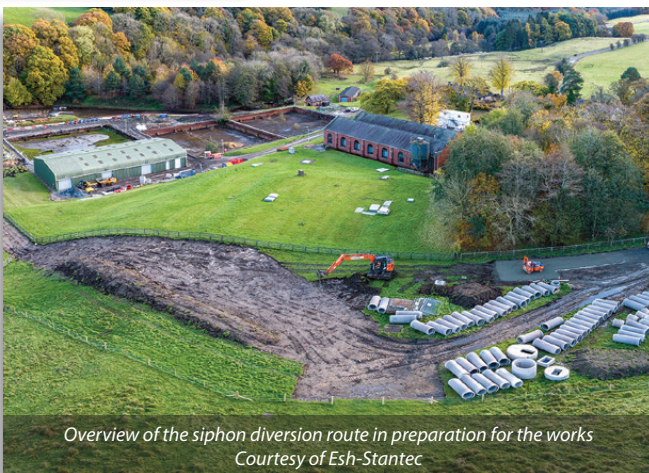
Overview of the siphon diversion route in preparation for the works
Courtesy of Esh-Stantec

Various options were considered at the concept stage in order to restore the use of an existing siphon that was abandoned in the early 2000s when the treatment works were decommissioned. The preferred option involved the following:

- a. A siphon discharge chamber to break the siphonic effect. This was decided given the uncertainty about the existing

system and the significant difference in levels in the downstream leg. Thus, the water would flow by gravity between the chamber and the outfall. This discharge chamber also functions as a thrust block to restrain the thrust acting on the new gate valve that has been installed immediately upstream of the chamber.

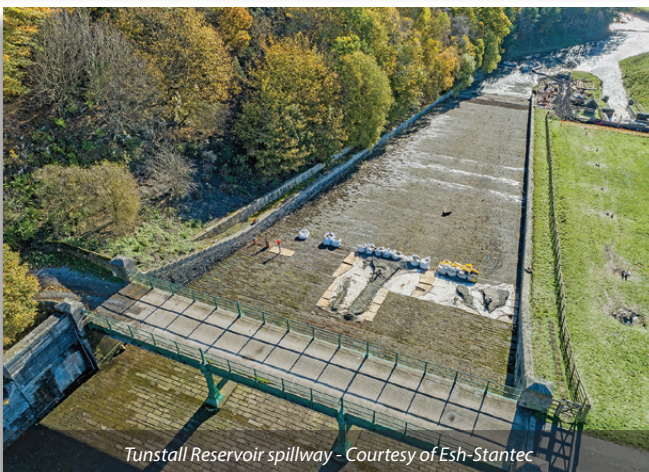
Tunstall Reservoir spillway - Courtesy of Esh-Stantec

spillway presented signs of wear and tear and needed replacement. The proposed solution consists of four new reinforced concrete slabs that have been placed over the existing spillway, except the most upstream slab where blocks had to be removed to tie-in with the existing structure and avoid a step. An expansion joint was necessary in the centre of the new slabs. The flexible sealant in this joint has been covered by a stainless steel plate that has been designed to protect the sealant from the predicted high velocities expected in the flows and reduce the maintenance requirements.
