Pontsticill Water Treatment Works solving concrete corrosion problem at DAF plant

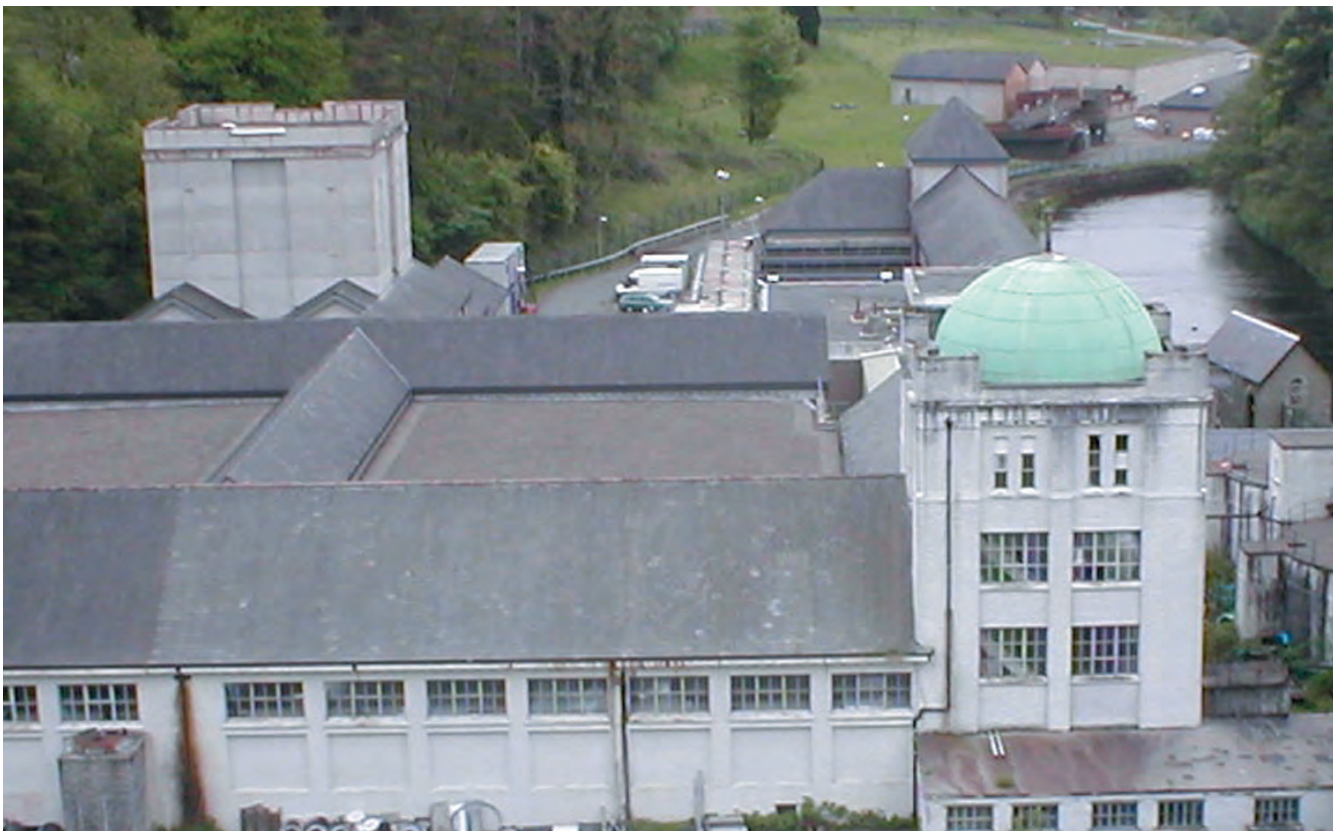
Pontsticill WTW showing filter house built 1927 (courtesy Welsh Water Alliance).

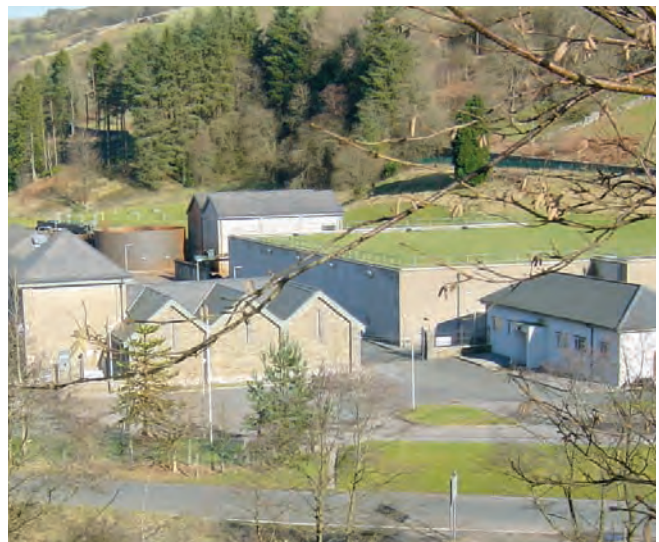
Pontsticill WTW - general view of new works (courtesy Welsh Water Alliance).
