Ulley Reservoir Rehabilitation Scheme

new £3.5m spillway to replace storm damaged overflow structure and prevent risk of dam wall failure

by Matthew Jenkins MEng MICE

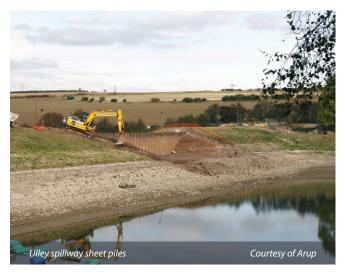
which would have presented major geotechnical challenges. The width of land available was also limited here which would have required a less efficient and more expensive weir arrangement. The decision was made to line the new spillway up with the receiving watercourse. This avoided any bends, provided an efficient weir and removed the water quickly away from the toe of the embankment.

The spillway design was based on a re-calculated PMF of 123m³/s and incorporated articulated joints with waterbars to allow for potential settlement. Underdrains were installed at each joint to monitor performance and ensure that any seepage did not affect the dam fill material. V-notch measuring chambers were also constructed to enable future seepage monitoring.

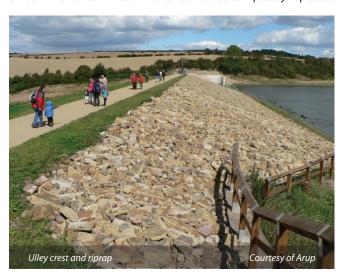
The existing wave protection on the upstream face of the embankment was limited in extent and was completely replaced.

This comprised of an outer 440mm thick rip rap layer on top of two filter layers (110mm and 130mm thick) and extended from the top of the embankment to 1.75m below top water level. The sandstone was a locally sourced dense Pennine sandstone (from Appleton Quarry near Huddersfield).

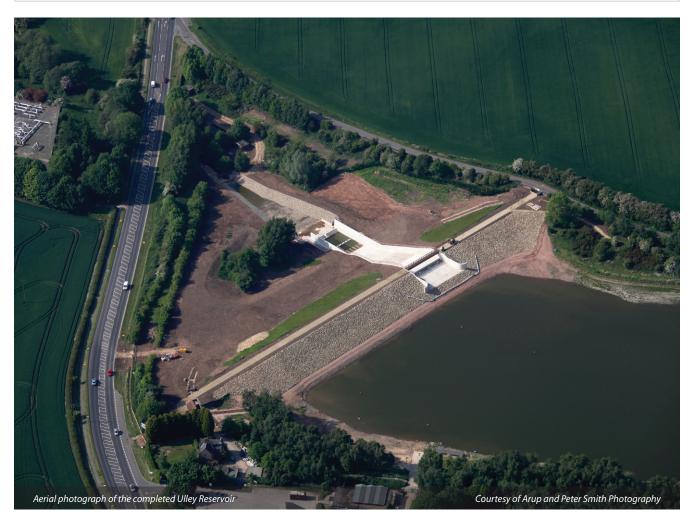
Casting the benched concrete spillway on a 19 degree slope presented a novel practical challenge. Permanent steel mesh formwork (exponet) was installed vertically at regular intervals between the top and bottom layers of reinforcement, held in position with z-bars. This helped control the slump of the concrete and enabled a good power float finish to be achieved. Reinforcing mesh was also installed on top of the main reinforcement on thickened benched areas of the spillway. This again helped to prevent concrete flowing downhill and also provided a more secure walkway for the concrete installation gang.
