# Blackburn UID Scheme

detailed design and construction of extensive modification works to an existing CSO chamber to resolve an unsatisfactory intermittent discharge

by Katie Eyton BEng

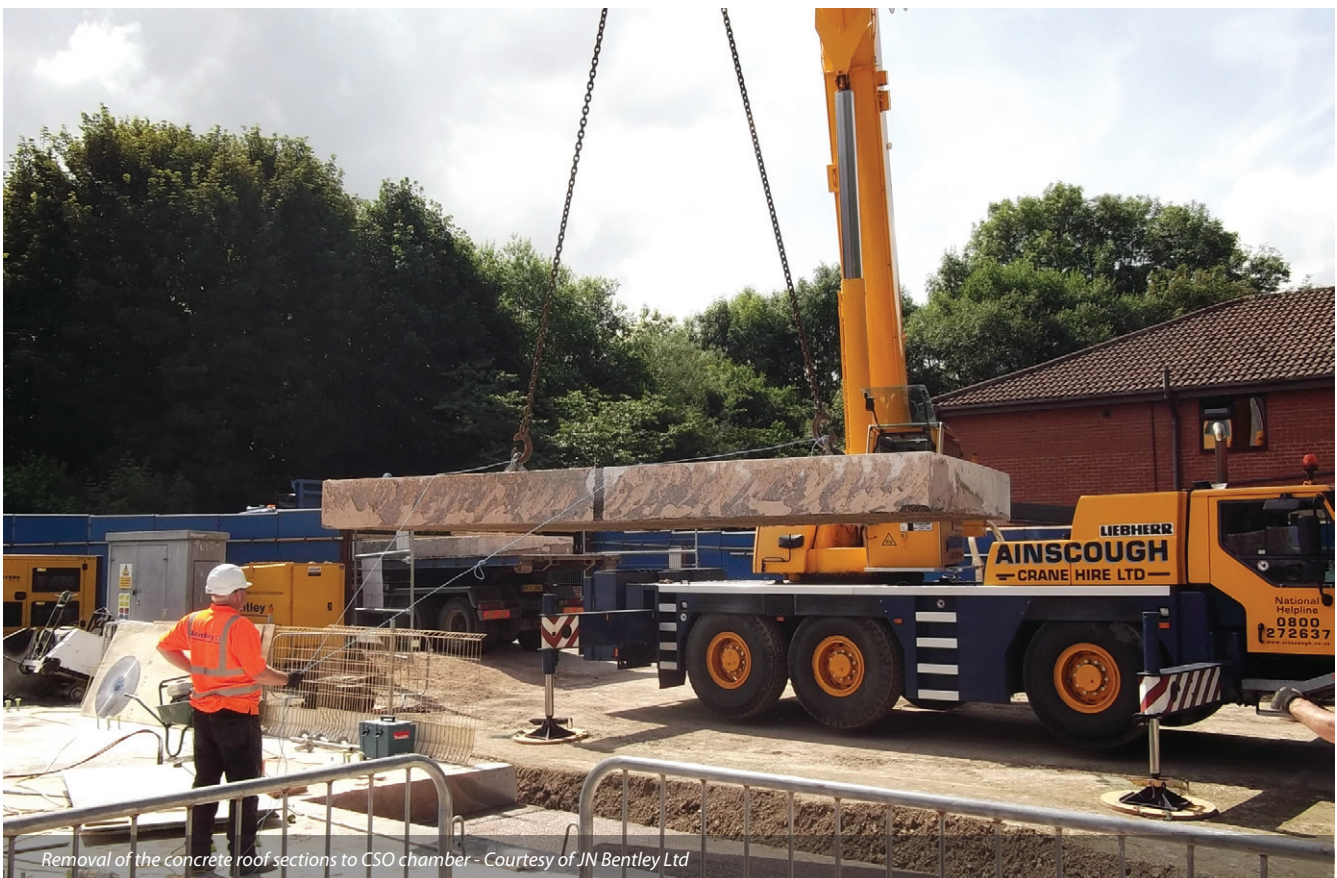
Removal of the concrete roof sections to CSO chamber - Courtesy of JN Bentley Ltd

### Removal of the existing roof

The existing reinforced concrete roof structure comprised two slabs – an original 410 mm thick roof slab, and, a secondary 350mm (in some places 450 mm thick) slab on top of the original. The upper slab had been constructed after sections of the original roof slab were removed to allow installation of the screens. Reinforced concrete beams had also been added at the same time to trim the new openings and to strengthen the roof structure. Both the upper and lower slabs were one-way spanning (across the width of the chamber).

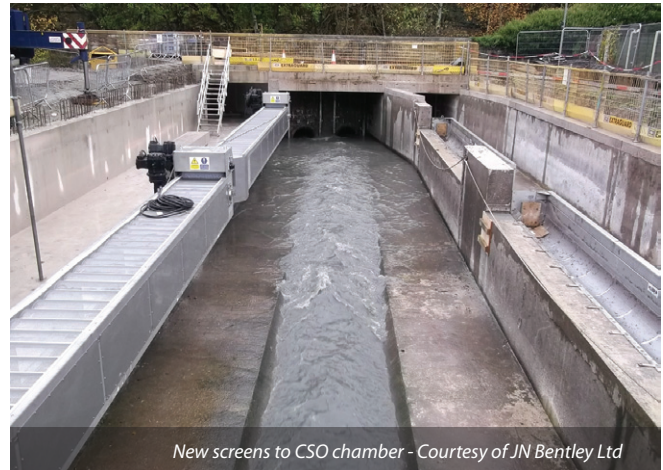
New screens to CSO chamber - Courtesy of JN Bentley Ltd

The 2 (No.) existing powered screens were to be replaced by 4 (No.) Longwood 'StormGuard' 650 model screens. Both existing screens spilled in to a single 2.6m wide spill channel on one side of the main 5m wide through-flow channel. The 4 (No.) new screens were to be configured as two pairs of two such that a secondary spill channel was required on the opposite side of the through flow channel. Some modifications to the existing chamber walls and weirs were also required.

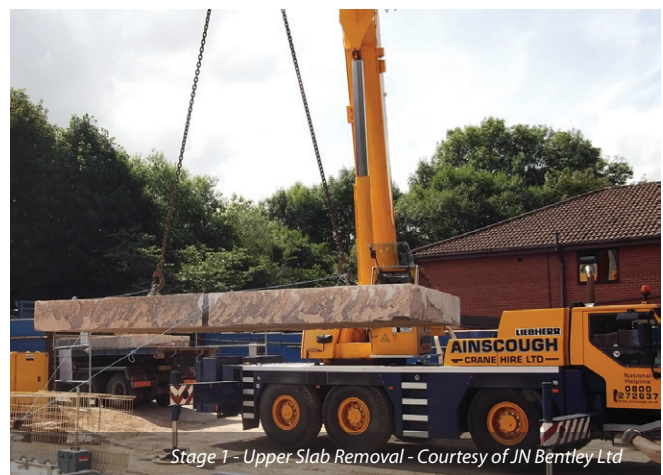
Stage 1 - Upper Slab Removal - Courtesy of JN Bentley Ltd

**Stage 1: Removal of the upper slab:** Calculations, following the information determined by the cores, had revealed that the lower slab could not support the combined weight of both slabs. Therefore, additional dowels were installed adjacent to the up-stand beam to tie the lower slab to the beam, which would allow the lower slab to take the weight of both slabs. Epoxy resin anchors were pre-installed ready for the lifting plates. The upper roof slab was then cut into sections approximately 10T in weight. Longitudinal cuts, i.e. in the direction of the span, were completed first. Transverse cuts were then completed in stages with the crane lifting each slab section away after it was cut.

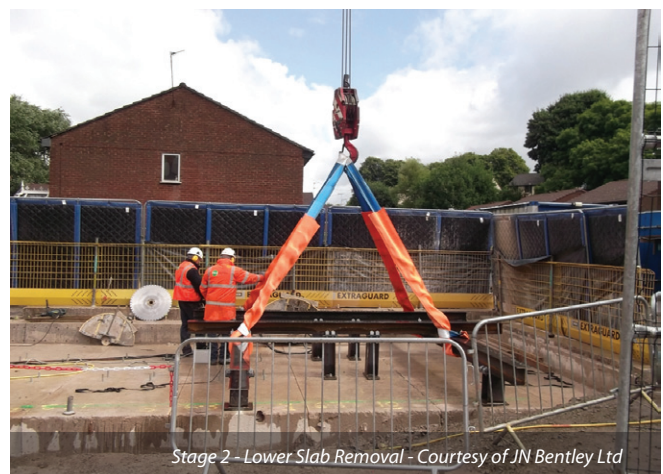
Stage 2 - Lower Slab Removal - Courtesy of JN Bentley Ltd

**Stage 2: Removal of the lower slab:** Removal of the lower slab was more complicated. The lower slab now spanned from beam to wall and was to be removed by cutting it into 4.2m by 1.6m sections, weighing approximately 7T each. Whilst it was cut, the weight of each slab was temporarily supported by effectively hanging it from a bespoke steel H-frame, which was designed also to span from beam to wall. The H-frame was fixed to the slabs using epoxy resin anchors. The end cuts were then completed, requiring the H-frame then to take the full weight of the slab. The crane could then lift the slab sections out complete with the H-frame attached. This method did not require any work inside the chamber and also prevented any shock loading of the crane.

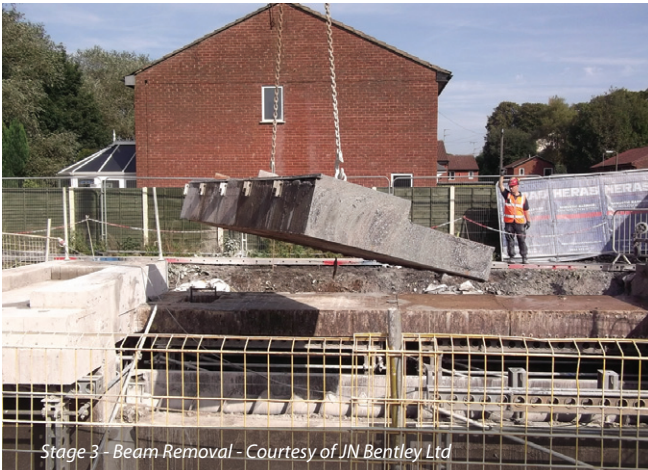
Stage 3 - Beam Removal - Courtesy of JN Bentley Ltd

**Stage 3: Removal of the supporting beams:** This required underpropping to support the beams during cutting and removal. This required some work inside the chamber, but with the roof slab removed, the chamber was now open, allowing adequate ventilation and also affording much safer means of access and egress. The existing mechanical screens were isolated during removal of the beams, reducing the risks of working in the chamber to an acceptable level. When wet weather required the screens to operate the work was stopped and the screens re-energised.

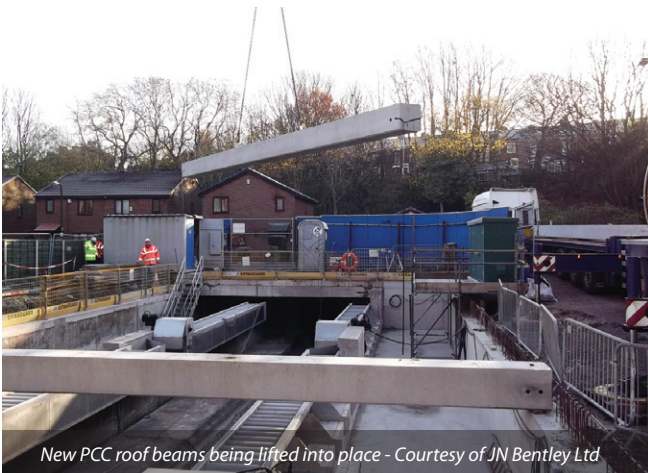
New PCC roof beams being lifted into place - Courtesy of JN Bentley Ltd

In order to replace the screens, the roof of the existing chamber needed to be removed. A new roof would be provided with access arrangements specifically suited to the operation and maintenance requirements for the new screens.

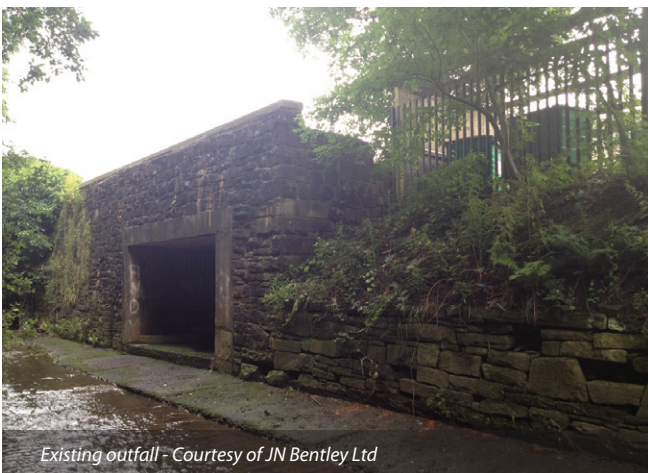
Existing outfall - Courtesy of JN Bentley Ltd

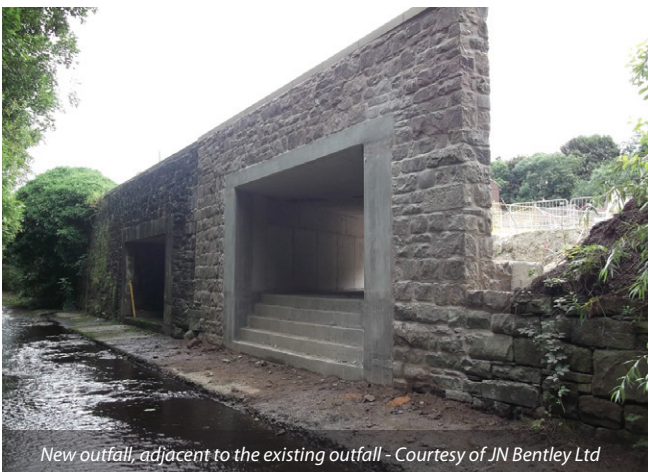
New outfall, adjacent to the existing outfall - Courtesy of JN Bentley Ltd

New outfall structure and masonry walls were also to be provided for the new spill channel.
