Wimbleball Dam Grouting Project

a new grout curtain has been constructed beneath Wimbleball Dam and has reduced leakage to the lowest recorded rate since construction

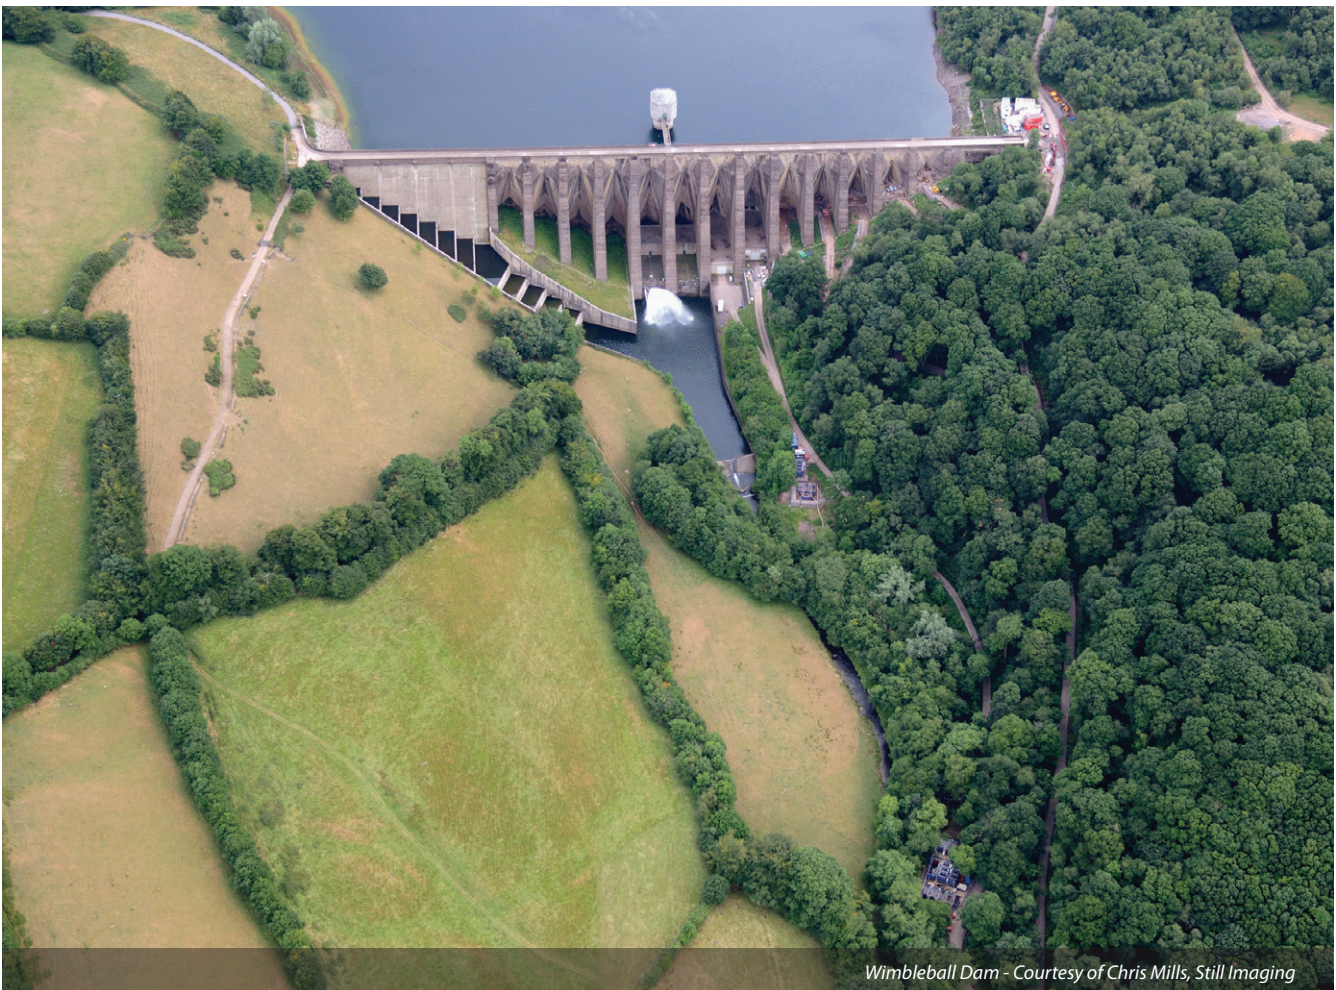
Wimbleball Dam - Courtesy of Chris Mills, Still Imaging

Wimbleball dam near Dulverton in Somerset is a 50m high concrete diamond headed buttress approximately 300m long and 50m high. The dam was constructed between 1974 and 1978 and stores 21.5 million cubic metres of water. The reservoir is a strategic water resource for South West Water and Wessex Water. South West Water are able to release water into the River Exe in dry summers to support abstractions at their water treatment works for Tiverton and Exeter (population of c150,000). Wessex Water pump directly from the reservoir to the treatment works which serves Taunton and central Somerset (population served c100,000).

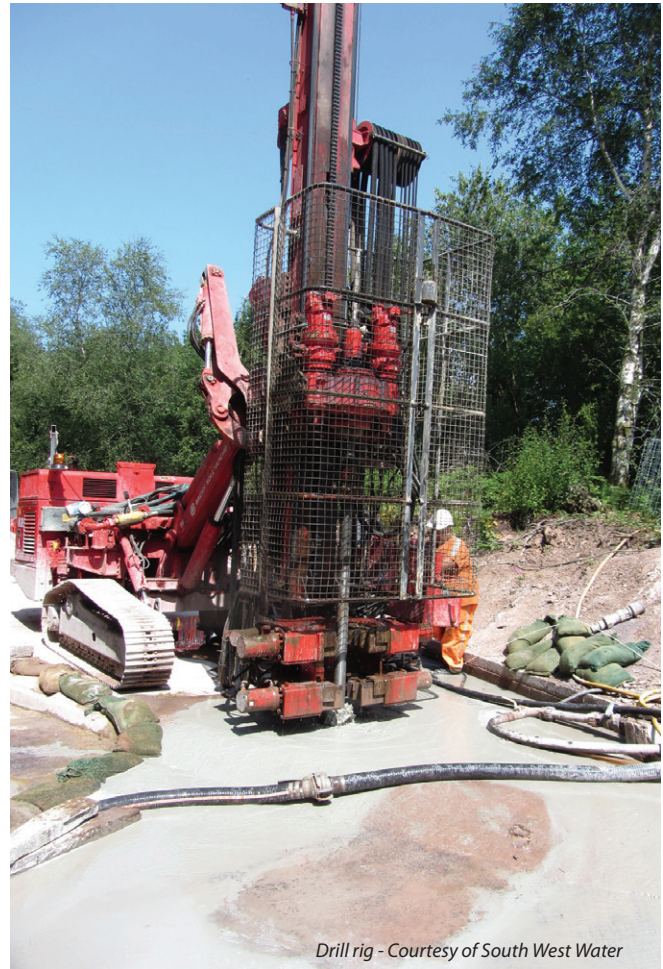
Drill rig - Courtesy of South West Water

Three drilling rigs and two self-contained and automated grout injection units (each capable of up to six simultaneous injections) were used enabling up to 50 grout stages to be completed in a week.

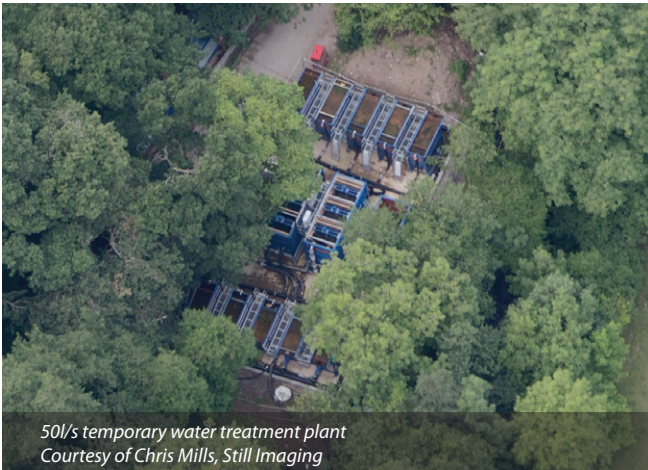
50l/s temporary water treatment plant
Courtesy of Chris Mills, Still Imaging

To mitigate this risk the project installed two water treatment plants (WTP), provided by Siltbuster Ltd, for the duration of the works. A 50l/s WTP was connected to the dam drainage system and was operated continuously. The discharge from the 50l/s WTP passed into a backwater of the River Hadeo immediately downstream of the dam. A temporary dam was constructed across the backwater about 200m downstream of the discharge point. A second WTP, with a capacity of 150l/s, could pump water from above the temporary dam if the quality of the water passing over it was found to be unsatisfactory.

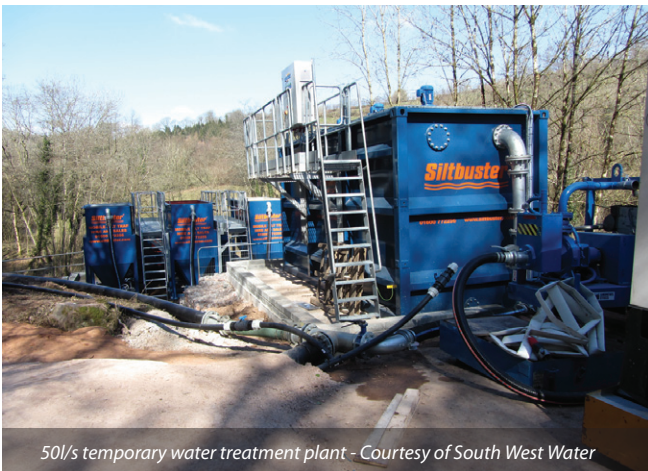
50l/s temporary water treatment plant - Courtesy of South West Water

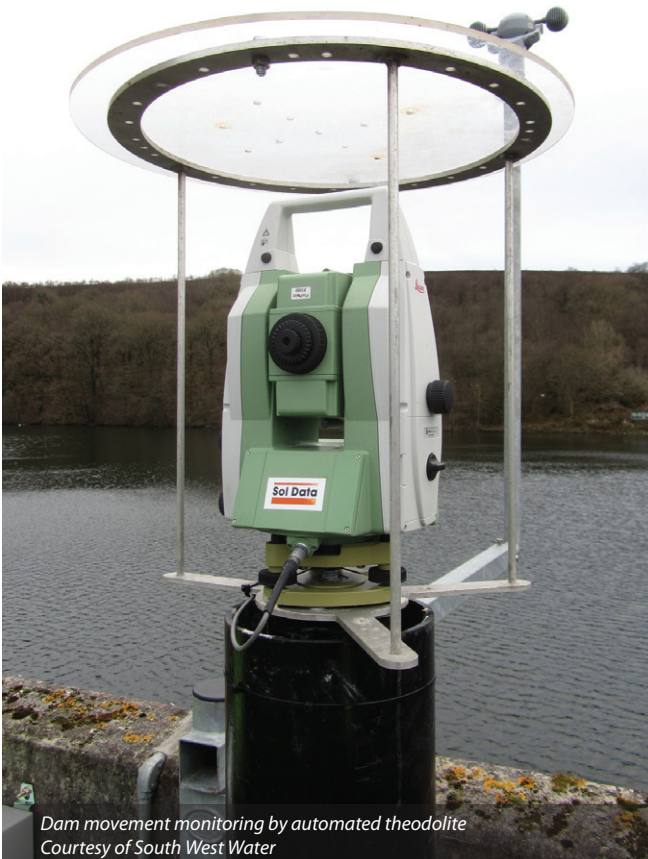
Dam movement monitoring by automated theodolite
Courtesy of South West Water

Monitoring of uplift pressures and displacements of the dam was a key aspect of the project. For monitoring uplift pressures 15 vibrating wire piezometers were installed in the dam foundations. These were connected to a data logger with a real time satellite link to a website maintained by Soldata Ltd. Threshold alarm levels were set for each piezometer such that high readings generated warning messages by text and email to key personnel.
