Bacton Combined Outfall

design and installation of replacement marine outfalls at the Bacton Gas Terminal to accommodate the UK's first sandscaping project

by Martin Berry CEng BEng FICE & Sean Burn MEng

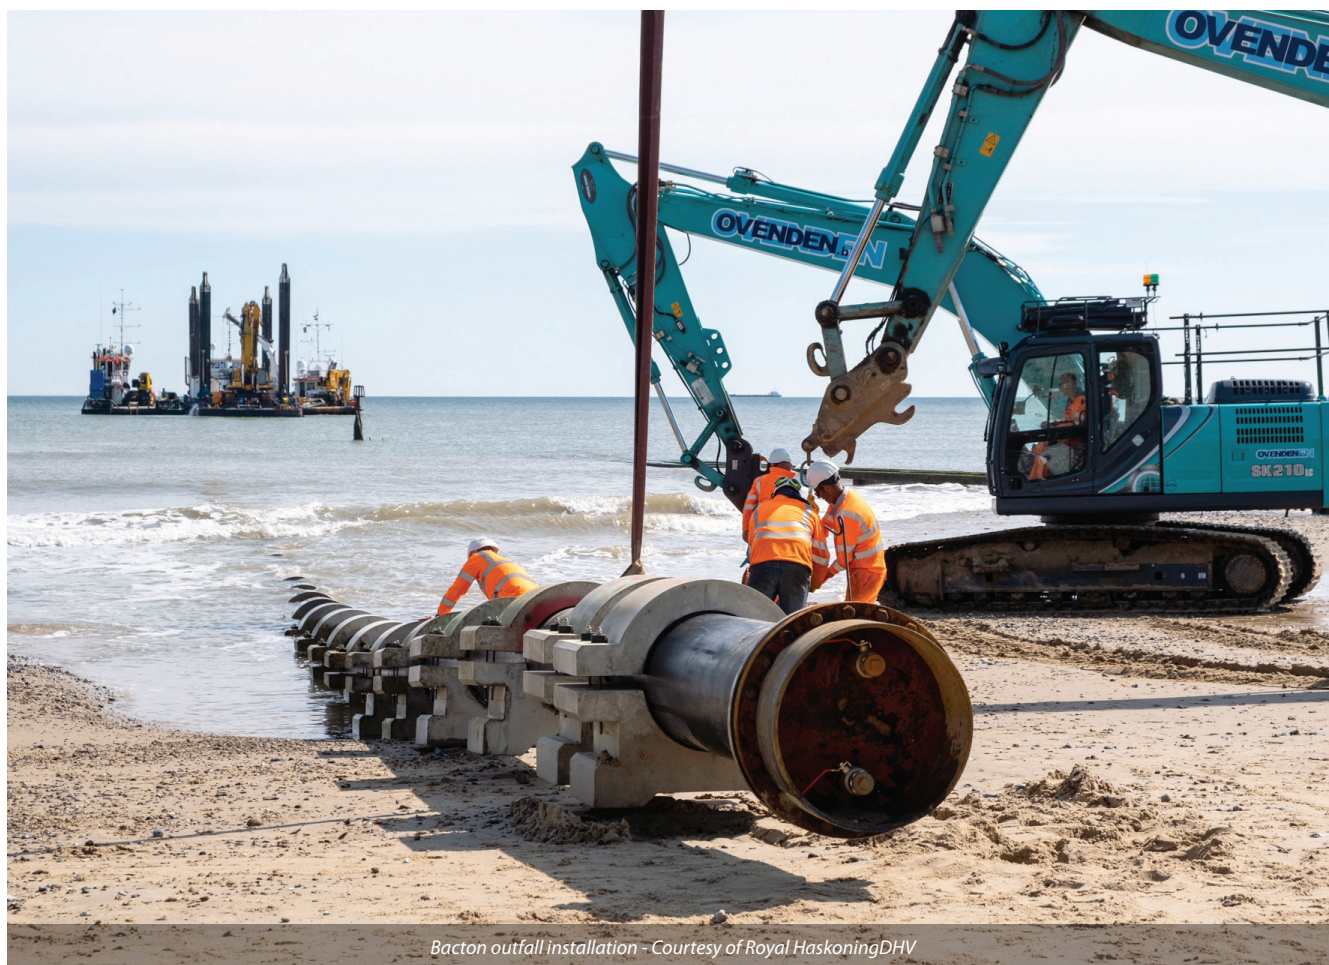
Bacton outfall installation - Courtesy of Royal HaskoningDHV

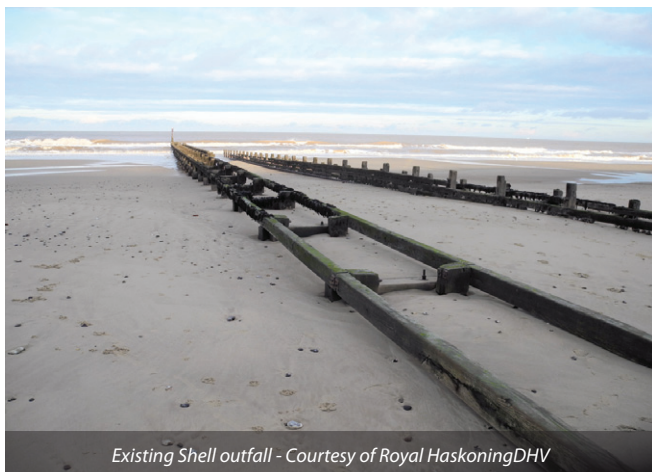
Existing Shell outfall - Courtesy of Royal HaskoningDHV

- **Shell outfall:** The Shell outfall was constructed in 1968. It is a 177m long 24" steel and cast iron pipeline which is routed from a storage facility within the terminal, through the coastal cliffs and continues along the beach supported within a piled timber trestle structure.

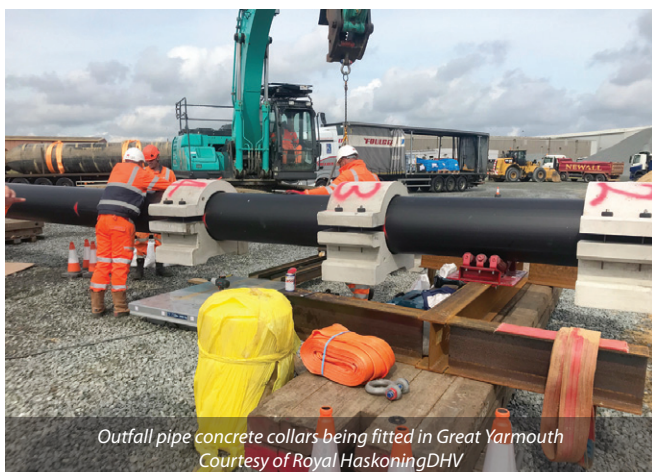
Outfall pipe concrete collars being fitted in Great Yarmouth
Courtesy of Royal HaskoningDHV

To combat flotation and provide stability under environmental loadings, the polyethylene pipes were fitted with concrete weight collars prior to installation and additional concrete kennels provided where additional weight and protection was required.

The marine outfall pipeline was welded into a single, approximately 300m long section in Great Yarmouth prior to the concrete collars being fitted. The 300m outfall pipeline was installed using the 'float and flood' method, with the offshore end of the pipeline controlled by a backhoe dredger fixed in position. The controlled pumping of seawater into the onshore pipe end initiated the sinking process which caused the pipe to form an s-curve between the seabed and seawater surface and descend into its final position.

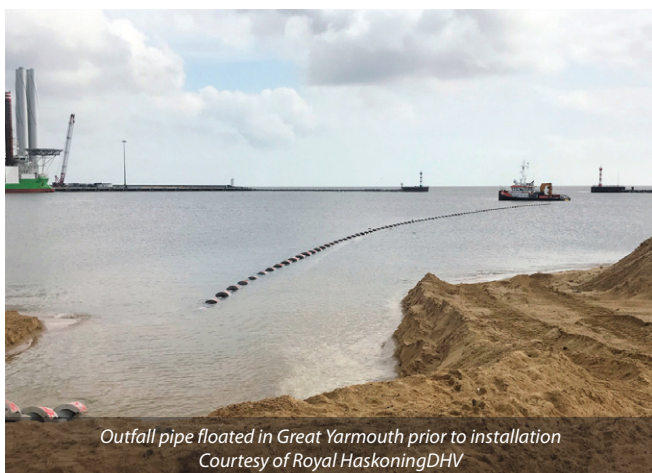
Outfall pipe floated in Great Yarmouth prior to installation
Courtesy of Royal HaskoningDHV

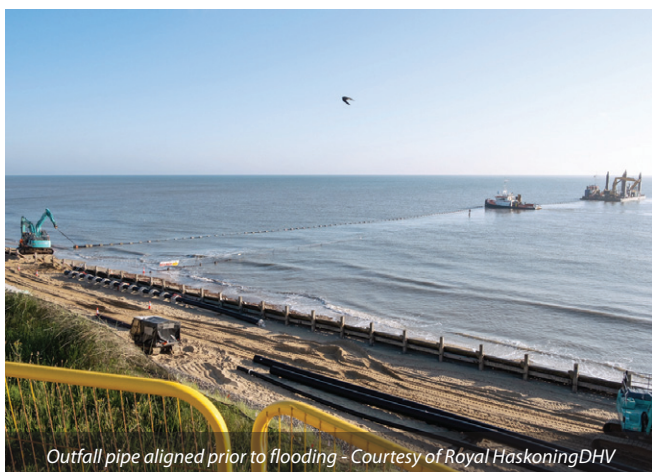
Outfall pipe aligned prior to flooding - Courtesy of Royal HaskoningDHV

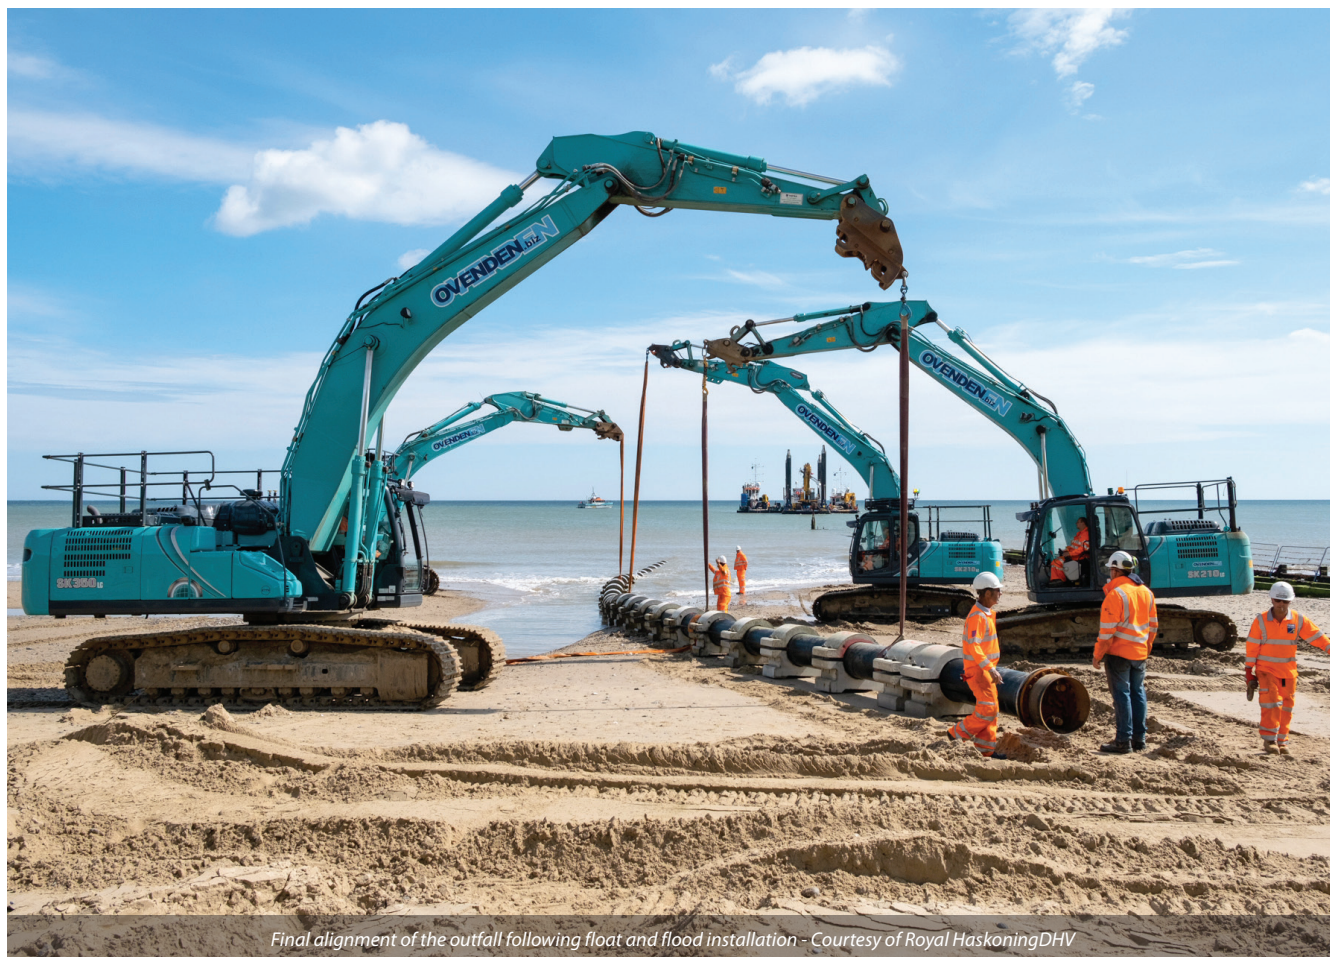
Final alignment of the outfall following float and flood installation - Courtesy of Royal HaskoningDHV

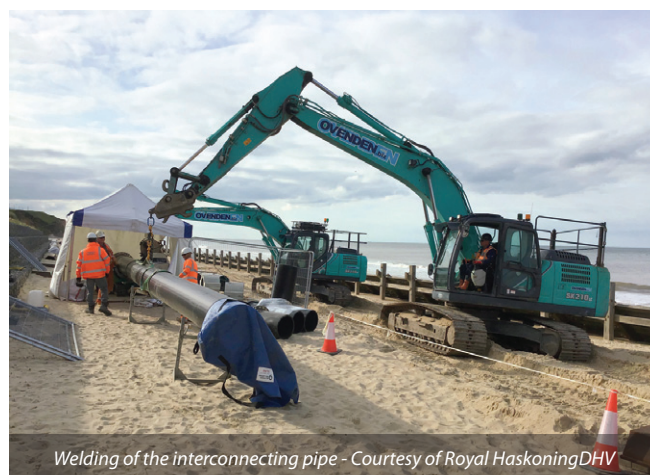
Welding of the interconnecting pipe - Courtesy of Royal HaskoningDHV

The 250mm and 500mm diameter polyethylene pipes for the interconnecting land section were delivered to site in 12m lengths and butt-welded using automated equipment to ensure strong and consistent joints. The trench for the interconnecting pipework was excavated using conventional land-based plant, with the excavated material side-cast and used as backfill once the pipework was installed. The pipelines were pre-assembled into 48m strings at the top of the beach which were then transported and lowered into the excavated trench. The pipe strings were jointed using flange couplers to avoid the need for welding within the excavated trench. The connections to the existing outfalls were undertaken using a configuration of bends, T-pieces and couplers.

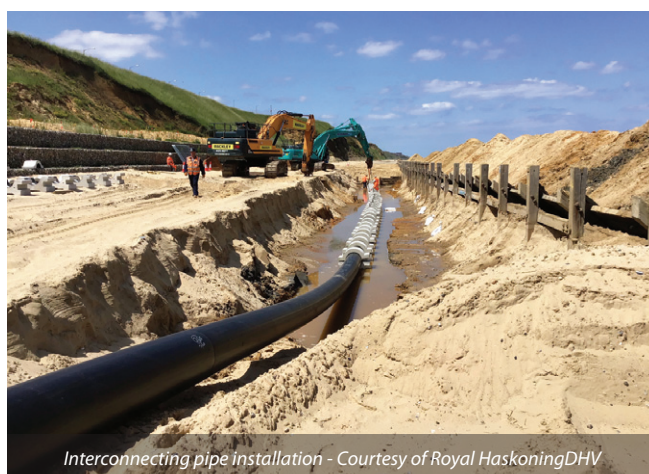
Interconnecting pipe installation - Courtesy of Royal HaskoningDHV

The agreed project scope consisted of 747m of solid wall polyethylene pipe (HDPE) 250mm outside diameter (OD) increasing to 500mm OD laid at the top of the beach to interconnect the existing outfalls. The beach location was chosen because connection within the terminal was not possible due to the limited space available in proximity to existing services and incoming gas supply pipework.

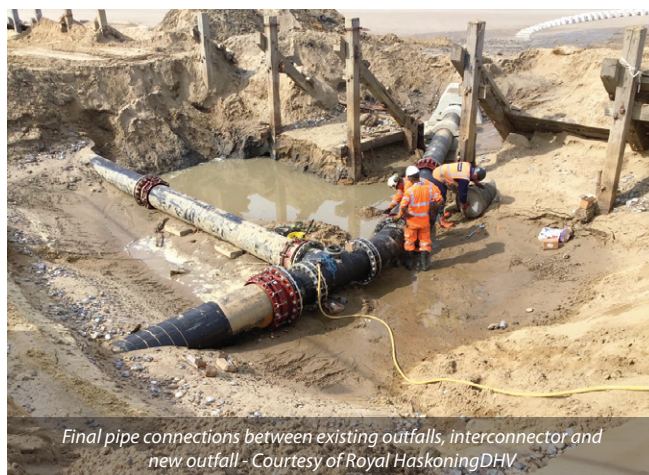
Final pipe connections between existing outfalls, interconnector and new outfall - Courtesy of Royal HaskoningDHV

The interconnecting pipe connects to a new 500mm (OD) outfall adjacent to the Shell outfall at the southern end of the terminal before extending an additional 152m beyond the existing outfall and terminating in a 2-port diffuser with a concrete protection dome. The outfall and interconnecting pipe were to be constructed off-line to allow existing discharges to continue prior to final connections being completed.

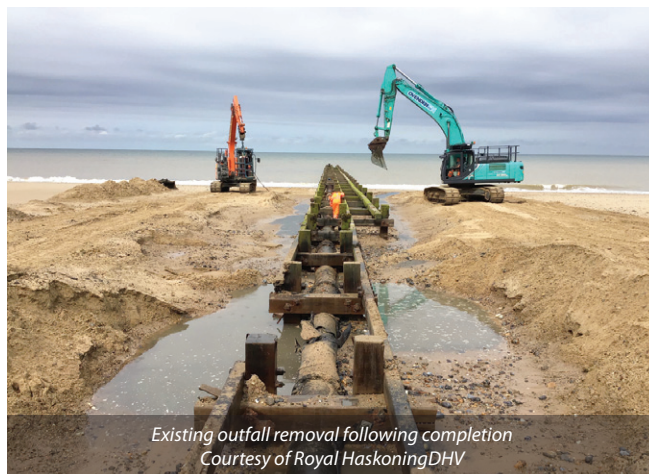
Existing outfall removal following completion
Courtesy of Royal HaskoningDHV
