Albert Street - Wessex Water

A fish exclusion intake screen, compliant with the Eels Regulations, was required at the Albert Street pumping station, Bridgewater, Somerset.

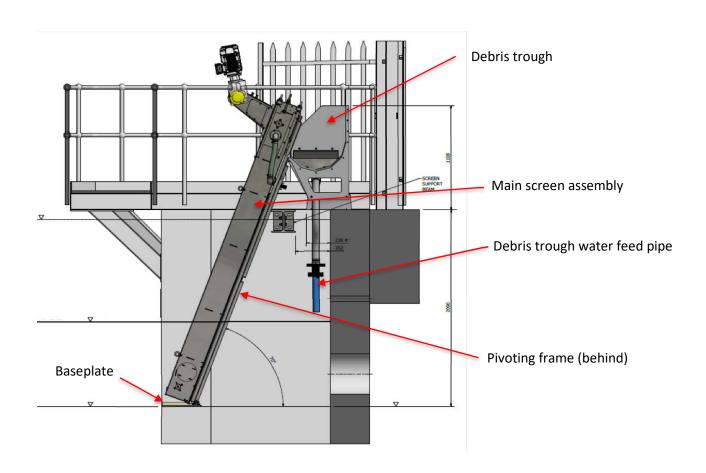
The screens being installed on the river-side meant that an access platform would be required for access and maintenance of the screens. The screens can pivot forward into the vertical position for better access to the drive motors etc. The screens are moved into this position if there is a need for one to be lifted out for major servicing.

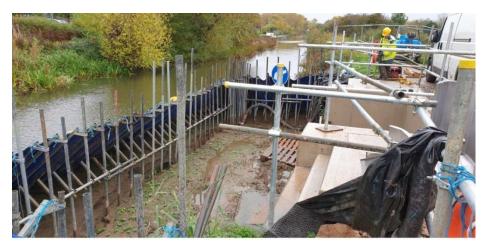
The pumping station intake required a new concrete structure to accommodate the GoFlo

screens, house the new pipework, cabling and also provide support to the access platform. GoFlo were not contracted to supply the access platform on this occasion, although some design input was required so the contractor could design the structure around the two screens and incorporate winch anchor points for pulling the screens forward into the maintenance position.

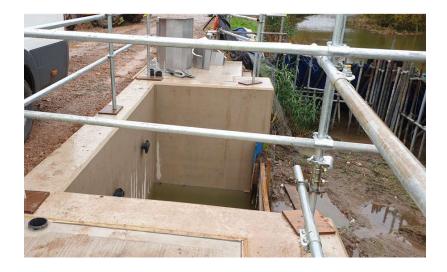
The new in-river structure required a cofferdam had to be in place before any civils works could begin.

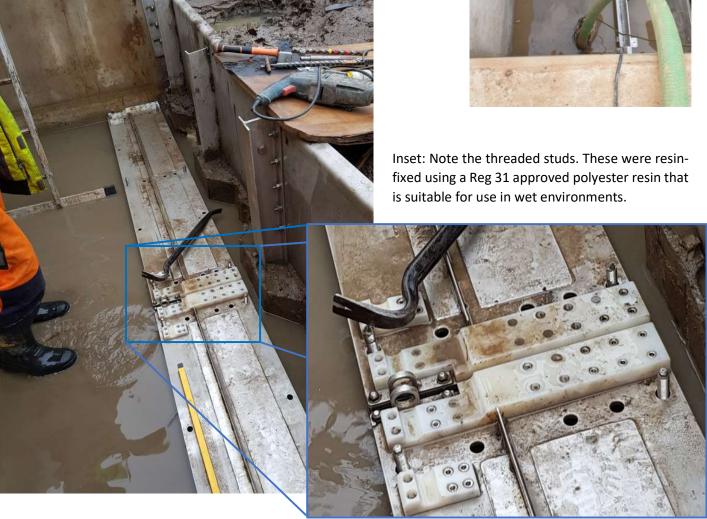
This picture shows a more permanent solution for retaining the silt.

The chamber being below the riverbed level meant there had to be shuttering to retain the silt. There was some water leakage, which made conditions in the chamber less than ideal for marking out the floor anchor points for the baseplates, even though a pump was used to keep the water down to an acceptable level.

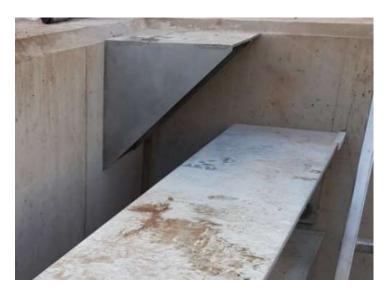
Galvanised I-beam mounted across the back of the chamber supports the top of the two screens when they are inclined in the operational position. The beam support brackets are made in stainless steel and have to include galvanic isolation sheets between the beam and bracket. The fixings are also stainless steel, so these include isolation washers.

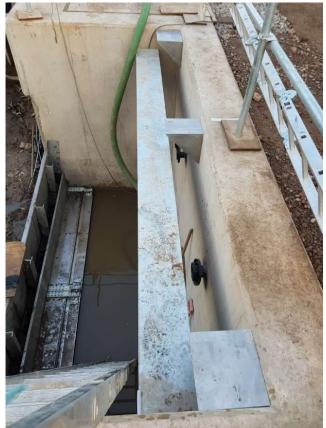
Above: Angle bracket in position. These were an addition to the original design due the back wall being further way that it should have been. The brackets were to support the debris trough, which overhangs the concrete wall, hence the extra supports needed.

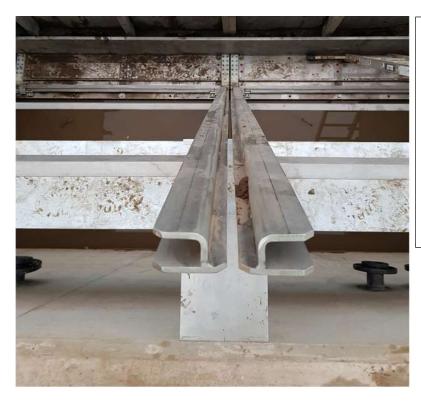
It was noticed that the chamber wall was bulging out and would interfere with the screen support frames. The side of the wall had to be ground down until the frame had enough clearance, which took several hours to achieve!

Clearance between the wall and frame is minimal, but enough to allow the screen's side brush strips to fit.

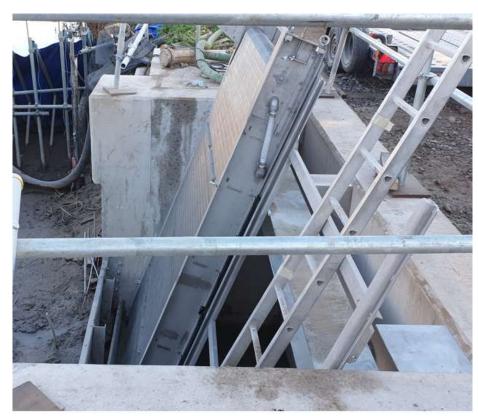
First screen being lifted into position.

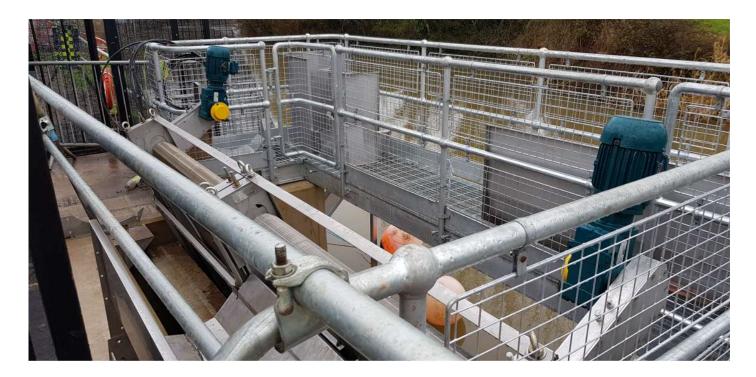
Both screens were in position within a few hours. Most of that time was due to crane availability: The screens slide into place on the pivoting frames and are then leaned back onto the I-beam that spans the chamber.

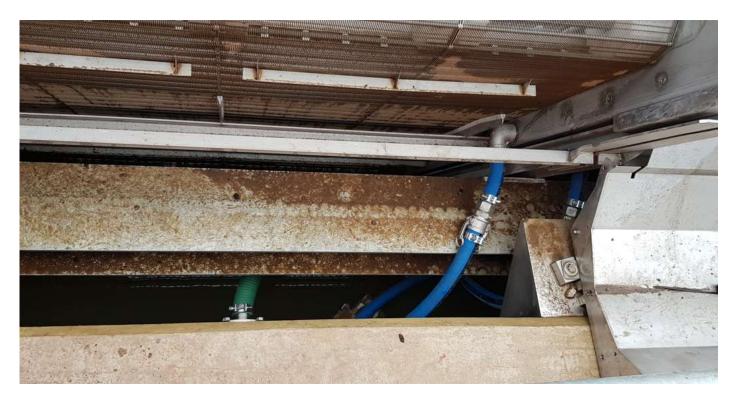
Debris trough section to the right of the picture showing how the angle bracket below supports the overhang of the trough. Blue hose is the wash water feed to the screen spray bars. These have quick-release connections to allow the screens to be pivoted forward from their resting position for access to the drive motor from the platform.

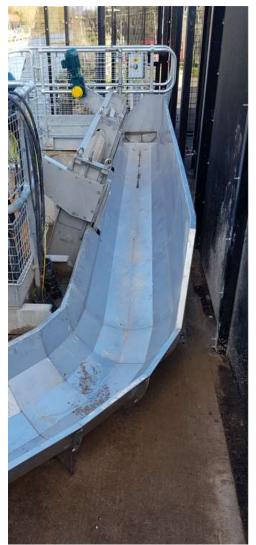
Completed stainless steel debris trough.

The trough is anchored to the floor at several locations and has a gentle slope to aid flow back to the canal.

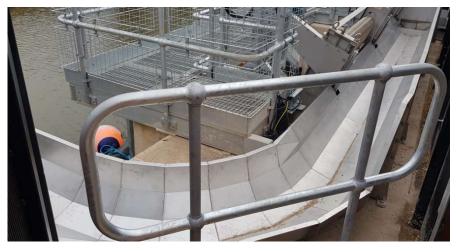
Trough is made up of flanged sections bolted together, all in TIG welded 304 stainless steel.

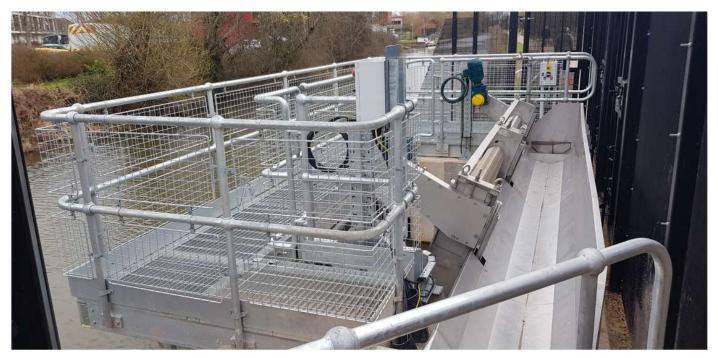
Completed and operational. Security fencing was required at this site due to the location of the inlet structure being adjacent to a public footpath.
