# Steynton Pumping Station planning for success

by Mark Paduch BSc Hons

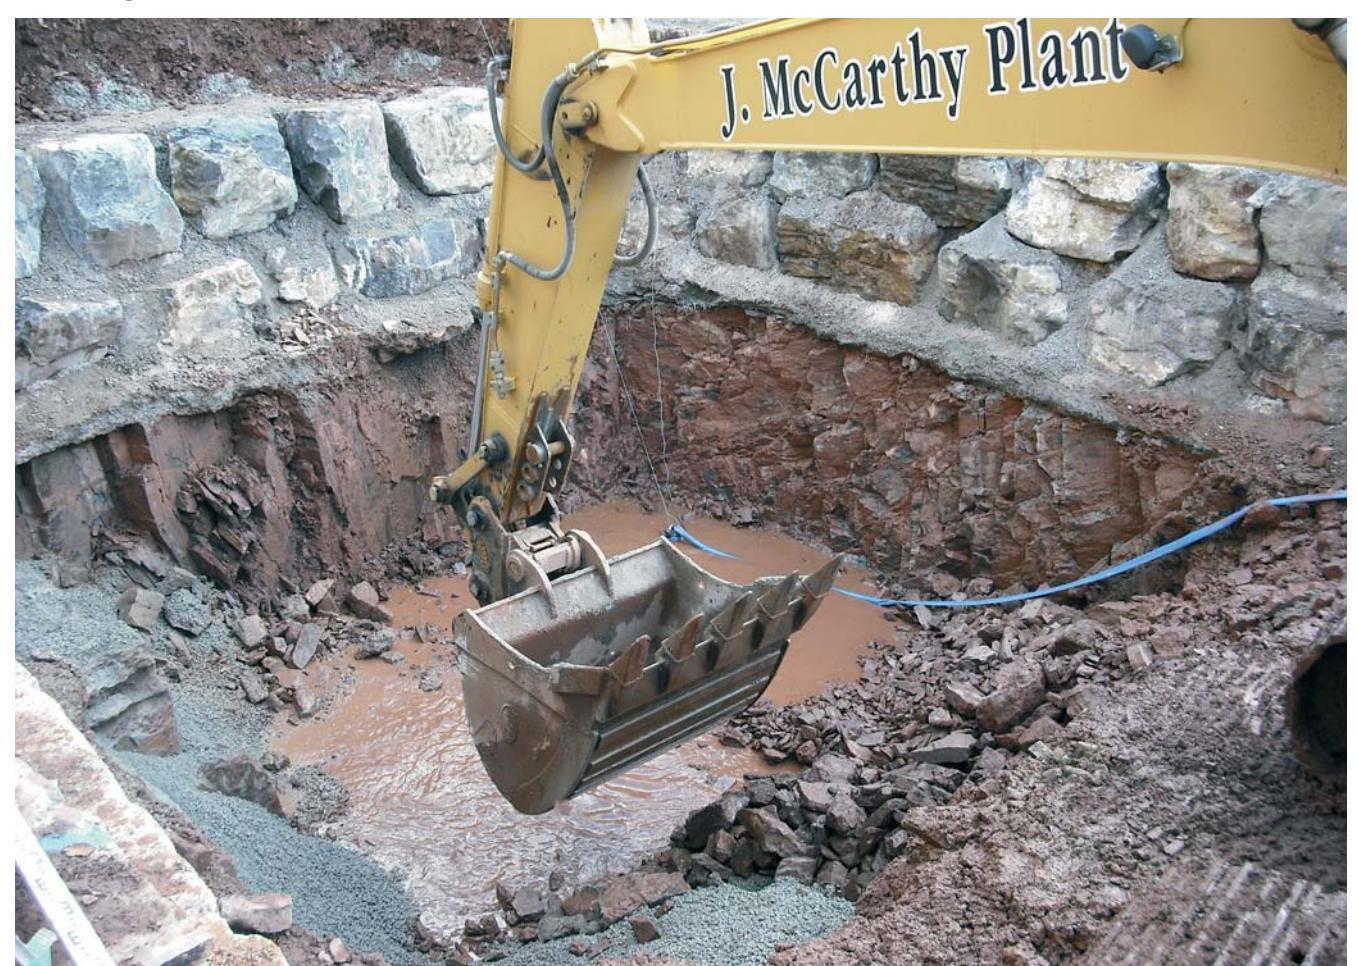
Excavation to Formation

- The existing Pumping Station and proposed new works are located within the Steynton village green, adjacent to the main link road running from Haverfordwest to Milford Haven. This coupled with the close proximity of a comprehensive school and housing, meant careful planning would be required to minimise impact, through disruption, to the local community.
- The size and depth of the excavation that would be required to install the Storage Tank. The Storage Tank would consist of two (no.) 2.5m diameter storage pipes 22m long running parallel to each other. The depth of the excavation would vary from 7.5m on the high side to 5.5m on the low side.

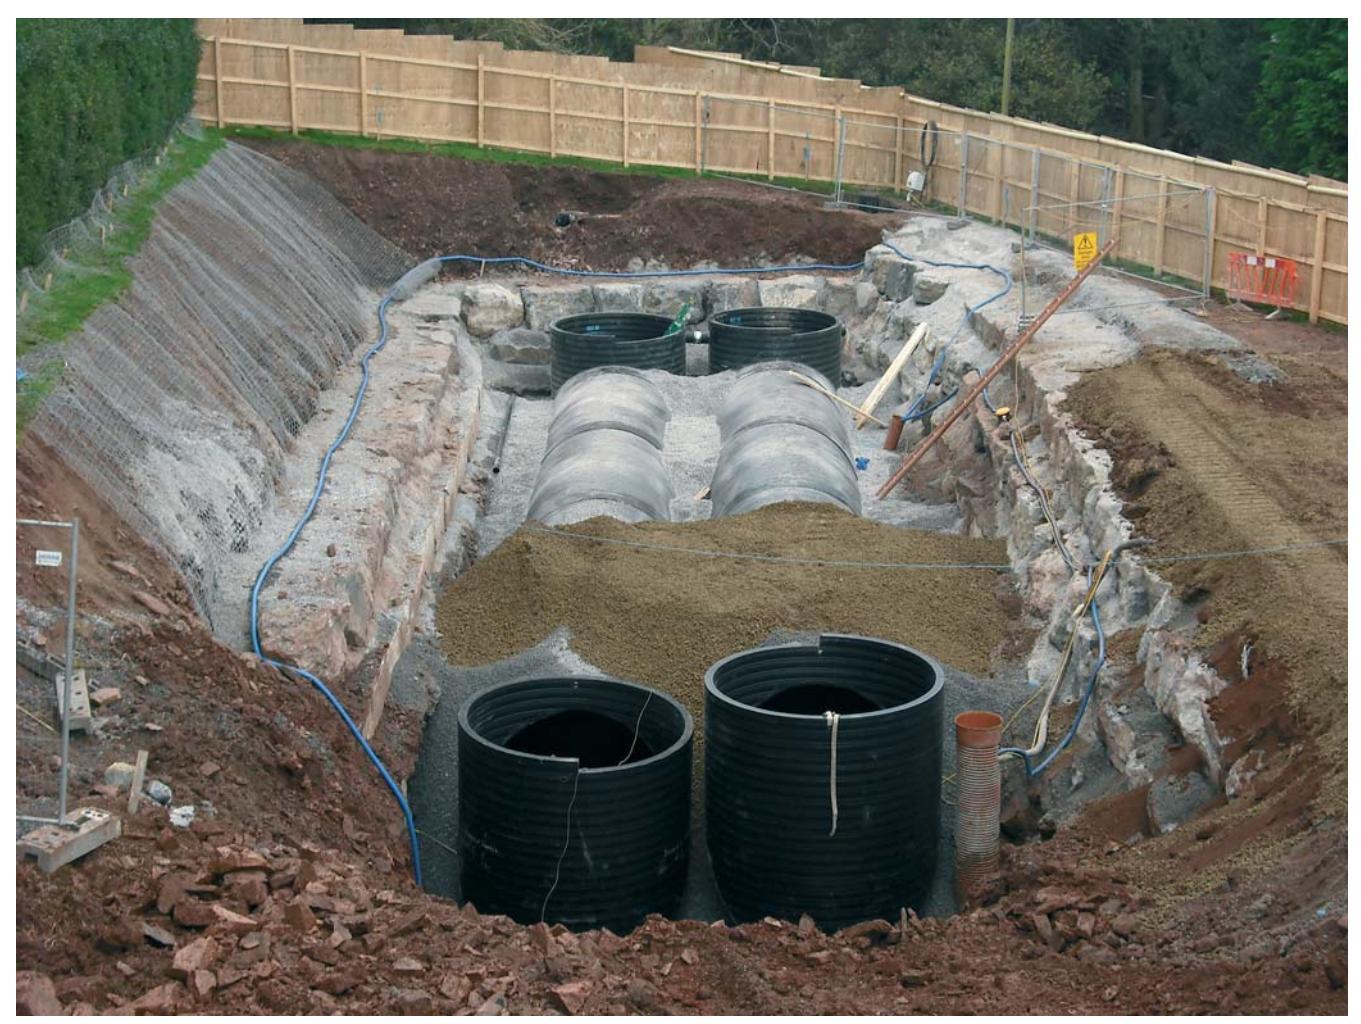
Processed Top Backfill Layer

In accordance with Asset Internationals installation process for their Weholite pipes and with approval from Asset's Senior Technical Engineer, Vasilios Samaras, the material was deemed suitable for backfilling up to the previous existing ground level. This resulted in the re-use of 750m<sup>3</sup> of the 2000m<sup>3</sup> initially excavated.

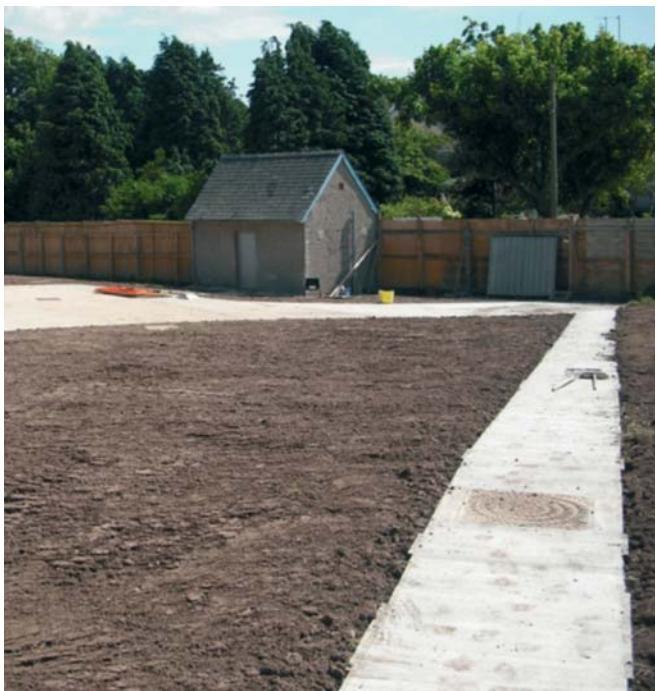
Steynton Nearing Completion

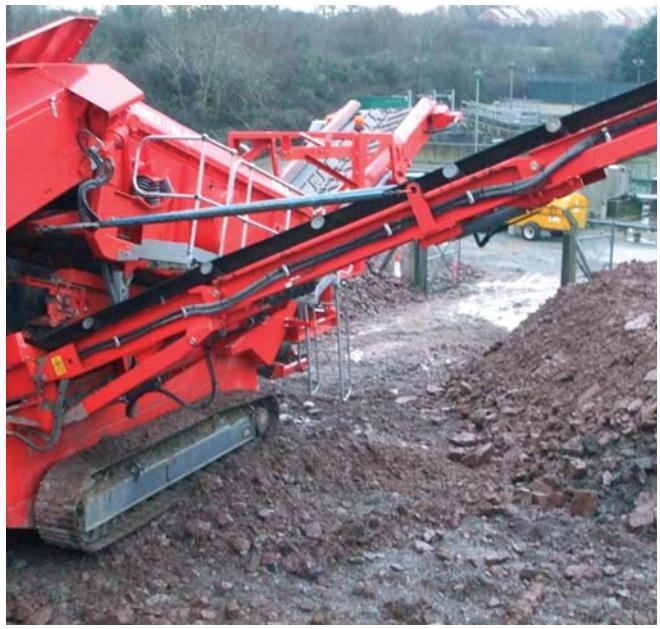
Screening at Merlins Bridge

Morrison Construction applied for an exemption under 'Paragraph 13' from the Environment Agency in order to carry out the proposed activities at Merlins Bridge, which was granted by the EA. The material was hauled to Merlins Bridge where it was processed in a number of ways to produce a product fit for re-use. Through the use of grated sieve buckets, selective screening and crushing on site a product was produced in accordance with the 'Earthworks series 600' classification 6A.
