Torbay Sewer Rehabilitation Scheme delivering £1.9m of extensive sewer rehabilitation works in the midst of the South West's flagship holiday destination

by Geoff Willcocks BEng (Hons)

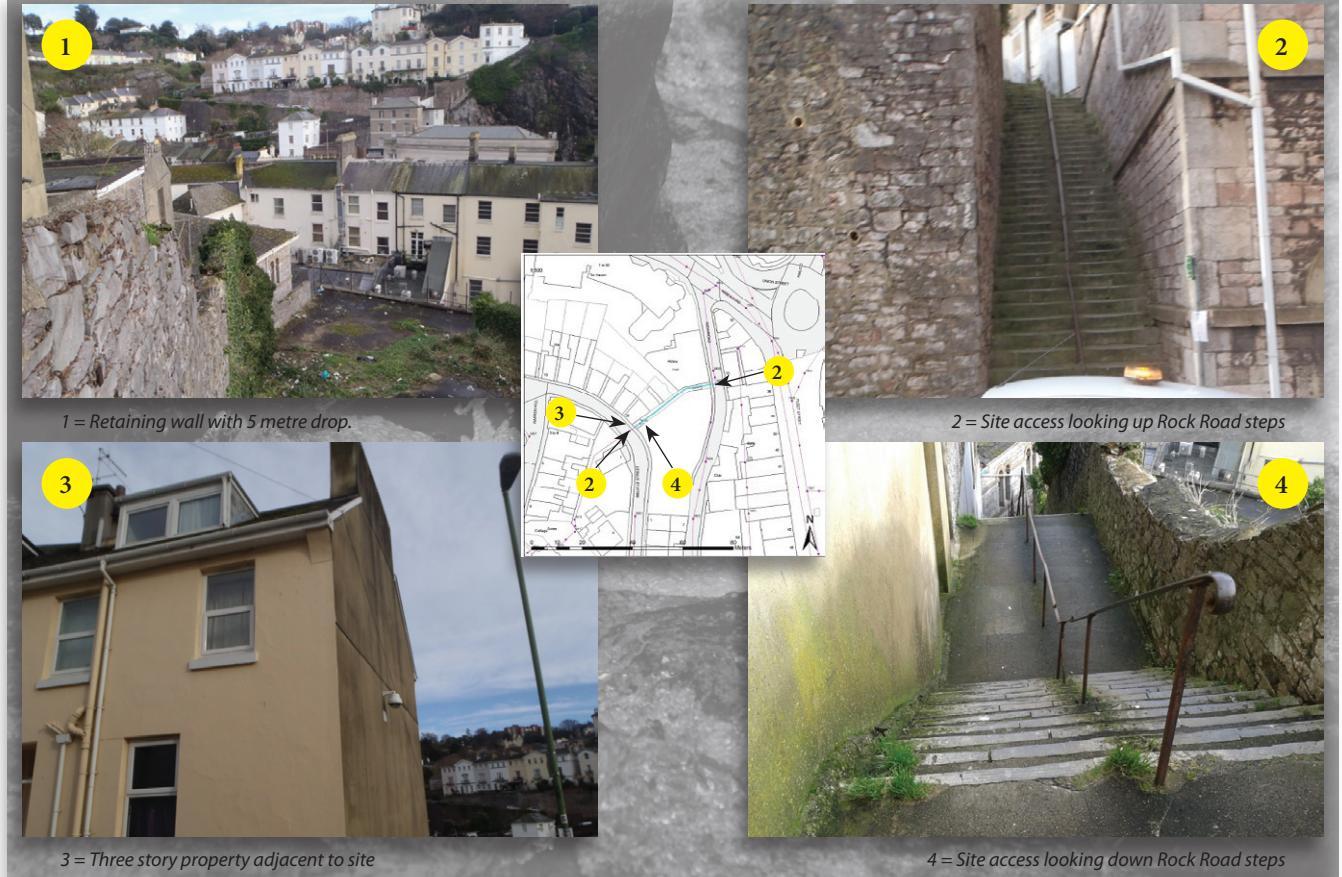
Location of works - site access: Illustration of the access constraints to the pipeline route. The north side with a three storey building and a retaining wall with a 5m drop to the south - courtesy of BBUSL & Exjet

The entire 42m pipeline length followed a stepped pedestrian thoroughfare with a maximum width of 2m. The depth of

excavation averaged 2.5m with a three-storey structure to the north and a retaining wall to the south with a drop of 5m to ground level. The path gradient of 1:3 combined with highways restrictions at either end presented the site team with a number of dilemmas. Seasonal traffic restrictions permitted a limited window to carry out the works with a road closure only being granted at one end of the pipeline.

H₅O consulted with Exjet to formulate an innovative trenchless solution to minimise risk to properties and workforce. To further complicate a lining option, the pipe diameter varied between 150mm and 225mm along its length and deviated with a number of bends and six lateral connections. In developing the no-dig option Exjet promoted a new variant on the previously used Brawoliner[®].

The Brawoliner 3D[®] liner system was developed to meet the challenges of pipelines where there are several changes in diameter within specified ranges. The seamless textile liner can adjust itself to the host pipe within the stated diameters without creases or wrinkles including 90° bends. In this instance, the 150mm to 225mm diameter range could be accommodated along with deviations with a single liner.
