Yorkshire Water – Crofton WwTW

meeting consent & improving river quality

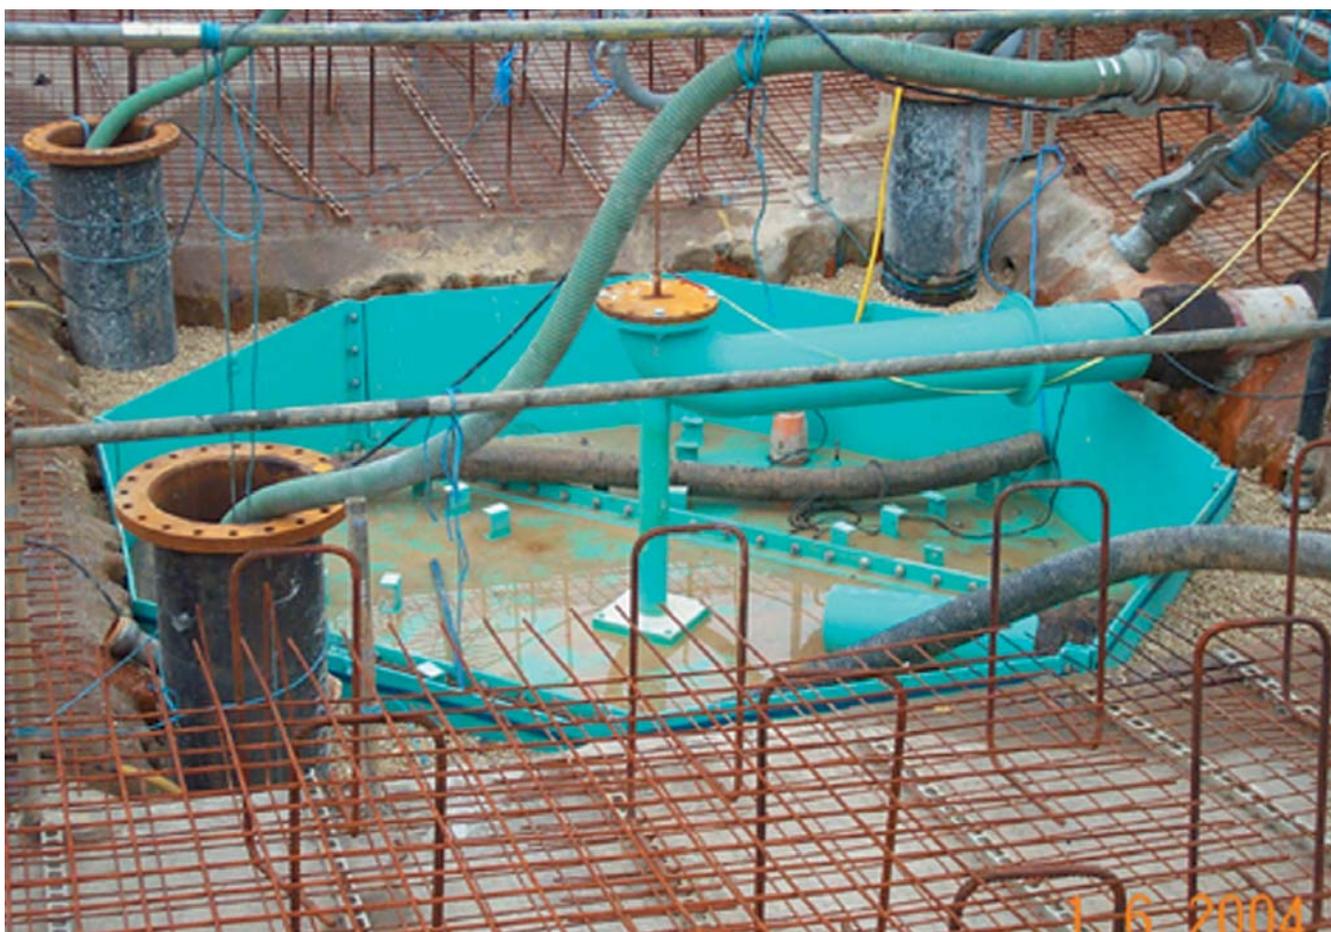
Removing groundwater for construction of final settlement tanks

Site investigations revealed that ground water was not present at the depth required for construction of the new final settlement tank. However, during excavation within the fissured mudstone, excessive ingress of water was experienced. The source of ingress was assumed to be from old mine workings in the area.

Design checks revealed that the proposed tank did not require amendment to account for groundwater. However, diesel pumps were required to operate constantly in an effort to keep the excavation dry. The initial concrete pour to the sump was affected by water ingress and operations ceased in order to investigate alternative methods of construction.

Well point dewatering was rejected, as it was not clear if flows within the fissured mudstone would reach the well points. Eventually, it was decided to place three 150mm dia. pipes vertically at the corners of the excavation, to below the base slab level, with submersible pumps placed in each pipe to transfer ground water via settlement tanks away from the excavation.
