# Scunthorpe, Ashby South Grange UID

## two key CSO overflows that had UID's within catchment

by Frank Thompson BEng (Hons), CEg MICE

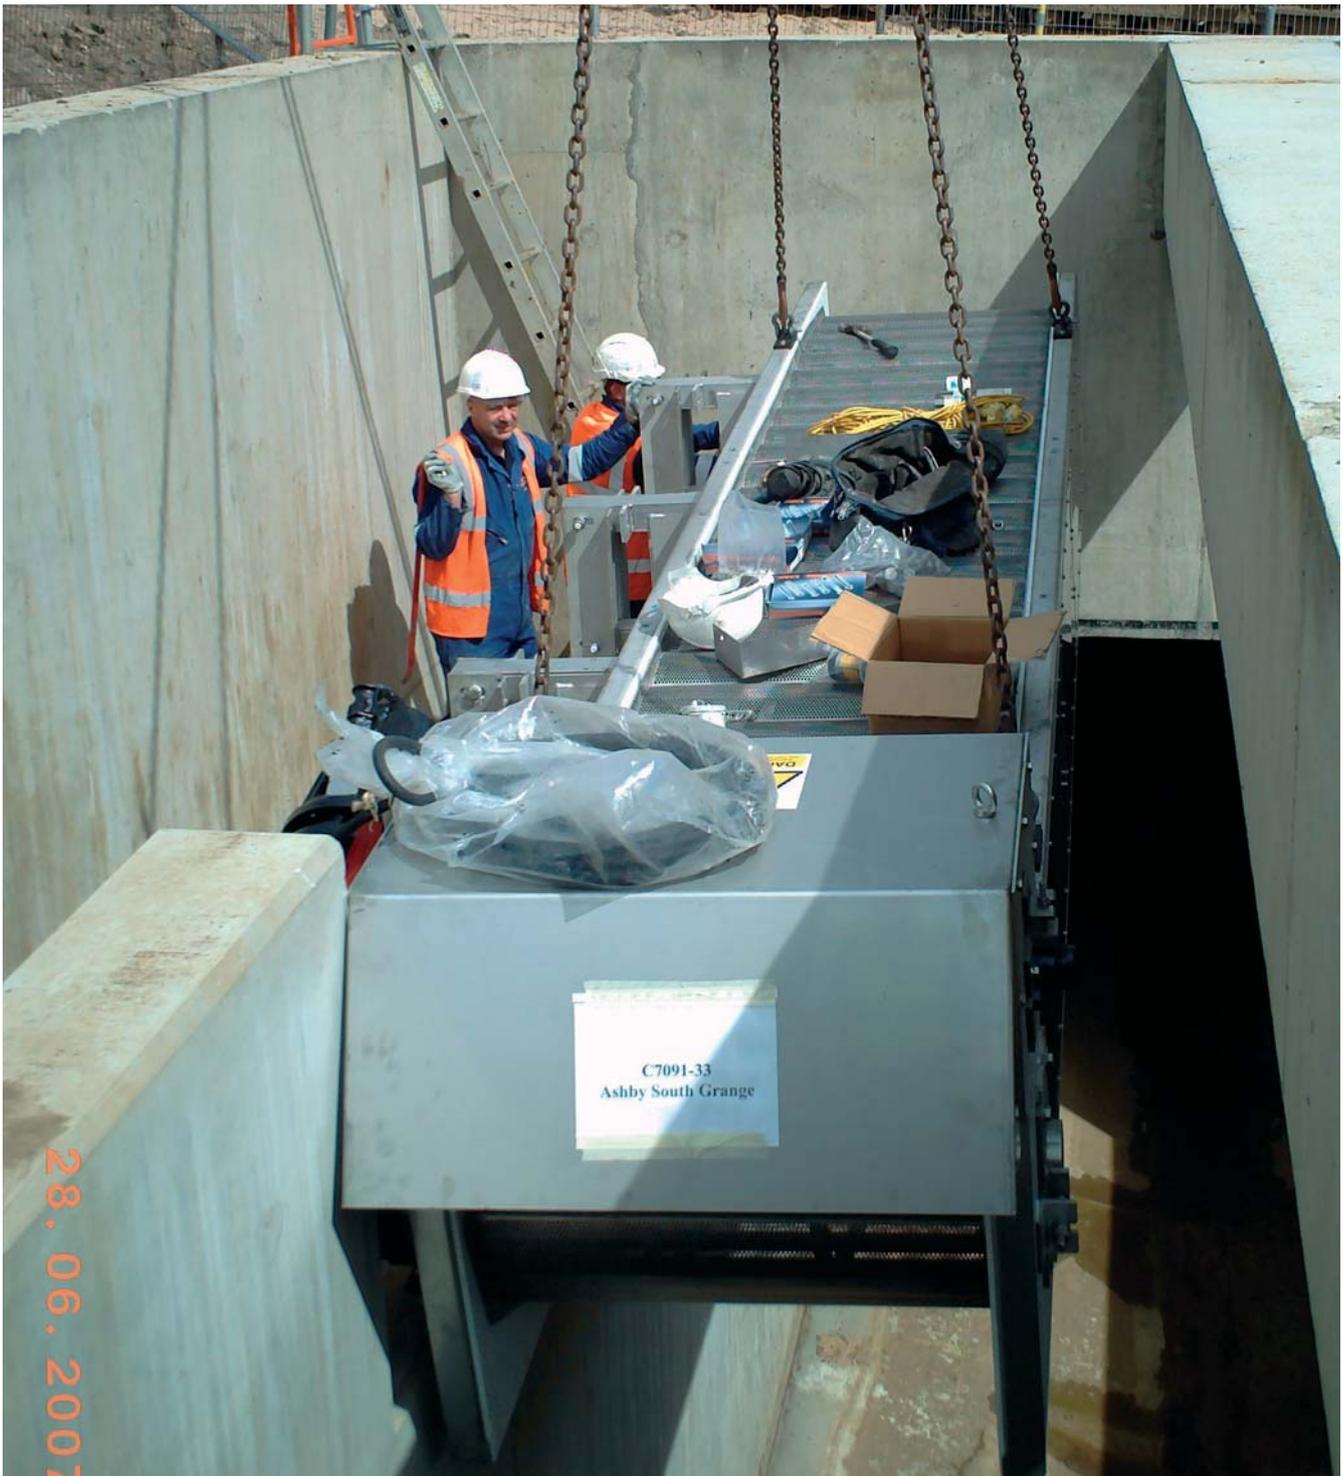
Screen installation at Ashby South Grange

This CSO is located in a public open space and the site was previously a Sewage Treatment Works before being abandoned in the late 1970s. The CSO had operational difficulties and the screen was prone to blinding, therefore resulting in unsatisfactory performance. As a result, the CSO was the cause of aesthetic problems at the nearby watercourse (Bottesford Beck) and a works identified to rectify the problem.

- \* provision of 1300m<sup>3</sup> of storage at Ashby South Grange;
- \* construction of a new CSO chamber incorporating a mechanical screen;
- \* increase flow to full treatment at Yaddletorpe Sewage Treatment Works; This required an additional final settlement tank to be constructed and would coincide with other planned works at this site.
