Clough Foot Minewater Treatment Scheme

delivering environment improvements within the Upper Calder valley

by
J Bagnall

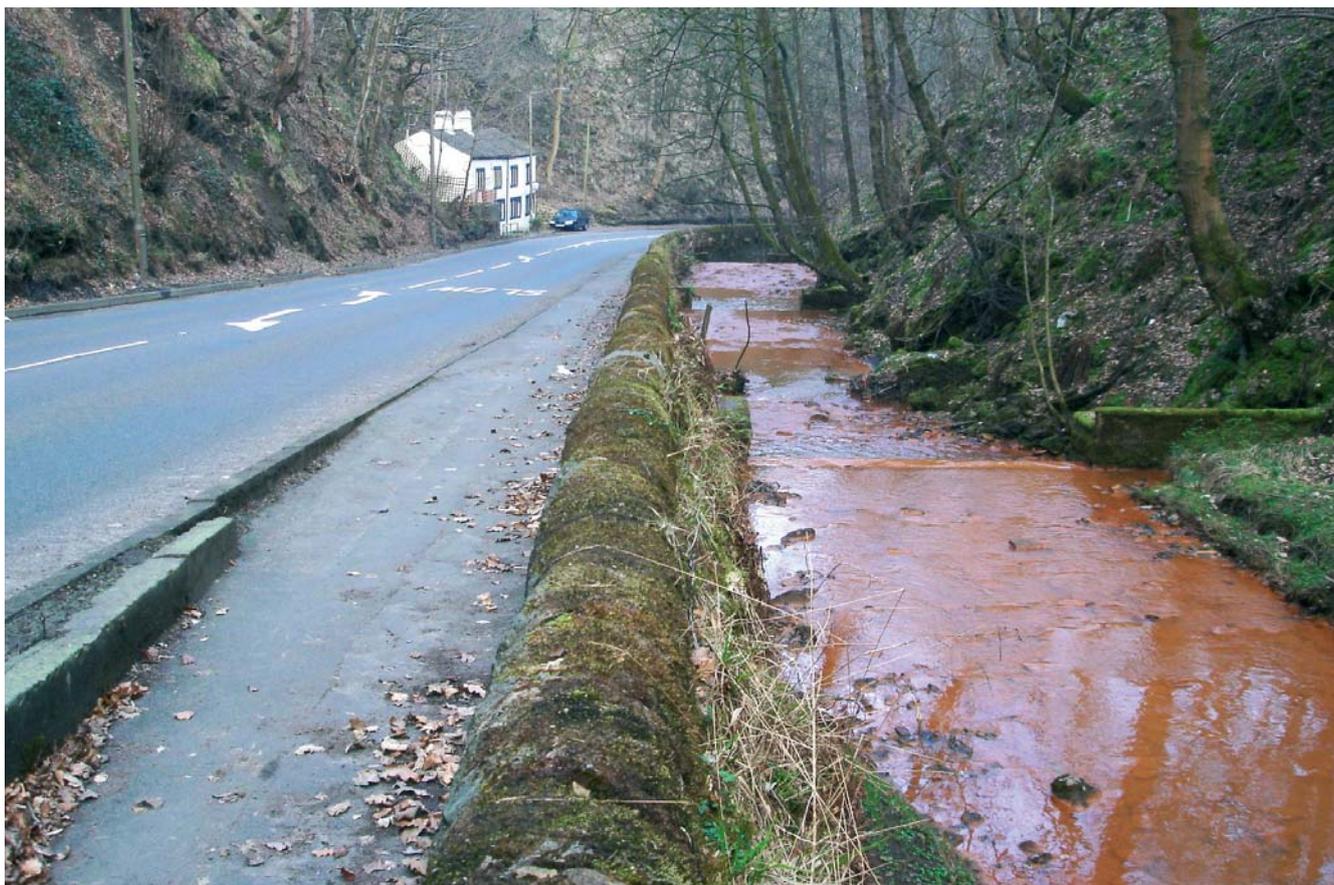
Photograph of ochre staining of Midgelden Brook

As the minewater leaves the workings the dissolved iron oxidises, depositing a layer of iron ochre along the stream bed, smothering aquatic flora and fauna. To date the pollution has impacted the Midgelden Brook and a section of the River Calder for a distance of up to 8.5km from the discharge point. The completed scheme will have a positive impact on both the flora and fauna of these affected watercourses.

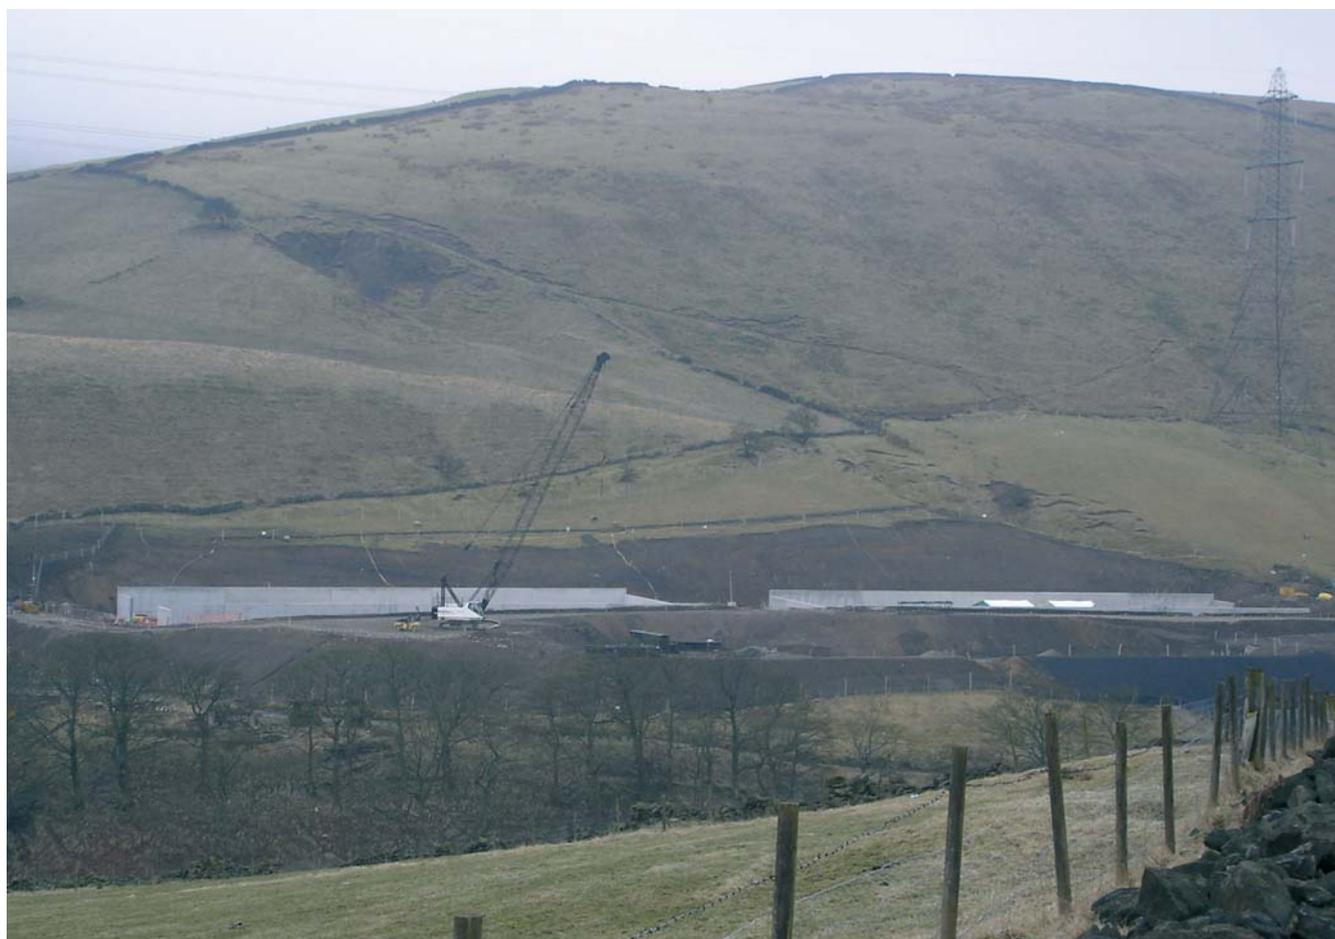
View of settlement lagoons under construction

After dosing, the minewater passes into settlement lagoons sized for 2 days retention to allow the influent to be fully oxidised and the iron ochre to settle within the lagoons. The total iron loading will be reduced to 10mg/l within this stage. The scheme is expected to generate 1000m³ of sludge per annum. The tanks have been sized to

allow one to be taken off-line to allow the sludge to consolidate, increasing the density, and minimising the volume that has to be removed from site.

Additionally the excavated material is argillaceous. Compressible boards have been used on the outside faces of the lagoon walls to

mitigate the compressive forces which would otherwise be applied to the structure as the material swells. This allowed excavated material to be used as backfill against the structure, eliminating the need to import some 1400m³ of granular fill.

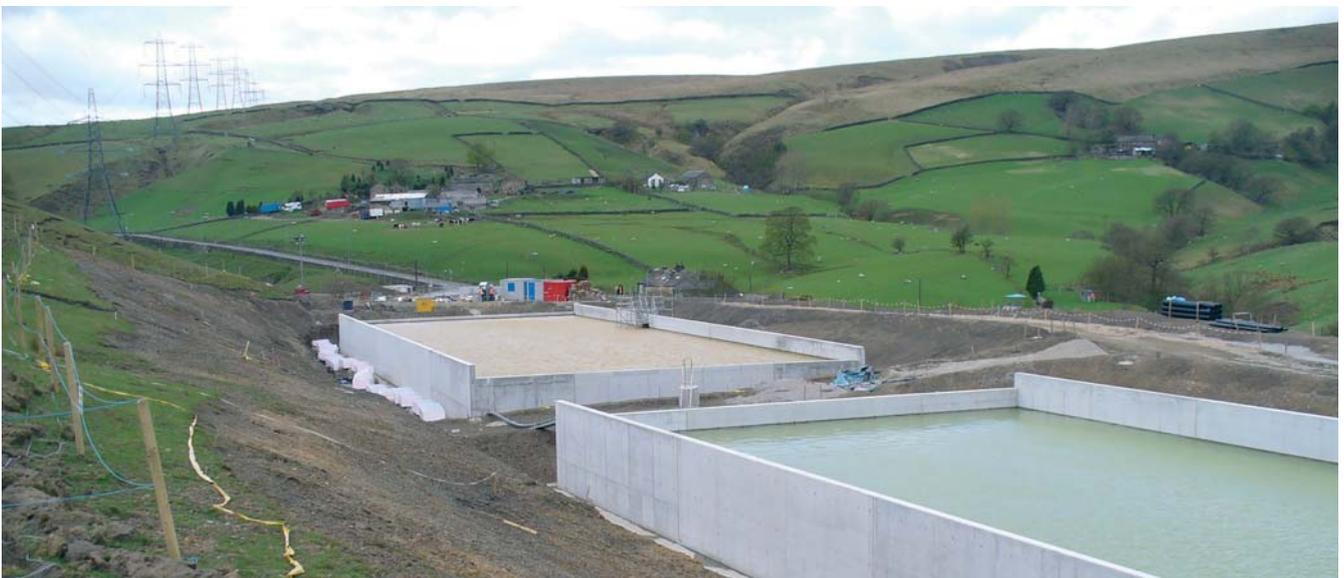
Completed lagoons during water test

The scheme is on target for completion in August 2010. Despite numerous challenges the project team has worked in a collaborative manner to deliver the scheme. At the time of writing the settlement lagoons have been completed, tested and backfilling has commenced. The scheme is expected to be delivered within the Target Cost. Over 40,000 hours have been worked with no reportable Health and Safety incidents.
