# Avoch & Munlochy

## upgrade & remediation of Scottish Highland RBC plant

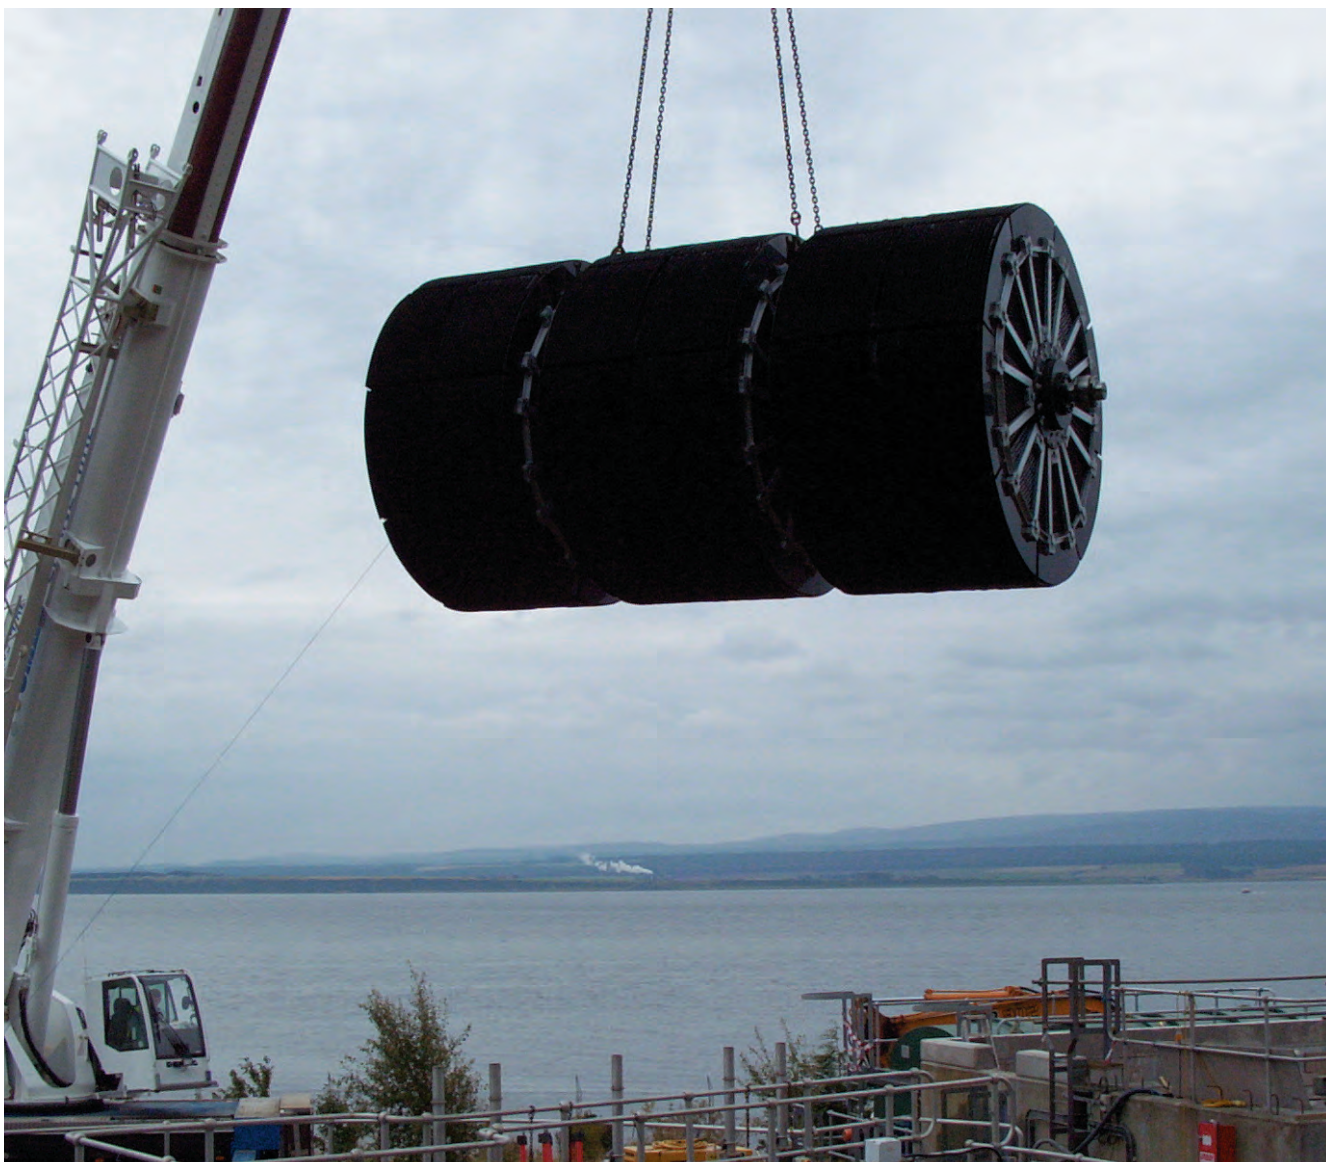
Second rotor installation in modified RC tanks (courtesy Copa Ltd)

Each rotor is 3.3 metres diameter and seven metres long. In order to minimise costs, the existing tanks were modified to accommodate the new *Copa* rotors and the bottom of the tank benched to avoid sludge settlement. The third rotor is located in a free standing GRP tank designed to resist gales of up to 40 mph.

During commissioning the second (existing) rotor collapsed, consequently *Scottish Water* were compelled to operate with only one existing, and defective rotor, whilst the new rotor matured. *Copa Ltd* provided the second rotor ahead of programme to ensure that two reliable rotors were fully operational as soon as possible, at no extra cost to the client. *Copa's* contract required them to design and provide the distribution chamber serving the three RBCs. This not only ensures the distribution of flows is equal but also the

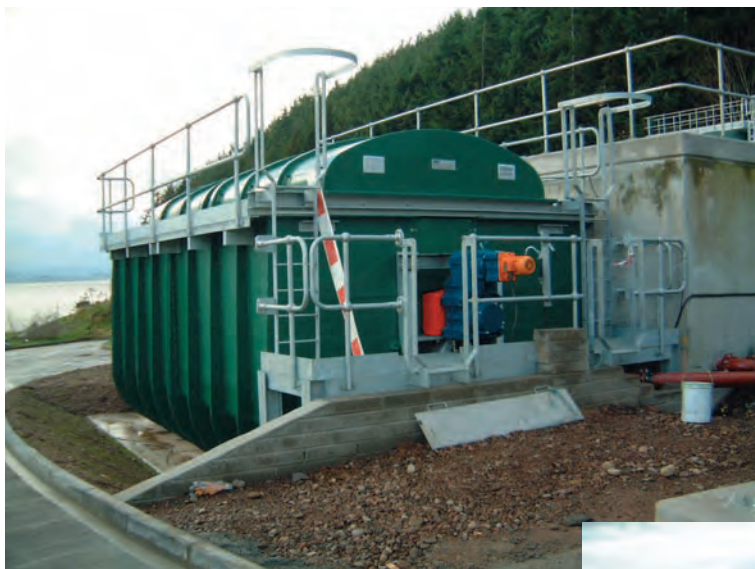
Avoch: Copa RBC - GRP tanks adjacent to original concrete tanks.

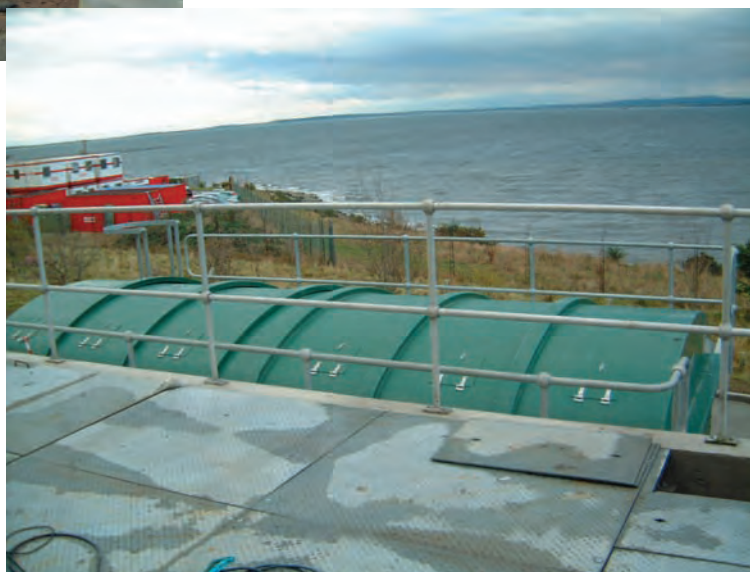
Avoch: GRP tanks & Moray Firth viewed from top of existing tanks
