Porthcawl, South Wales £5.8m investment cleans up the sea at popular resort

by Peter D Williams BEng, CEng, MIstructE

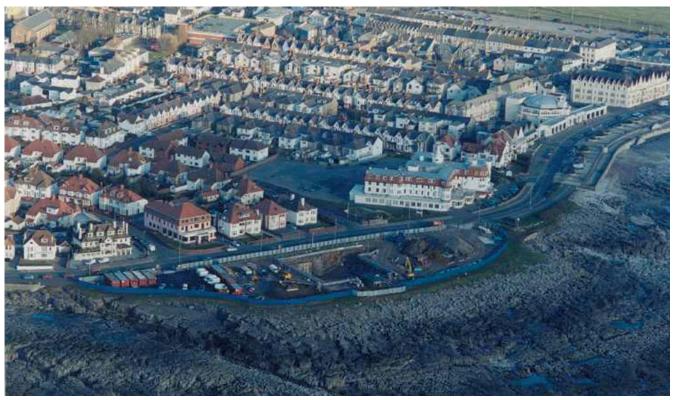
Porthcawl - works under construction (courtesy Hyder Consulting UK Ltd).

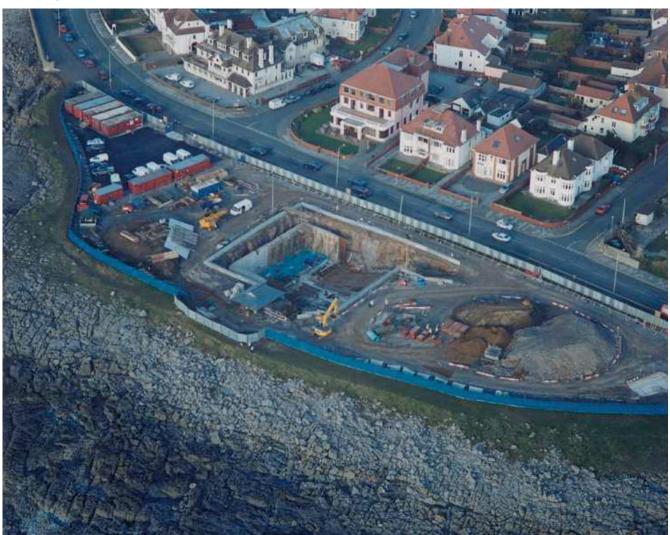
Porthcawl - works under construction (courtesy Hyder Consulting UK Ltd).
