# Crowlas Sewer Replacement

## the South West Water Alliance team (H<sub>2</sub>O) 'Innovate to Renovate' a failing strategic sewer in the heart of Cornwall

by Geoff Willcocks and Les Metcalfe

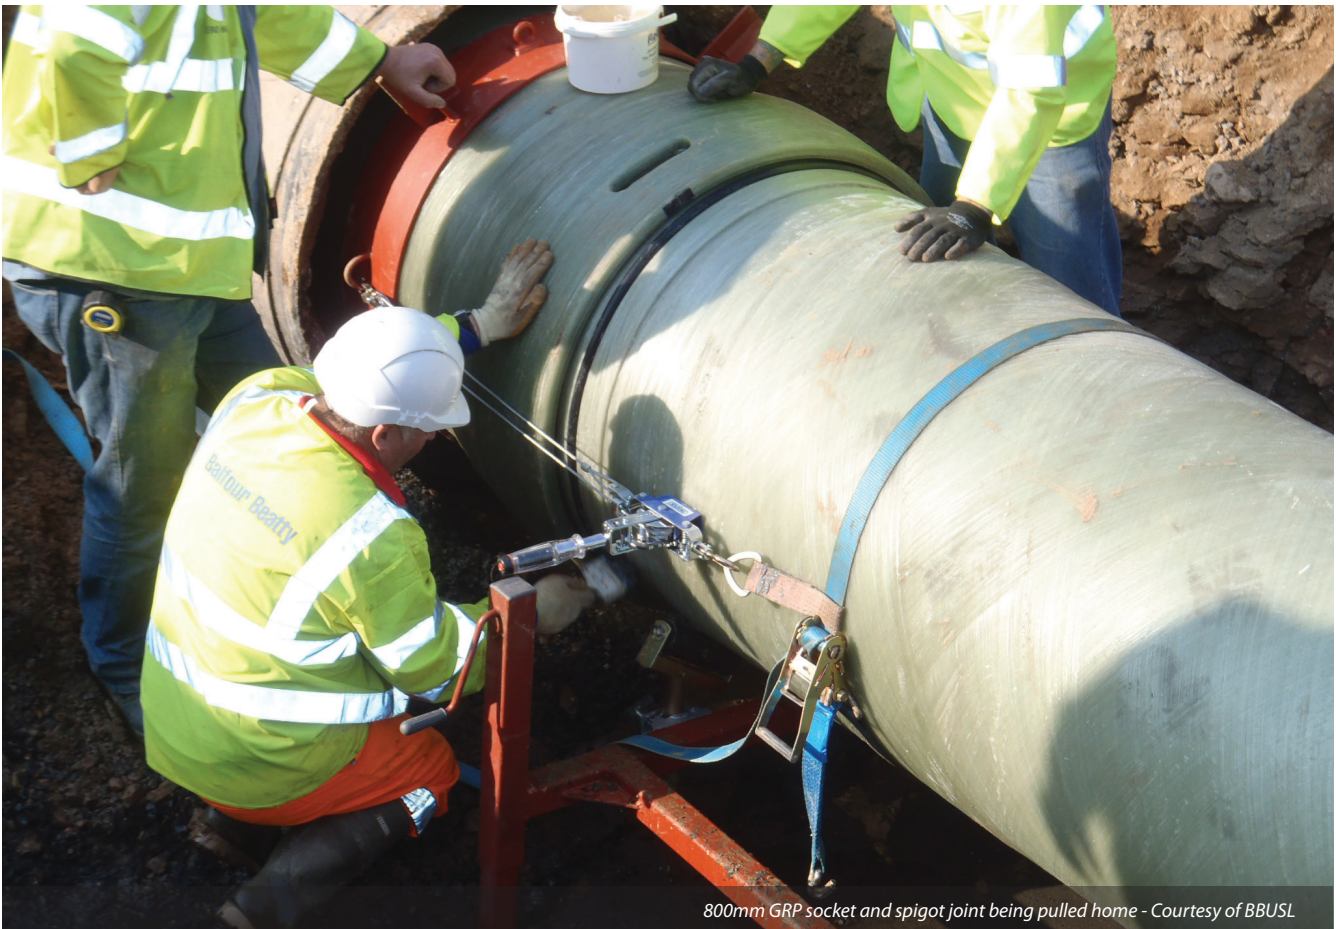
800mm GRP socket and spigot joint being pulled home - Courtesy of BBU SL

The 800mm (internal diameter) pipe utilised a socket and spigot system with a unique locking device to anchor each joint. Pipex Limited confirmed the anchors would cope with winching forces and abrasion wear tests confirmed the dragging process would not adversely affect the collars. Cost savings were also generated using containerised deliveries.

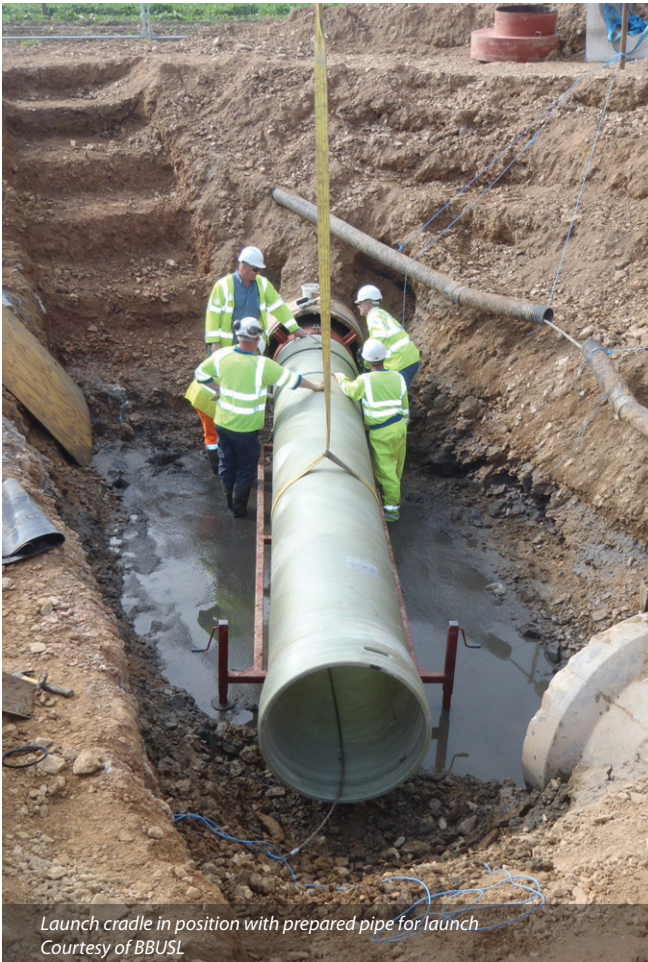
Launch cradle in position with prepared pipe for launch  
Courtesy of BBUSL

- **The launch cradle:** To accommodate the 5.85m long pipe with integral rollers and adjustable legs to match the required gradient.
- **The anchor clamp:** Serving two purposes; (i) providing an anchor to pull home pipes with ratchet straps and; (ii) to anchor the pipe against the host pipe if flows were restored prior to completion of the pipe pull.

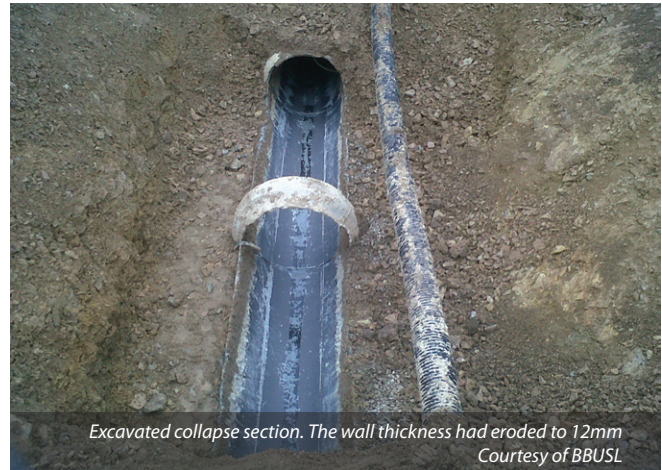
Excavated collapse section. The wall thickness had eroded to 12mm  
Courtesy of BBUSL

CCTV surveys had identified sections of missing soffit, hanging gaskets from pipe joints and reinforcement exposed in both manhole soffits and pipework walls. The consequences of a pipeline collapse were eventually realised during the scheme delivery when a section remote from the works area failed overnight. Two craters were formed and the resultant spill flooded an adjacent pig enclosure and farm courtyard.

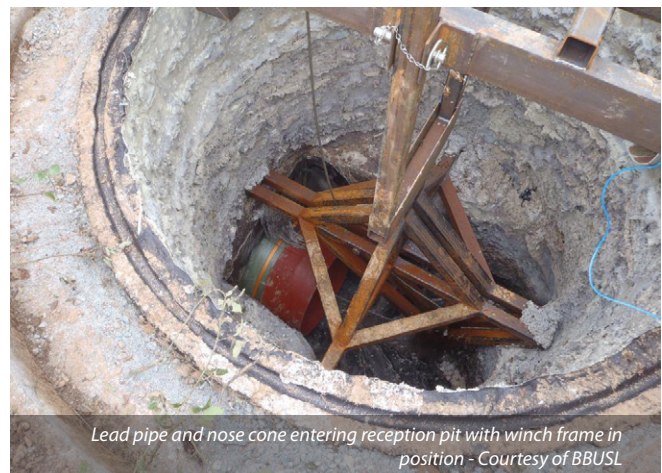
Lead pipe and nose cone entering reception pit with winch frame in position - Courtesy of BBUSL

- **The chamfered nose cone:** Attached to the lead pipe to avoid snagging on the host pipe joints.
- **The winch boot:** Fitted with a tested eye for winch rope attachment.

- **The pulley frame:** Inserted into the 'downstream' manhole to guide the winch rope to the centreline of the pipe for the pull. This was specifically designed to avoid man entry into the reception pit and could be rotated 180° to allow the reverse pull.

Entry into reception pits was avoided with the use of the winch frame (see right-middle photograph) lowered in following removal of the cover slab. Launch pits were battered rather than sheet-piled and air blowers were available in the event of gas detection.
