Carron Valley A Drinking Water Quality Project

improving water quality in central Scotland

by Martin McLvaney MICE MIWO CEnv

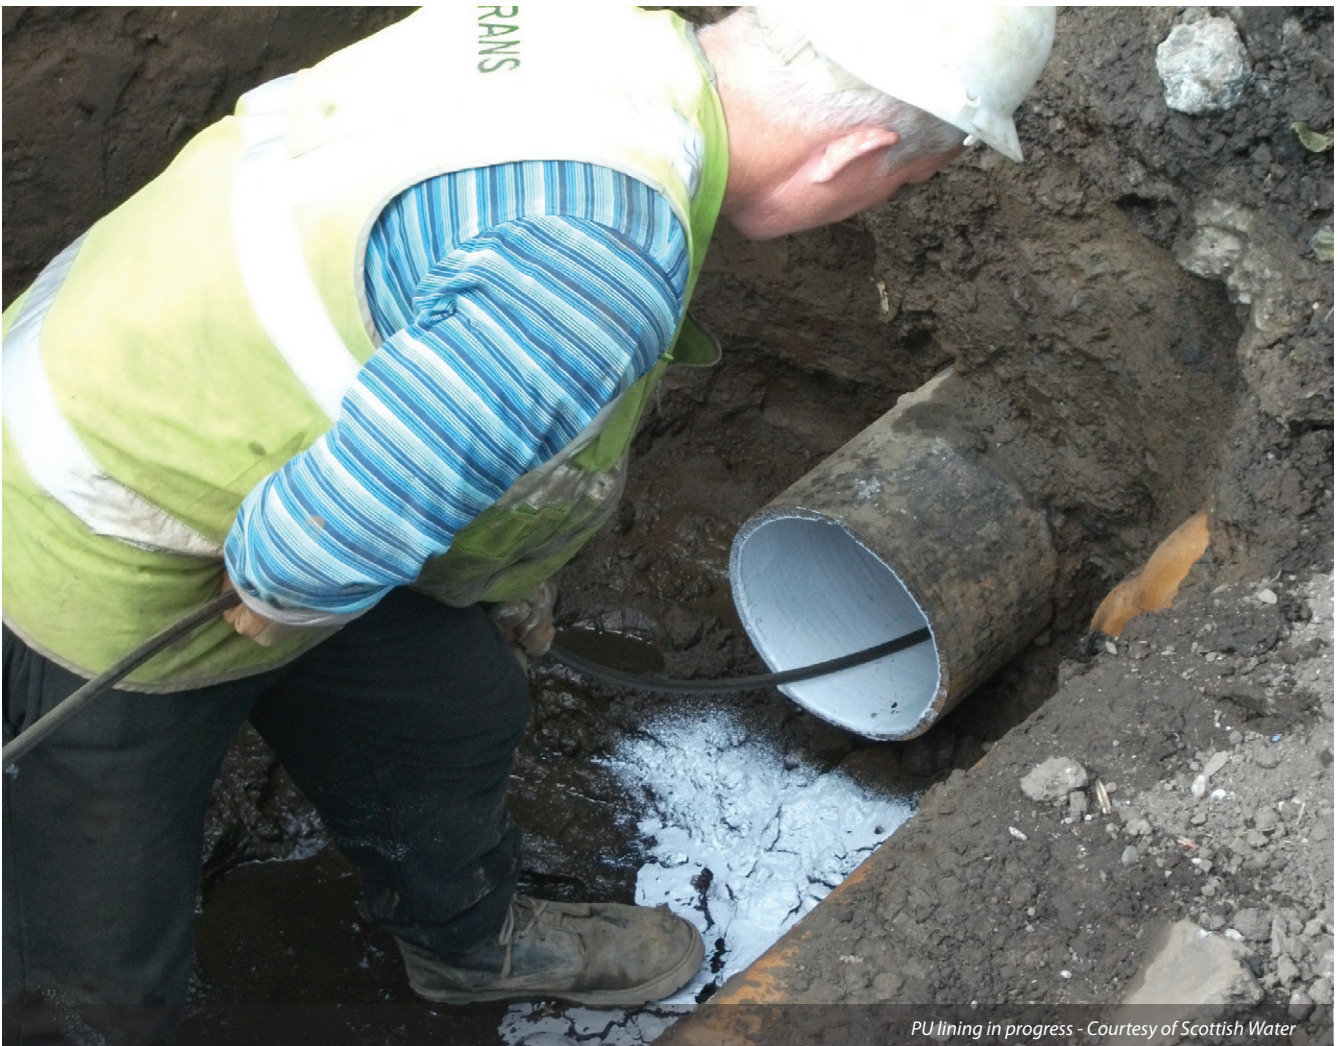
PU lining in progress - Courtesy of Scottish Water

- The mains are being cleaned by drag scraping and rackfeed boring. Labour and plant on site currently consists of two PU lining rig squads and one rehabilitation squad.
- The PU lining material being used on this project is Scotchkote 169LV supplied by 3M.
- The lining rigs and the individuals in the lining squads have been certified by WRC-NSF.
- All lining work is being undertaken in accordance with WIS4-02-01: *Operational requirements: In-situ resin lining of water mains.*

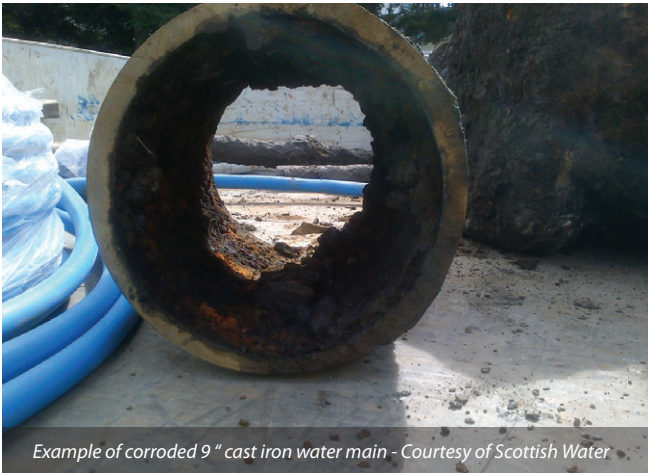
Example of corroded 9" cast iron water main - Courtesy of Scottish Water

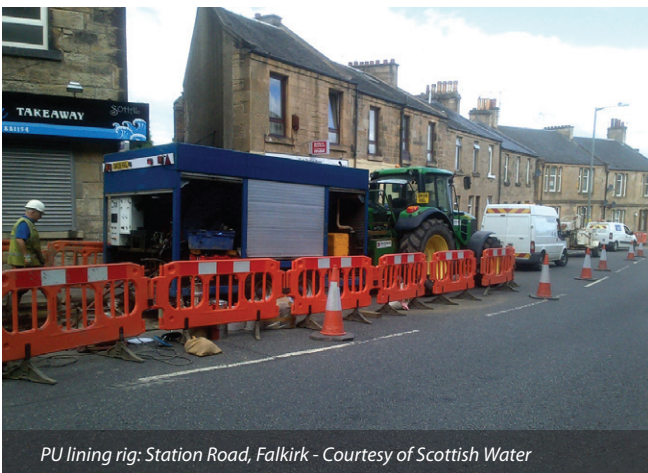
PU lining rig: Station Road, Falkirk - Courtesy of Scottish Water

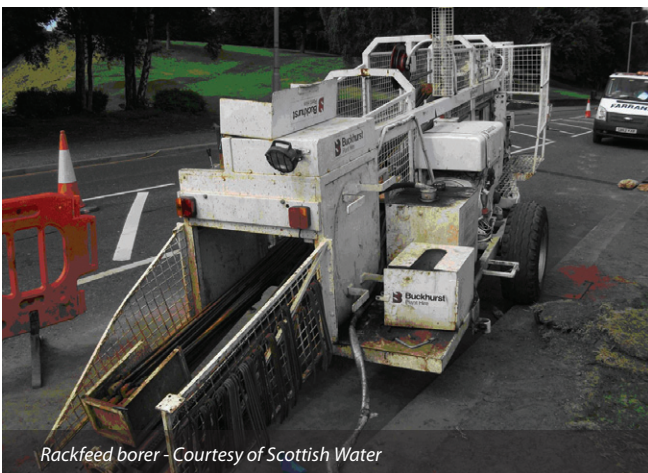
Rackfeed borer - Courtesy of Scottish Water

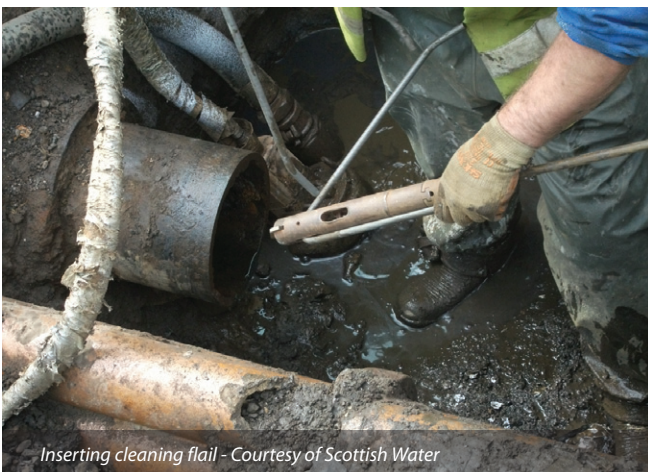
Inserting cleaning flail - Courtesy of Scottish Water

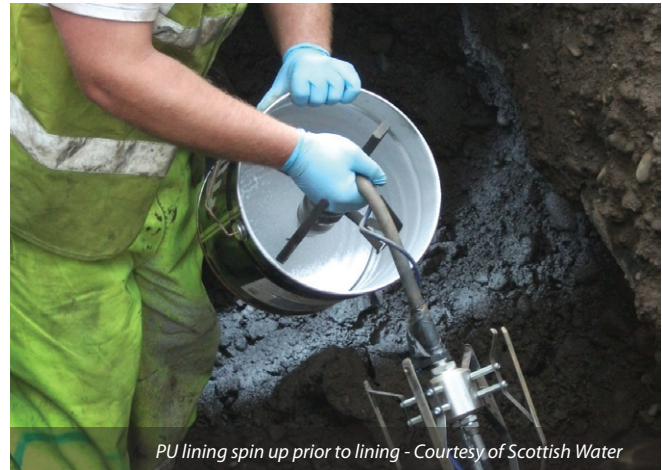
PU lining spin up prior to lining - Courtesy of Scottish Water

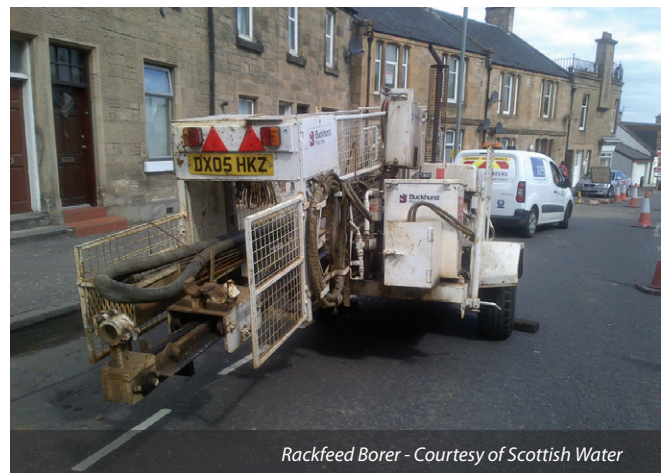
Rackfeed Borer - Courtesy of Scottish Water

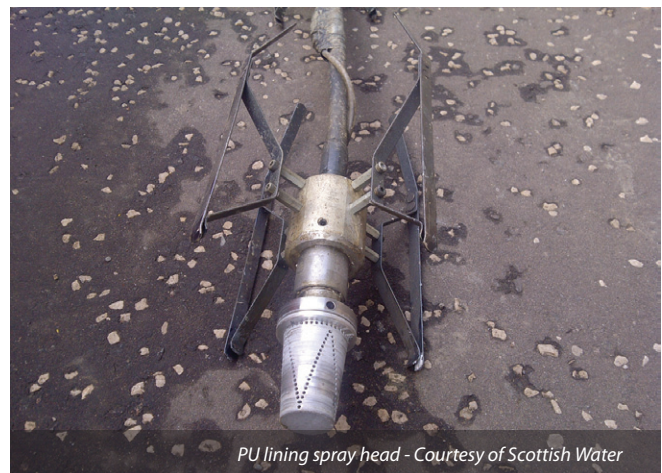
PU lining spray head - Courtesy of Scottish Water

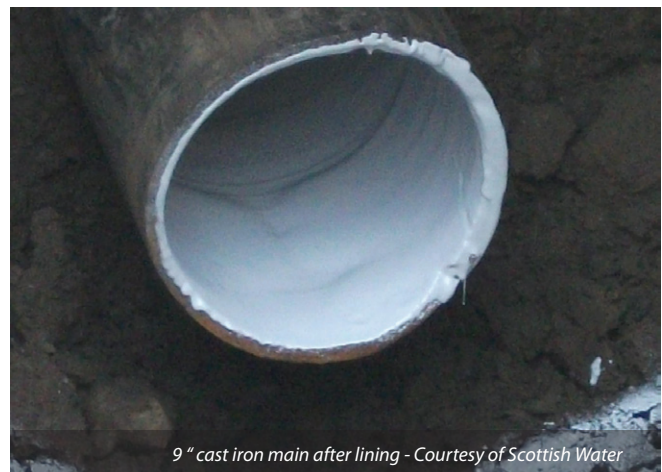
9" cast iron main after lining - Courtesy of Scottish Water

The rehabilitation techniques recommended comprised of flushing (20.15km) surface coating, 1mm thick spray resin lining applied in-situ (53.16km) pipe replacement (2.13km) and swabbing (9.50km).

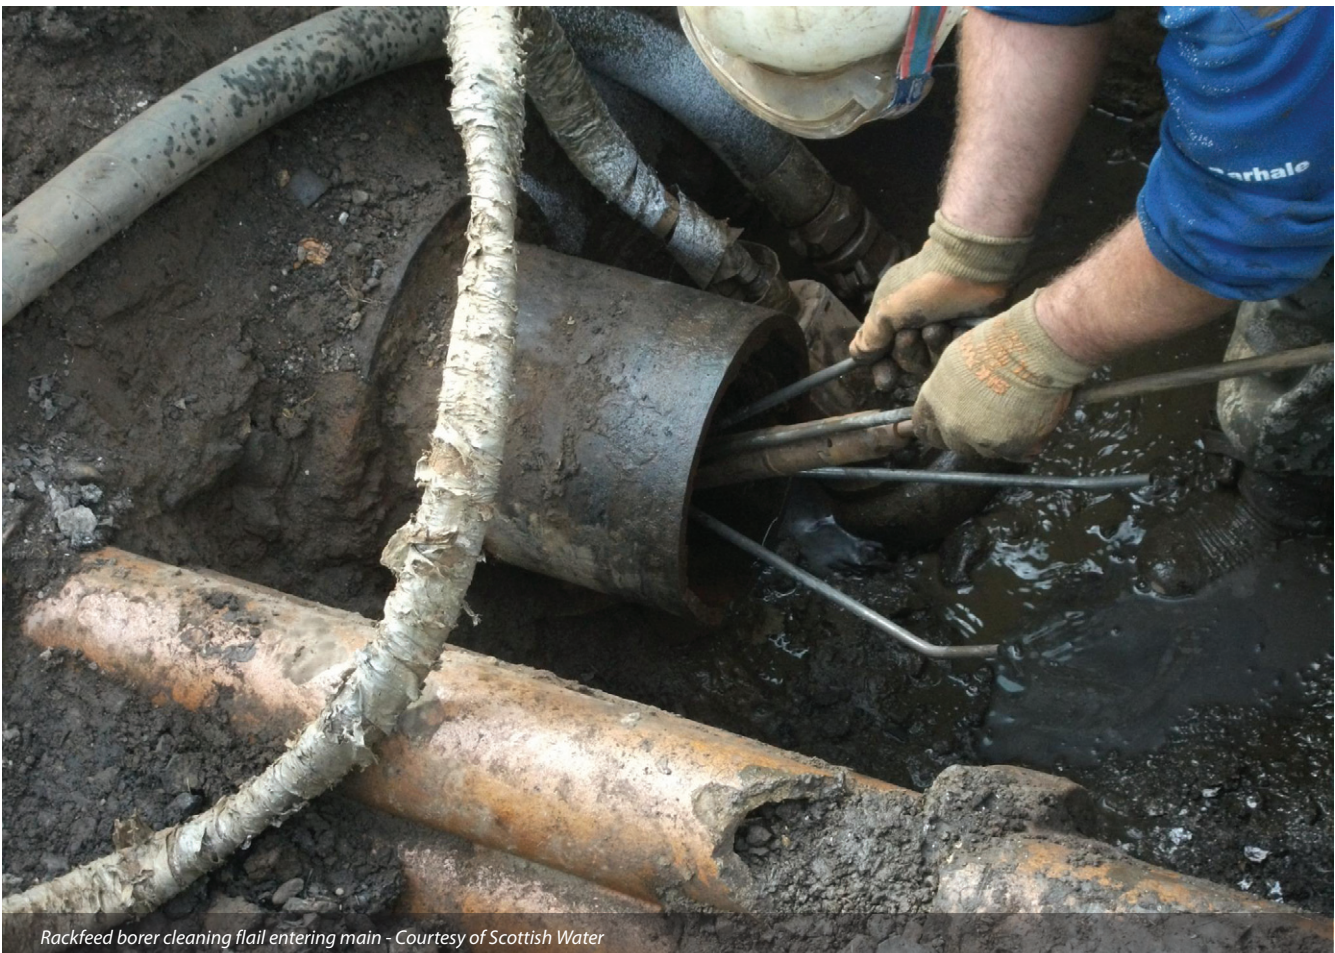
Rackfeed borer cleaning flail entering main - Courtesy of Scottish Water
