Highwood Bankside Storage Reservoir

Portsmouth Water Ltd's 'dark-side' solution to reduce the level of THM's at Highwood raw water storage facility near Southampton

by Gary Hynds CEng

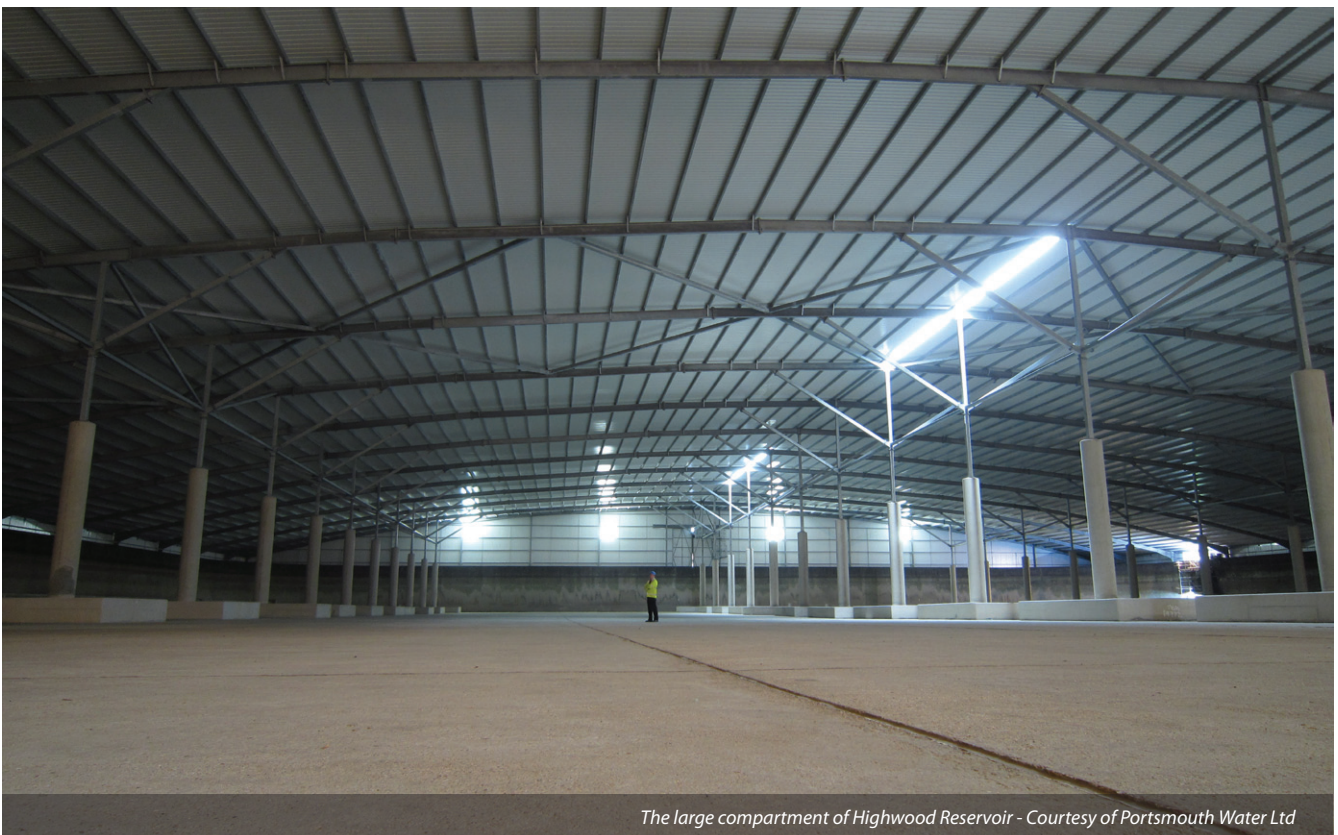
The large compartment of Highwood Reservoir - Courtesy of Portsmouth Water Ltd
