# Ravenfield Sewage Pumping Station

## a complete overhaul of an operational site on time, on budget and with zero defects

by David Greaves

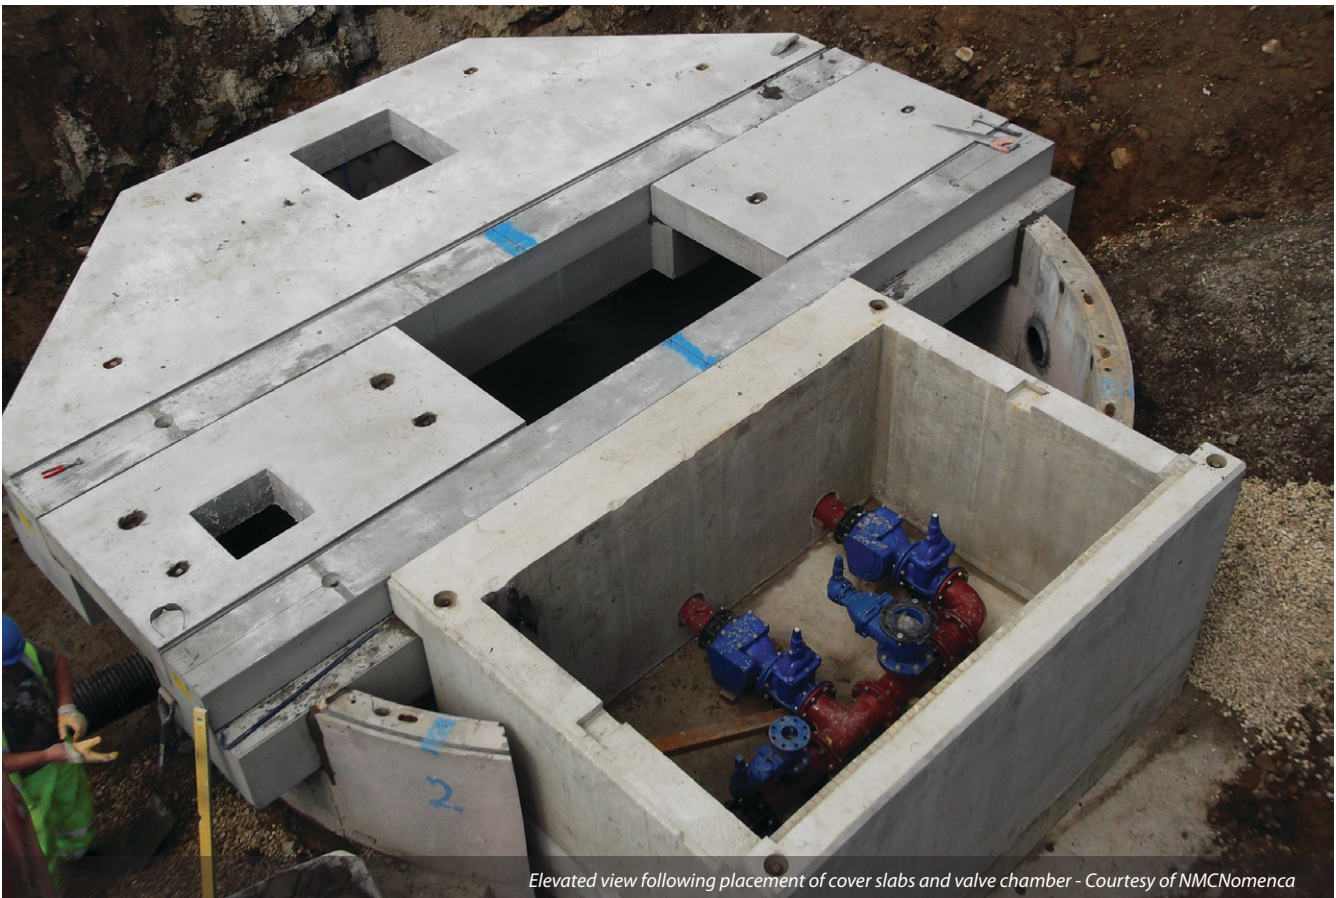
Elevated view following placement of cover slabs and valve chamber - Courtesy of NMCNomenca

**Precast suspended valve chamber:** Due to the very tight working space available within the SPS compound, NMCNomenca worked closely with structural consultants Eastwood & Partners Ltd, to design a precast concrete valve chamber that would be partly suspended on one of the cover slab cross beams as well as being sat on the shaft collar.

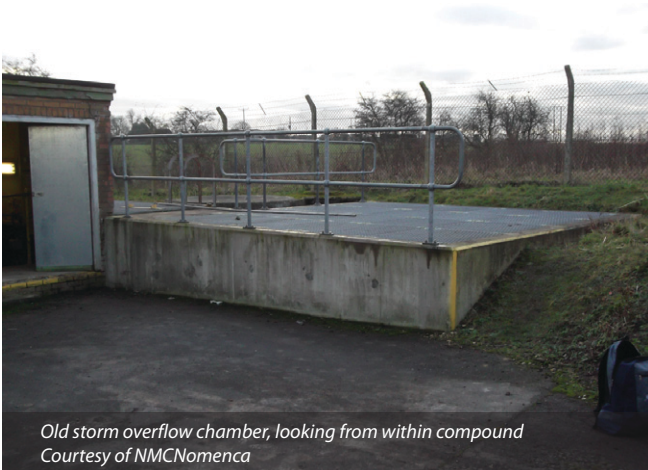
Old storm overflow chamber, looking from within compound  
Courtesy of NMCNomenca

A 5m square shallow overflow chamber had been installed next to the main wet well in the late 1990s to increase the storage capacity of the SPS. Although this was useful in times of increased flows, large build ups of rags and solids would remain in the overflow chamber and require regular jetting/cleaning by Severn Trent Water Service Delivery.

To satisfy the standard SPS design criteria of 2-hours wet well storage at 3 x DWF (dry weather flow), 100m<sup>3</sup> of extra storage would be required on site. With the storage obviously required on-line the only feasible option available was to demolish the existing storm overflow chamber and sink a new concrete shaft (5.5m diameter by 6m deep) in that location. The existing main inlet chamber, with built in emergency overflow, would be retained as part of the final solution whilst a second inlet would be created into the shaft, discharging the small amount of flow coming from the properties at the top of the access track. The existing brick building and wet well would also be demolished and replaced with a new 'walk in' GRP kiosk housing the new motor control centre (MCC).

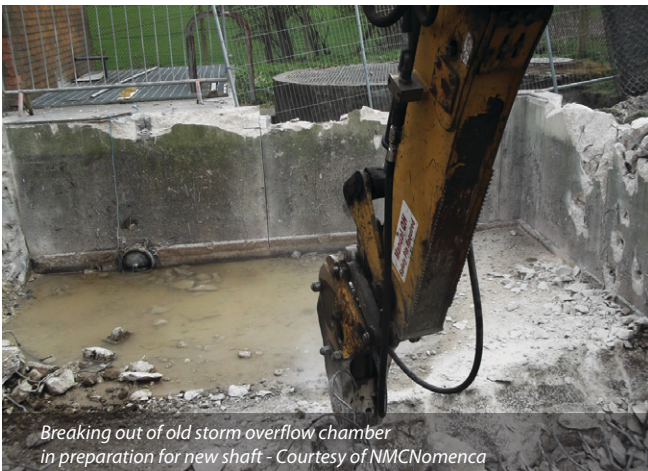
Breaking out of old storm overflow chamber  
in preparation for new shaft - Courtesy of NMCNomenca

The sequence of work had to be planned in great detail with as much construction being carried out 'off line' as possible. As previously mentioned, the overflow chamber had to be demolished to allow the new shaft to be sunk in that location. Doing this we could keep the existing dry well pumps running as long as possible.

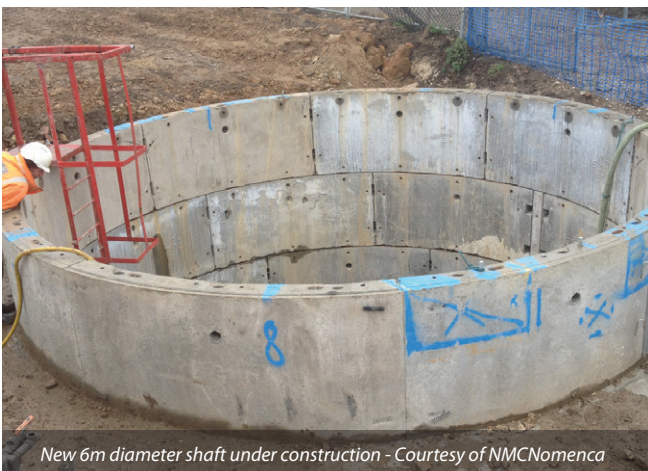
New 6m diameter shaft under construction - Courtesy of NMCNomenca

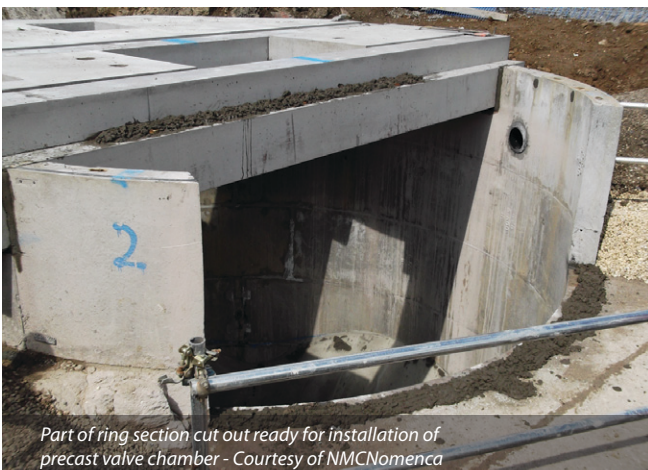
Part of ring section cut out ready for installation of  
precast valve chamber - Courtesy of NMCNomenca

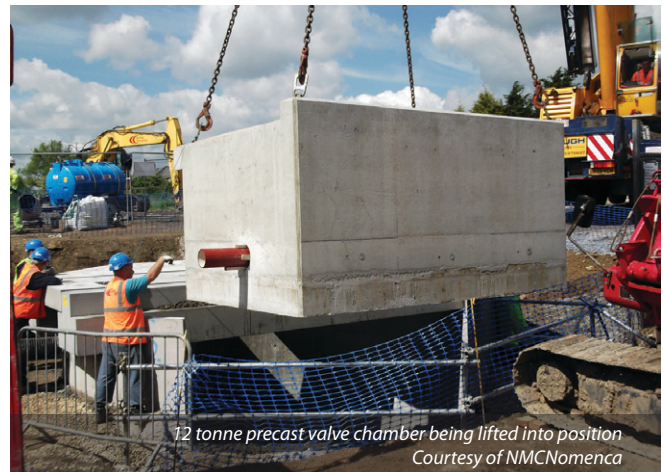
12 tonne precast valve chamber being lifted into position  
Courtesy of NMCNomenca

As well as saving a great deal of working space the valve chamber was also designed to be precast in a location away from site, delivered to the site as one complete item and then lifted into place via mobile crane.

To round off the complete installation, the new valve chamber pipework was also pre-installed off site (at the same location it

was cast) by pipework fitting specialists. This complete installation saved a substantial amount of man hours on site (approx. 2 weeks) which in turn saved money on site materials and other machinery.

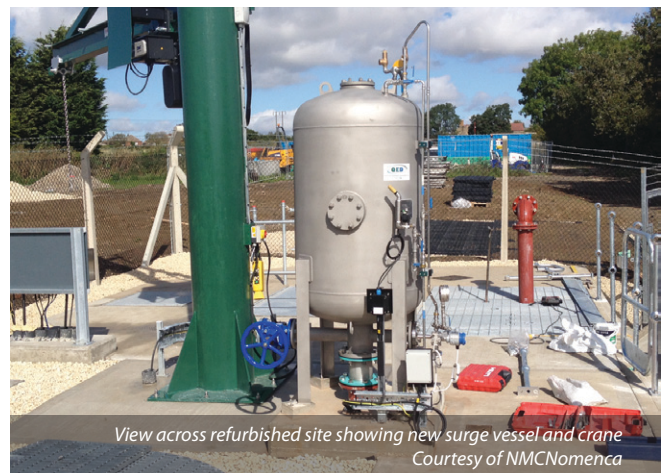
View across refurbished site showing new surge vessel and crane  
Courtesy of NMCNomenca

The final part of the upgrade required the entire replacement of all pipework and valves as well as the installation of 2 (No.) new 30kW submersible pumps complete with all the latest specification lifting chains. A swing jib crane with a 1 tonne SWL electric hoist would be installed to ensure the new pumps could be lifted from the new wet well safely.

**Pressurized surge vessel:** SPS sites with pressurized surge vessels on the rising main are usually quite rare in comparison to their use on clean water sites, but following a recommendation in the hydraulic study a 0.6m<sup>3</sup> pressurized vessel was installed at Ravenfield complete with its own compressor within the new GRP kiosk.

An approved pressure vessel designer, with a significant amount of experience in the field, was appointed as contractor to design, supply and install the pressure vessel and associated items. The control panel for the equipment was manufactured by a tier 1 control panel manufacturer.

The surge vessel maintains a safe working pressure along the entire primed rising main (1km) of around 1.5bar. In the unlikely event of any surges in pressure the vessel will act as an air brake to prevent any slamming of valves or collapsing of pipework.

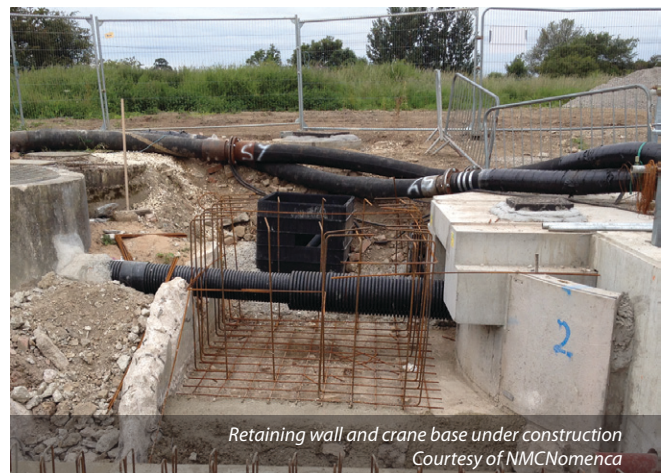
Retaining wall and crane base under construction  
Courtesy of NMCNomenca

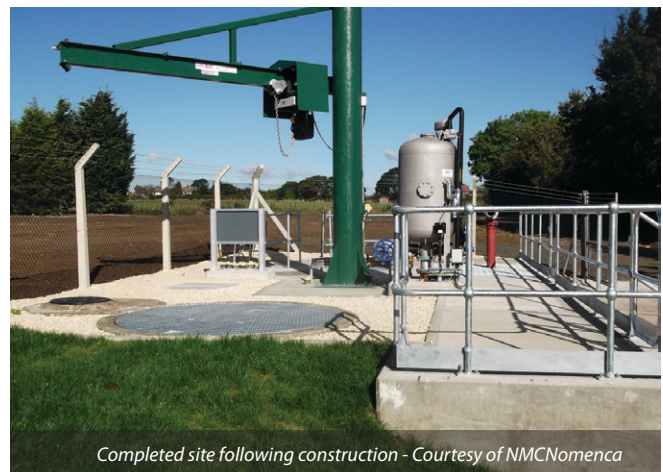
Completed site following construction - Courtesy of NMCNomenca
