# Digley IRE Valve Tower Metalwork Replacement

replacement of corroded metalwork within the valve tower to improve safe access

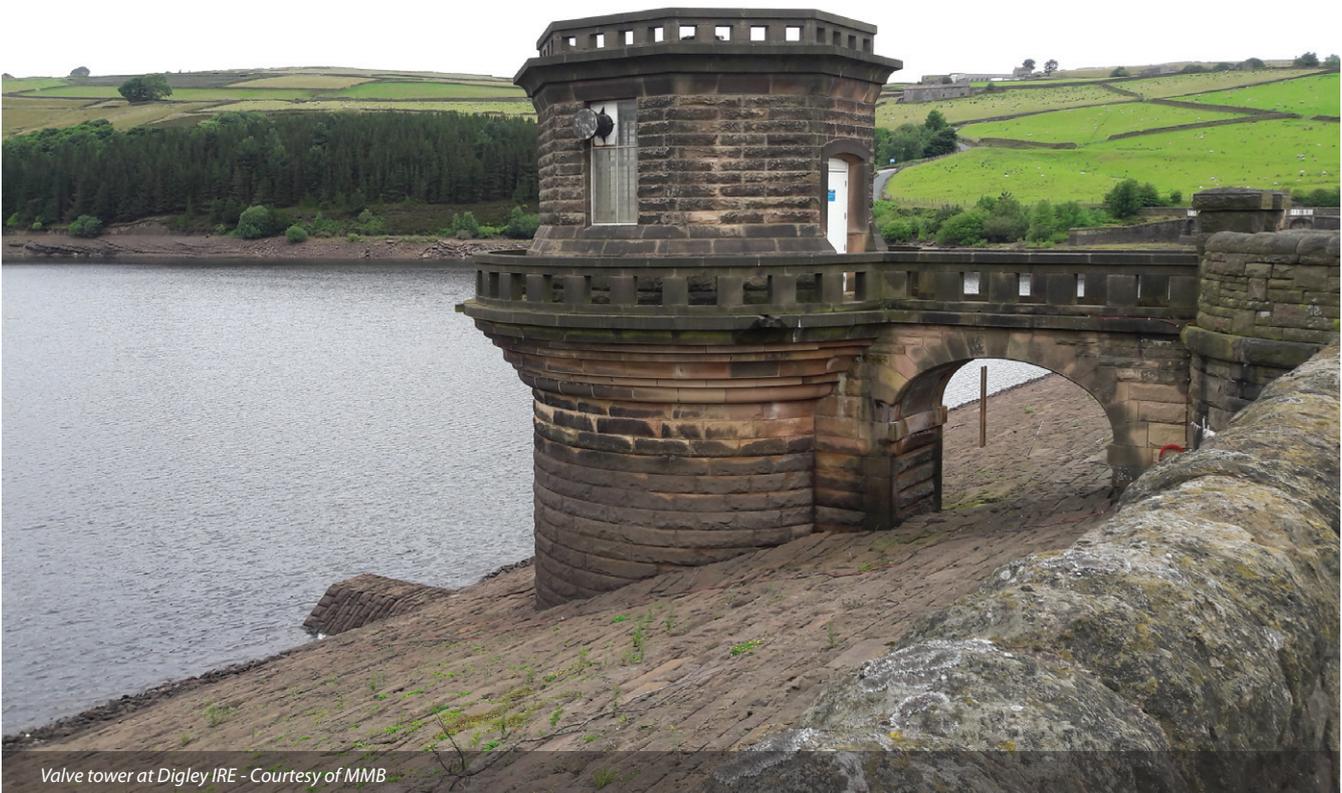
Valve tower at Digley IRE - Courtesy of MMB
