Bournemouth CIS Tunnel Renovation

biogenic corrosion of concrete sewerage assets, in nutrient rich environments, is ubiquitous. This project highlights a selection of tunnel repair interventions

by Julian Britton I.Eng MICE

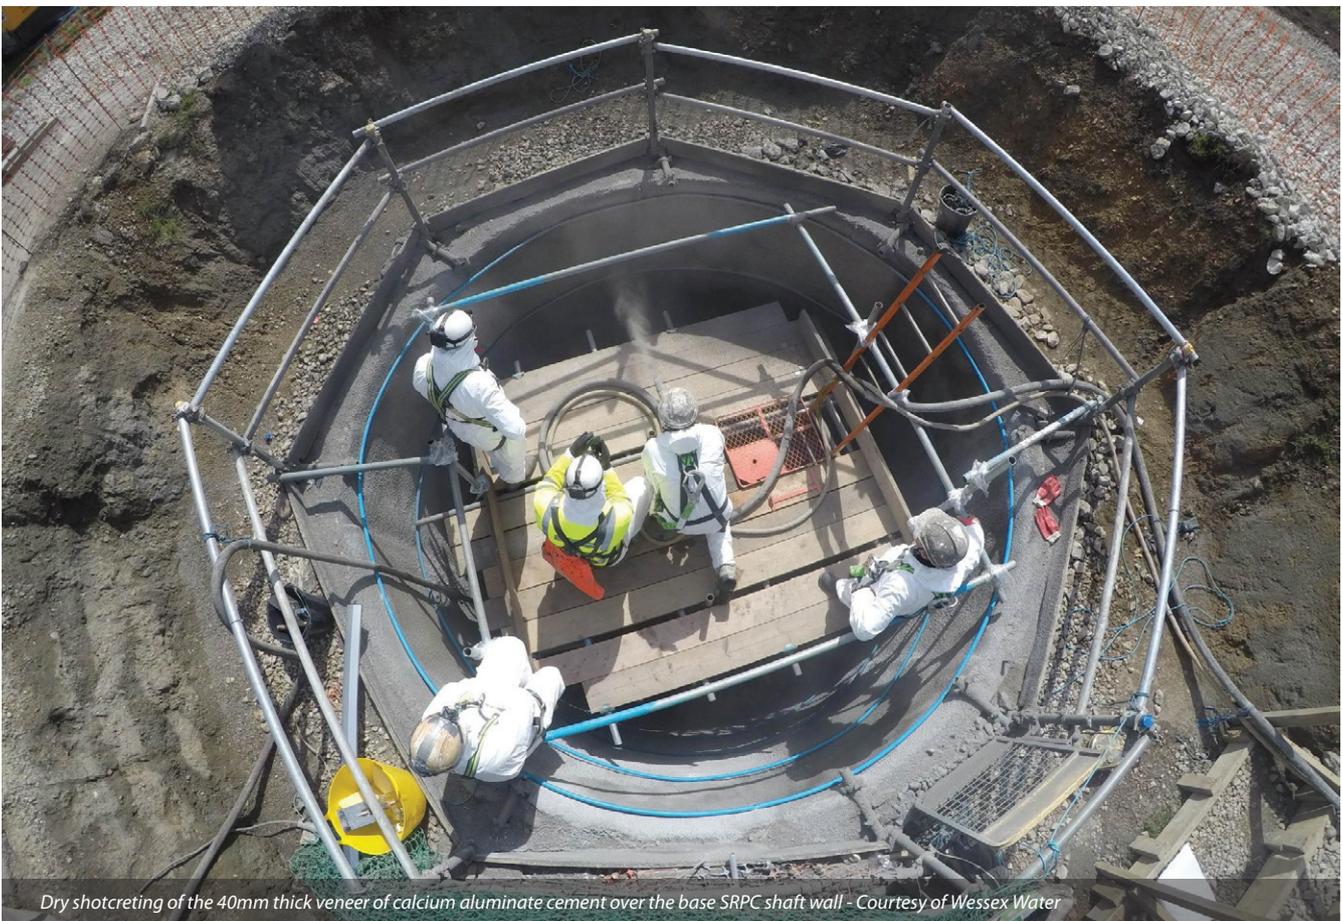
Dry shotcreting of the 40mm thick veneer of calcium aluminate cement over the base SRPC shaft wall - Courtesy of Wessex Water

Renovation of shaft 13 with calcium aluminate cement

Therefore, shaft 13 was scabbled back to the substrate, shotcreted by a make-up layer of SRPC concrete, and over coated by a 40mm veneer of CAC for protection, due to its enhanced cost.

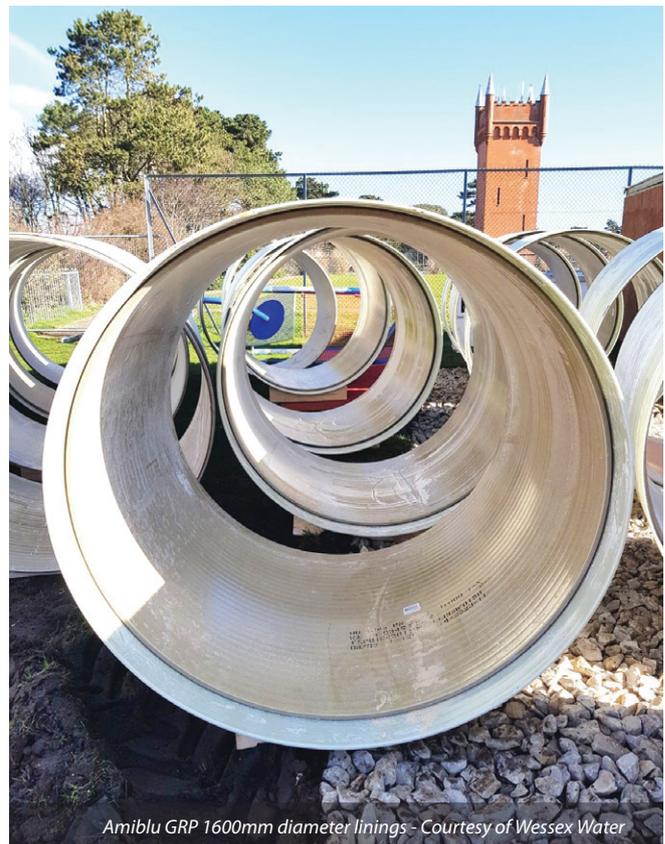
Amiblu GRP 1600mm diameter linings - Courtesy of Wessex Water

The GRP linings were designed to German standard DWA A143-2 (ATV-M 127) and the procurement tendered along with the main contract, awarded to Matt Durbin Associates Ltd, and linings supplied by Amiblu of Poland, a merger between the former Amiantit and Hobas in 2017. The liners constituted 1600mm internal diameter GRP one-piece circular segments with in wall joints.

The 42mm thick, segments were imported from Gdańsk, Poland, and were installed once the shaft cover slab was removed, over a two-week period during Easter 2018. The 450kg lining segments were winched home to close joints, and the annulus between the original secondary lining and GRP segments filled, in isolated bays of 20m length, with Pozament SPP3 in three lifts, using a cumulative 70 tonnes of mixed grout.

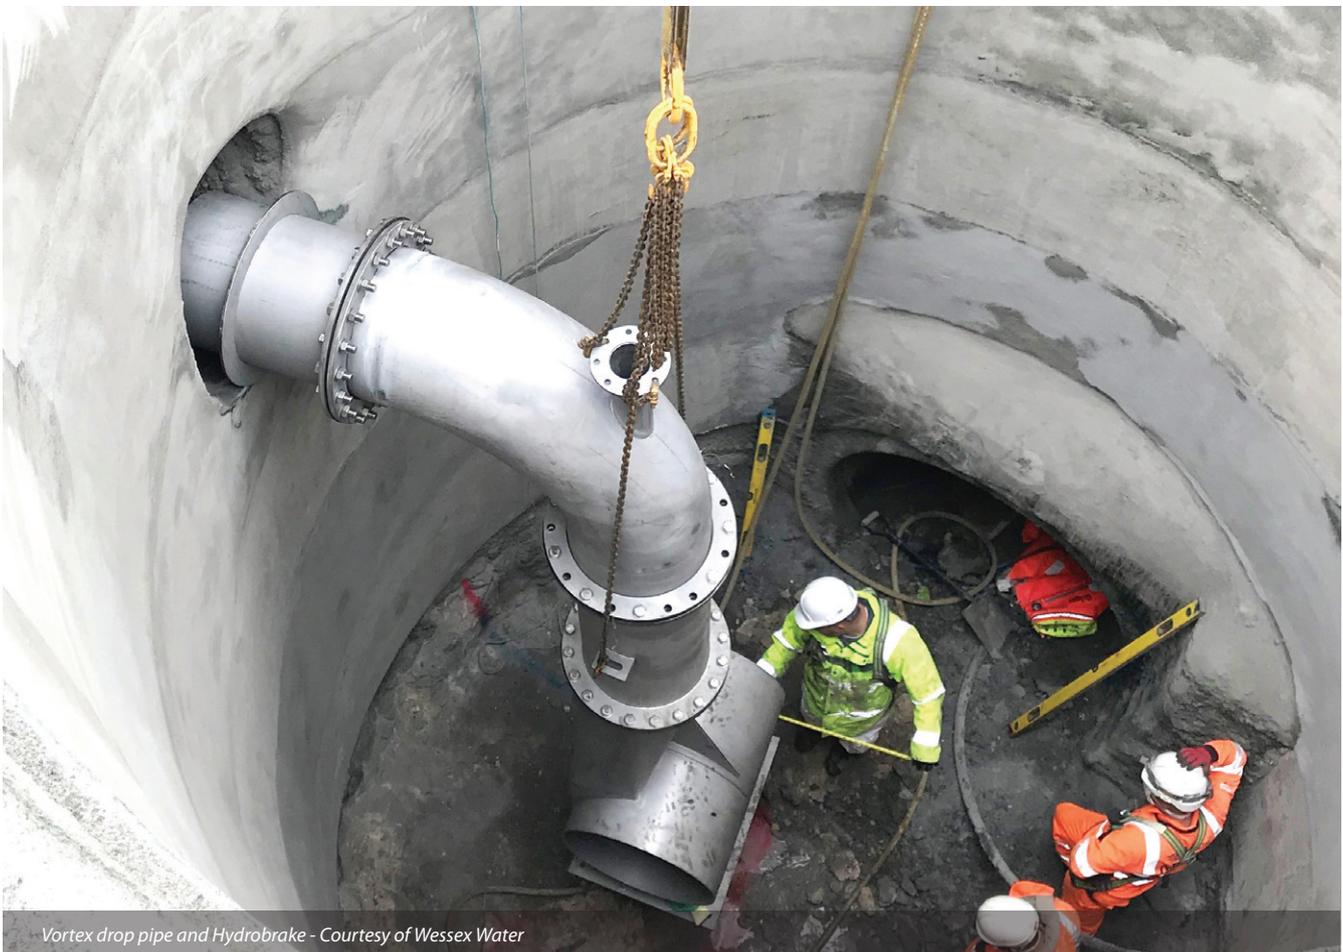
Vortex drop pipe and Hydrobrake - Courtesy of Wessex Water

Wessex Water are now installing the latest design with the addition of a Hydrobrake (manufactured by Hydro International Ltd), to quiesce the flows as much as possible. All of these measures should continue to offer mitigation of chemical dosing of the rising mains with sodium nitrate, a more cost effective renovation and operational intervention.
