# Minworth Lagoons - Curdworth South Embankment

## risk reduction in a constrained and sensitive environment

by Patricia Murfin-Snook & Stuart Bowmer

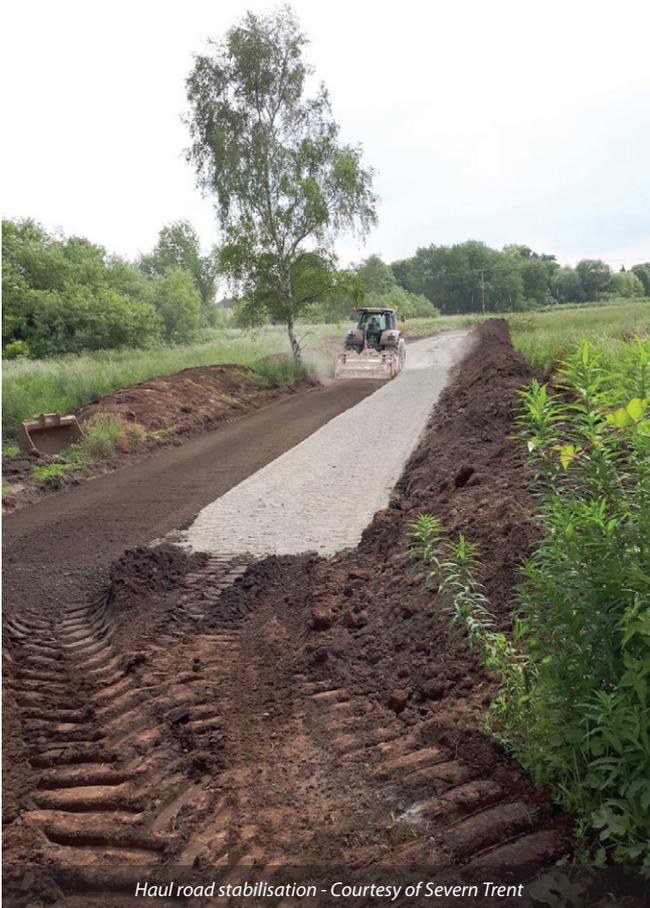
Haul road stabilisation - Courtesy of Severn Trent

A new haul road and associated crane platforms, providing access for piling works construction plant and site traffic, were formed using a cement based, ground stabilisation technique. Following vegetation clearance and ground preparation, material was mixed into a 300mm layer of the soil surface, rolled, compacted and cured to form a strong durable foundation. This was then protected by the addition of a compacted 75mm thick layer type 1 road stone along the running surface. This solution minimised the excavation and disposal of materials from the site, as well as avoiding the need to import significant volumes of road stone, traditionally required to form a comparable haul road. The haul road was created in around 6 weeks and this method produced significant cost savings.

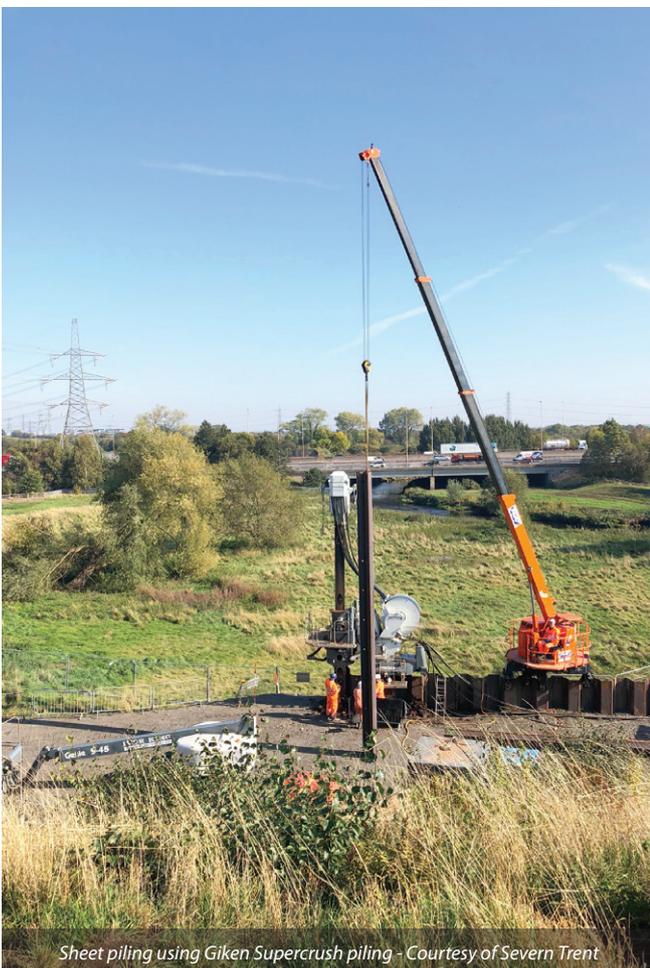
Sheet piling using Giken Supercrush piling - Courtesy of Severn Trent

Working collaboratively with Severn Trent and specialist sub-contractor Ivor King, the team developed an alternative solution adopting Giken Supercrush technology. This employs a silent piling rig which would press interlocking steel sheet piles into position, using a vibration-free method of installation.

Construction of the sheet piled wall commenced early in July 2018, using Ivor King's Giken Supercrush silent piling rig. This adopts a vibration-free process, which progressively presses piles into position. Following initial set-up, the system utilises adjacent installed piles to support the piling rig and provide a reaction to the downward force required to press the next pile into position.

This eliminates the requirement for the provision of extensive piling platforms, as work progresses to construct the sheet piled wall. The plant also incorporates a small mechanical auger that can be used to remove stiff material, in advance of pressing each pile into position.

This can be used to maintain a smooth and accurate installation process. The operation was also supported by a telescopic clamp crane that progresses along the top of the installed pile wall to take up its position for driving the next pile. The completed wall comprises around 750 steel sheet piles, 7 to 11m in length, embedded into the underlying Mercia Mudstone.

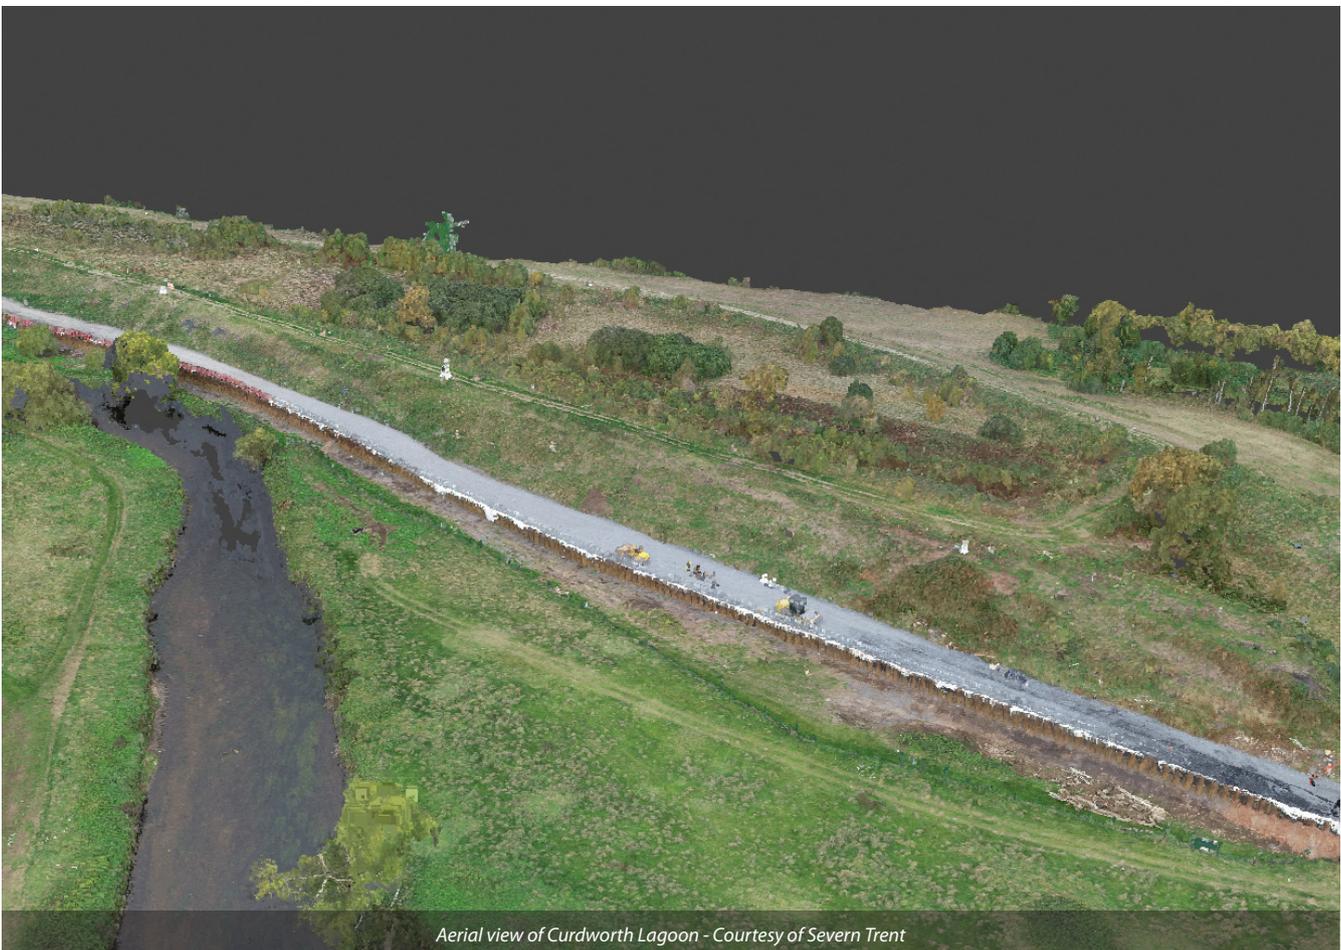
Aerial view of Curdworth Lagoon - Courtesy of Severn Trent
