Roundknowe CRFP

encapsulating an ageing pipe bridge in carbon fibre reinforced polymer provides a 60-year rehabilitation as well as time and cost savings

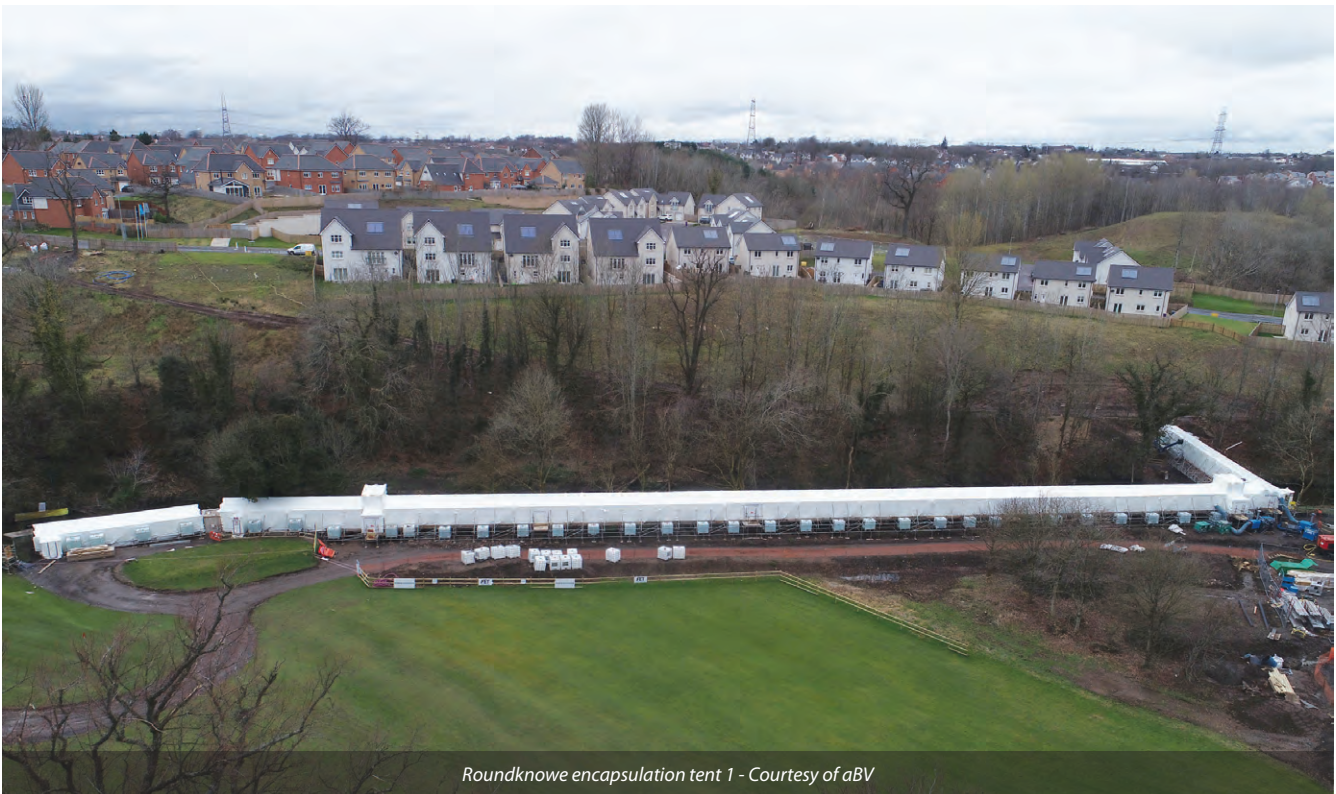
Roundknowe encapsulation tent 1 - Courtesy of aBV

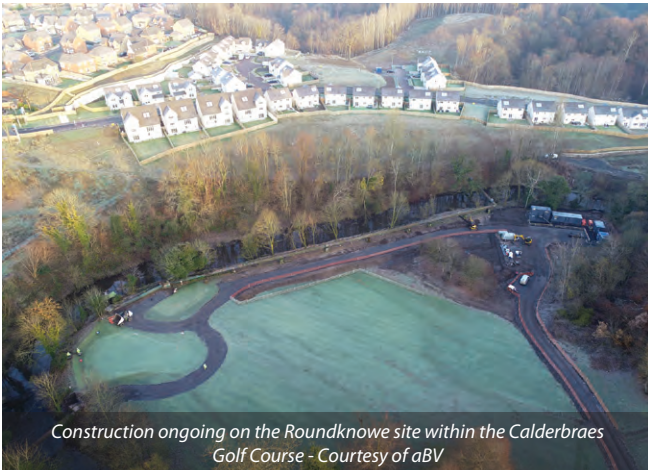
Construction ongoing on the Roundknowe site within the Calderbraes Golf Course - Courtesy of aBV

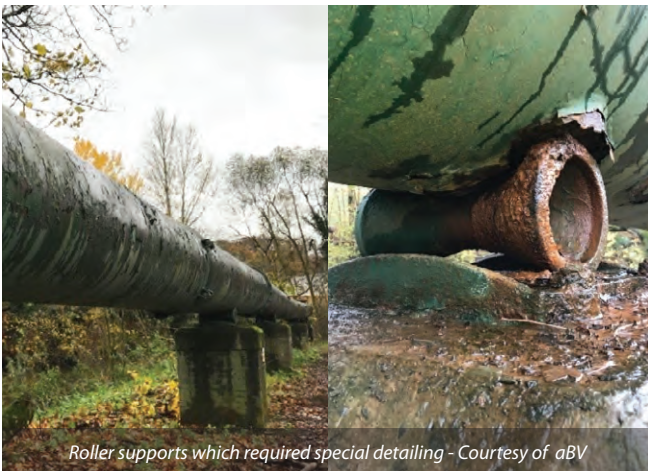
Roller supports which required special detailing - Courtesy of aBV

The pier locations

- Support pipe with temporary supports to remove roller and allow space for CFRP installation.
- Wrap around existing pipe as per normal design.
- Install new bearing support and remove the temporary supports.

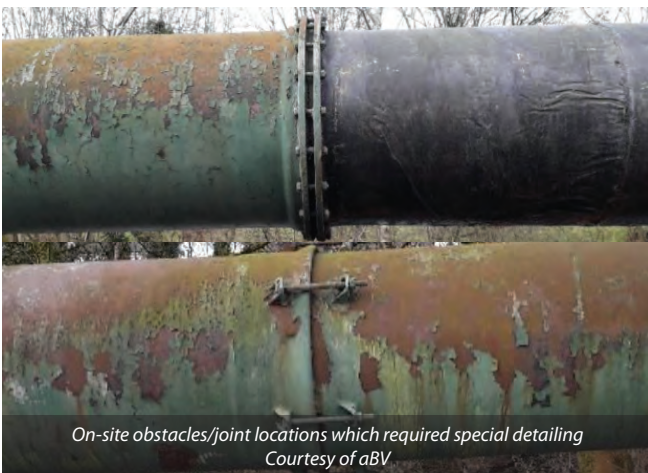
On-site obstacles/joint locations which required special detailing
Courtesy of aBV

For the joint location

- Remove the bolts to create a smooth surface of the pipe. The CFRP system will act as a bolt when installed.
- Apply 1 layer of the GFRP system in the hoop direction.
- Apply 1 layer of the GFRP system and CFRP system for additional longitudinal strength.
- Remove steel straps.
- Apply 2 layers of the CFRP in the longitudinal direction, per plans.
- Apply 2 layers of the GFRP system in the hoop direction, per plans.
- Apply top coat as required.

For the repair and flex-seal coupler locations

- Create a 4:1 transition slope with thickened epoxy or epoxy mortar.
- Apply system as per project requirements over the transitioned area.
- For repair areas that do not have any transition, the surface was prepared as required and the CFRP/GFRP System was applied per the project plan.

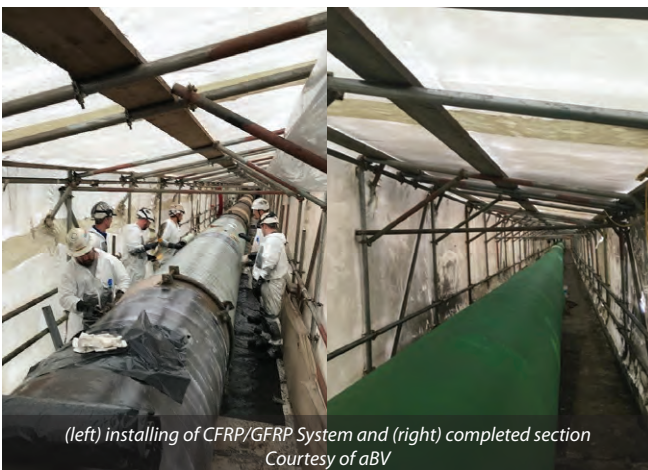
(left) installing of CFRP/GFRP System and (right) completed section
Courtesy of aBV

1. GFRP layers in the hoop direction for structural strength and to act as a dielectric barrier.

2. CFRP layers in the longitudinal direction to resist deflection loads and thermal issues.
3. FRP layers in the hoop direction for additional structural strength and encapsulation of the CFRP system.
4. A fire retardent layer and topcoat of green paint was applied to the system.

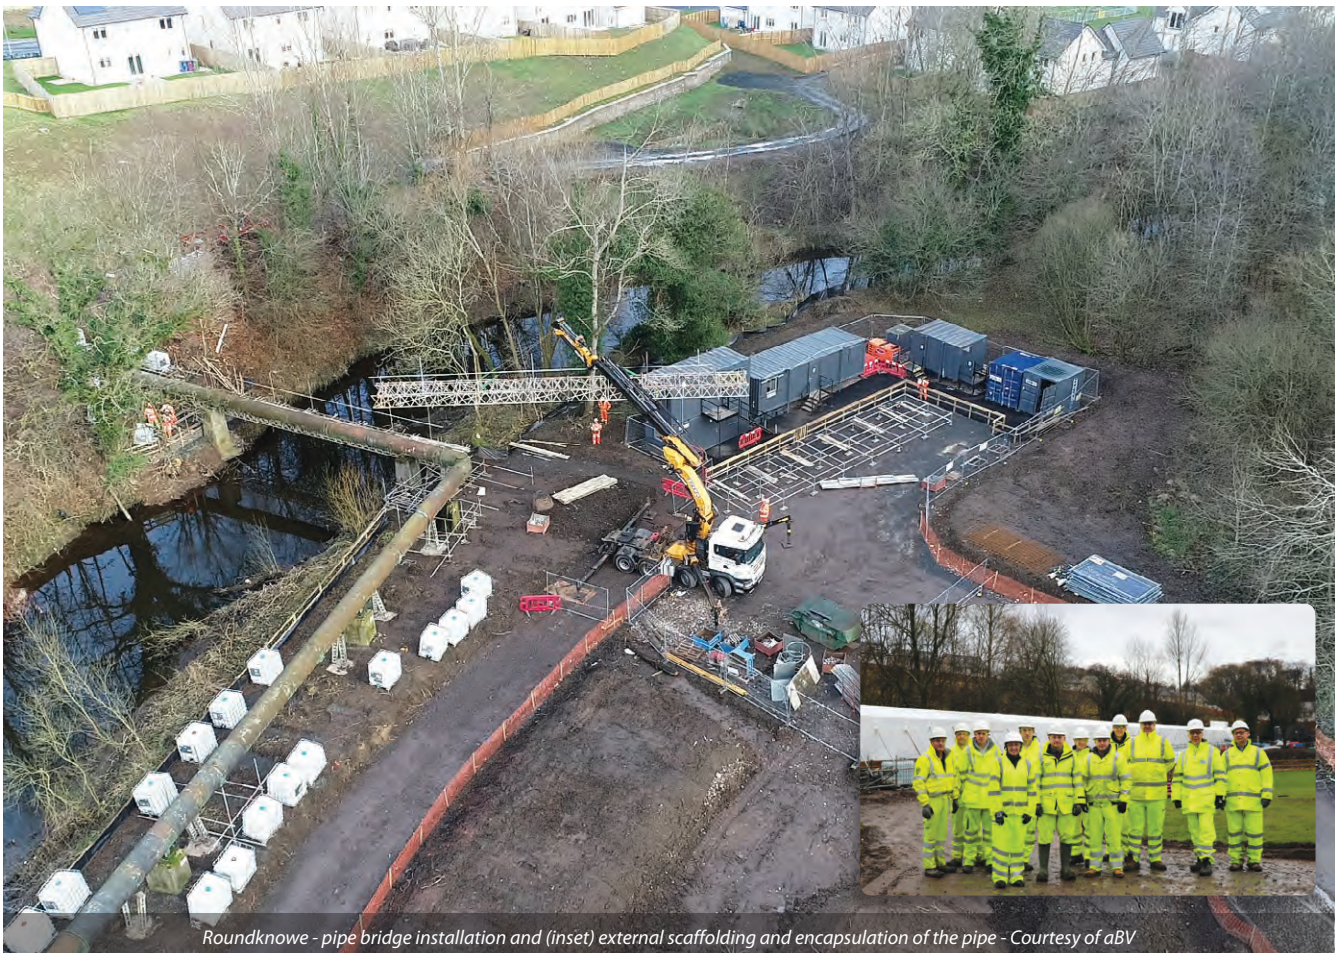
Roundknowe - pipe bridge installation and (inset) external scaffolding and encapsulation of the pipe - Courtesy of aBV

- Since the pipe is above ground more than a metre, external scaffolding was required to ensure the CFRP/GFRP system could be wrapped externally with expedience without hindering quality.
- Having a controlled environment for temperature and humidity is required to ensure the proper cure of the CFRP/GFRP system. This is especially important for this project, due to the extreme temperature and wind possibilities.

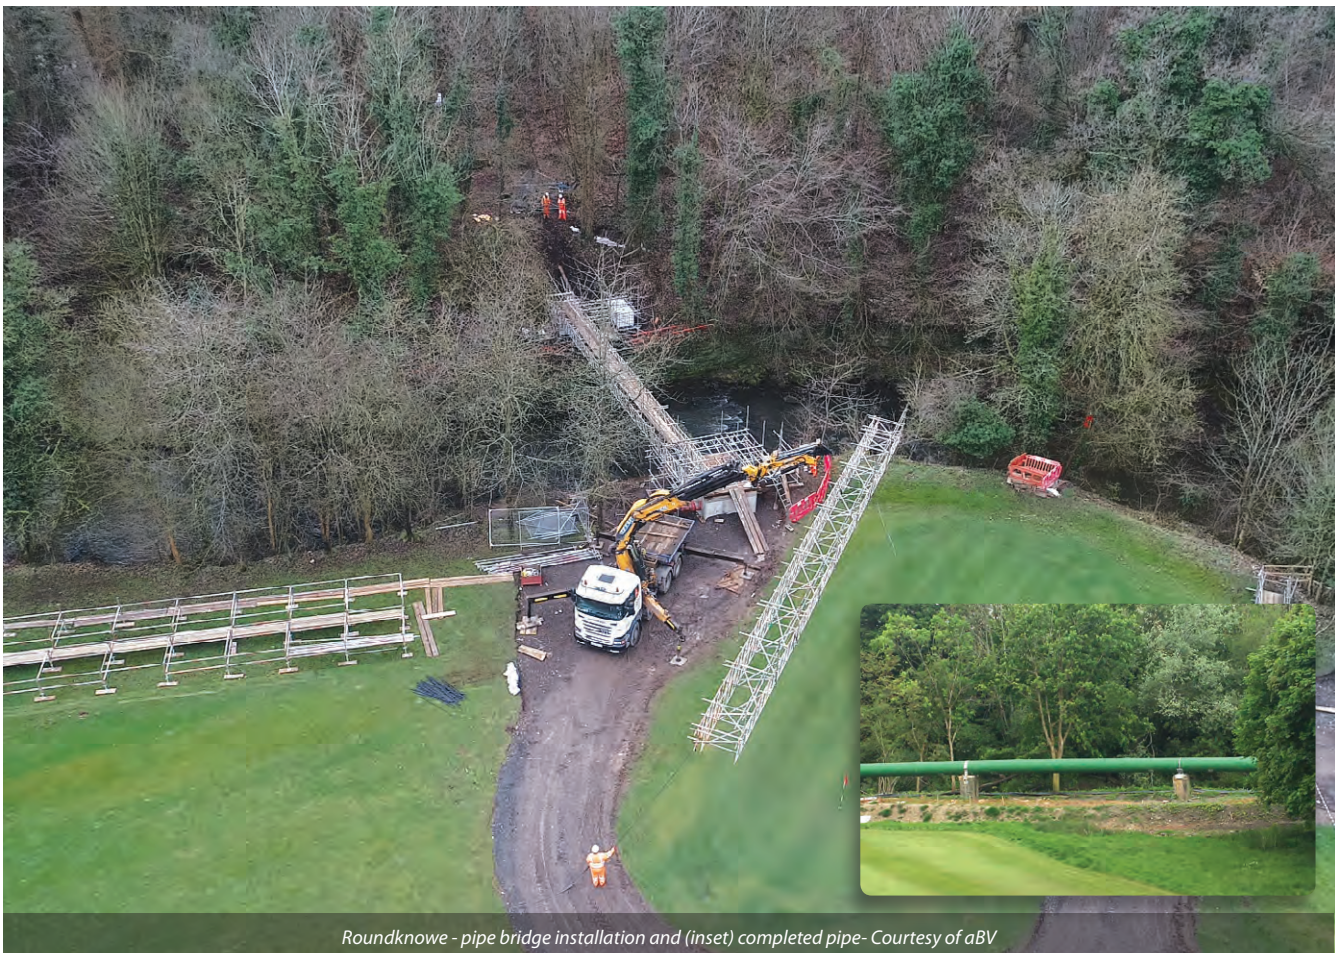
Roundknowe - pipe bridge installation and (inset) completed pipe- Courtesy of aBV
