Stockton Lane, York, Mains Rehabilitation

clean water infrastructure pipe spray lining

by Alex Spivey

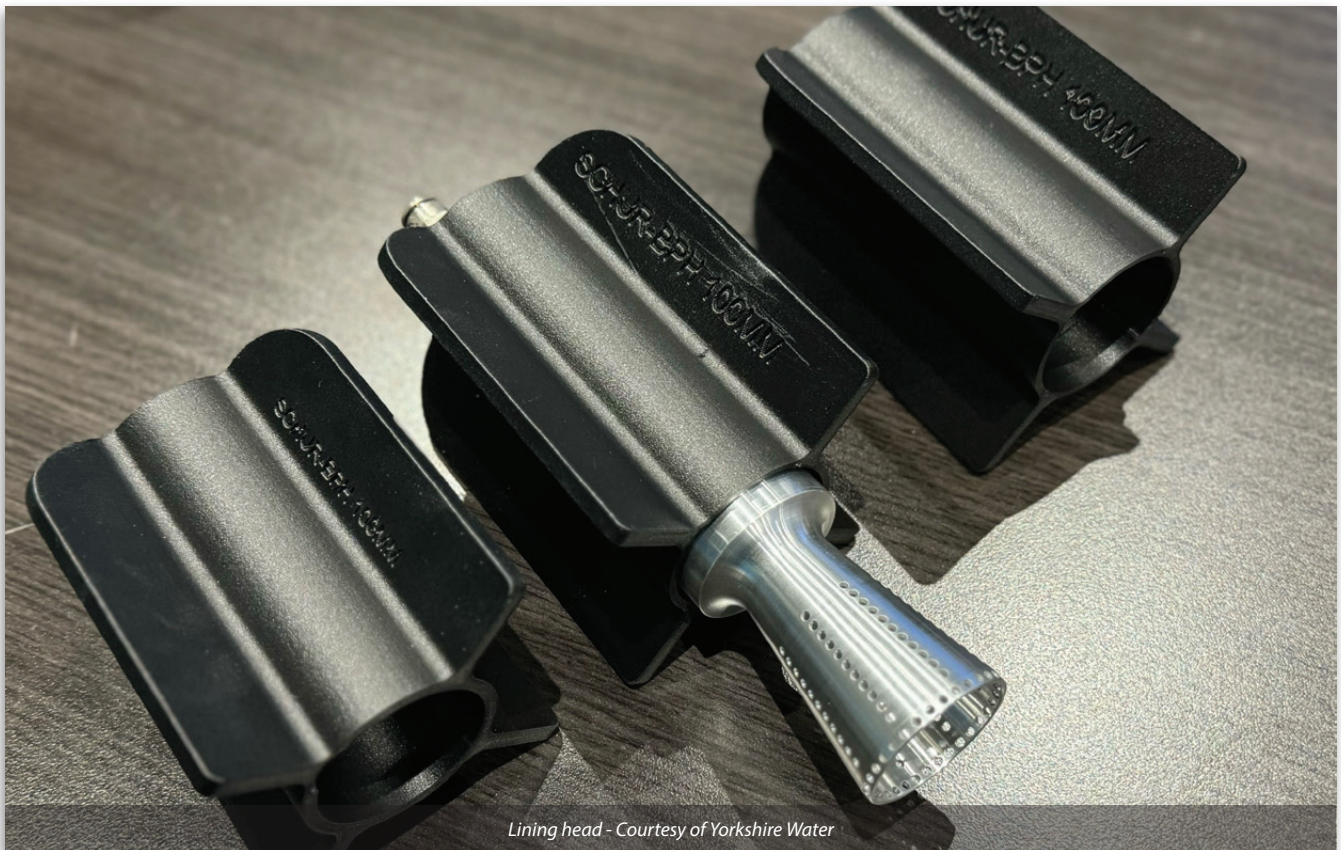
Lining head - Courtesy of Yorkshire Water

The lining material is made up of two paints; the base and activator, which are combined to make the Resiline 320 material. The paint is mixed by using a lining head that spins at 9000 rpm and applies it onto the pipework.

To ensure that the paint is mixed correctly, the operatives take dip cards. This is a visual check to ensure that the paint is of the correct blue colour and is not brittle, meaning that it is suitable for lining. Once these checks have been completed, the lining head will be guided into the pipe, and it will be electronically pulled through by the lining rig.

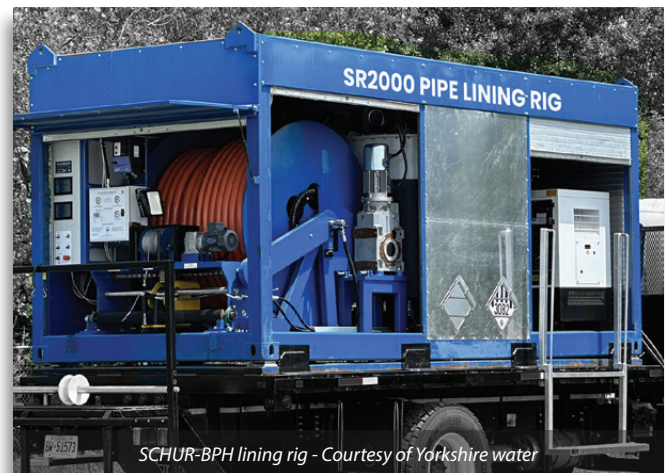
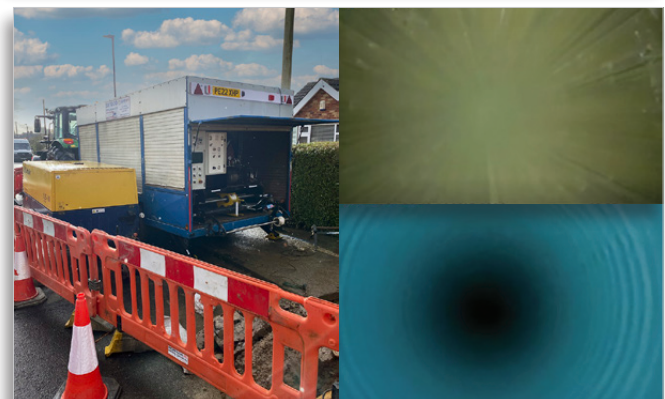
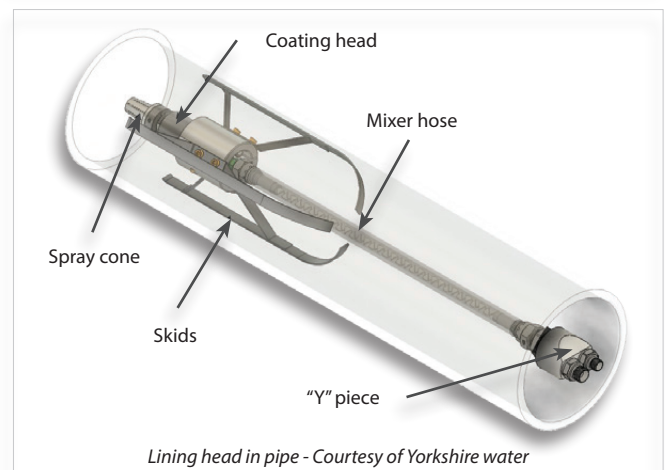
(left) Lining rig in operation, (top right) cleaning and (bottom right) spray lining - Courtesy of Yorkshire Water

The Whirlwind cleans the main by blowing down swabs, vortexes of air, and stones, that will scratch off any excess materials and dry the pipe; ensuring that the pipe is in a suitable condition to begin the lining process. The condition of the cleaning is checked by carrying out CCTV surveys on the main. The material is applied by using a lining rig from SCHUR-BPH Ltd.

The rig comprises two paint drums that hold the base and activator paints, which are pumped and heated to the optimum temperature required (30° Celsius) to apply the material onto the pipe. A hose situated at the front of the rig holds the base and activator tubes, and this is pulled through the pipe allowing the lining material to be sprayed onto the pipe interior.

The rig uses a computer system to ensure that each specific water main is lined to the required thickness - for the Stockton Lane Rehabilitation Project, the paint application setting is 3mm due to the works being semi-structural. As well as monitoring the paint thickness, the rig also monitors the flow rate of the lining application and the temperature. If any of these factors drop below the thresholds of + or - 5% of the thickness, an alarm will raise, and the rig will shut off as the application of the material will not be to the required standards.
