Case Study:

Tipping Buckets Storm Tank Flushing System

Site: Usk

Project: Tipping Bucket Storm Tank

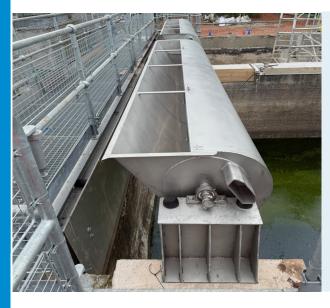
The lack of a sump was overcome by the use of "ski ramps" at the end of the tank to retain the flush water. The buckets themselves were mounted on elevated frames to ensure effective flush velocity and cleaning. After a storm event, a signal is received from a level sensor mounted in the tank sump, which opens the solenoid valve on the fill pipework.

The bucket fills continuously until the tipping point is reached and the bucket drops its contents against the rear wall flushing the tank.

A proximity sensor mounted on the bucket detects the tip and closes the solenoid valve.

2 No	4.3m Long x 300l/m 304SS TB
1 No	3.2m Long x 200 l/m 304SS TB
1 No	3.0m Long x 200 l/m 304SS TB
