## Case Study:

### *Flushing Systems—Flushing Drum*

**Site:** Mallow Bridge

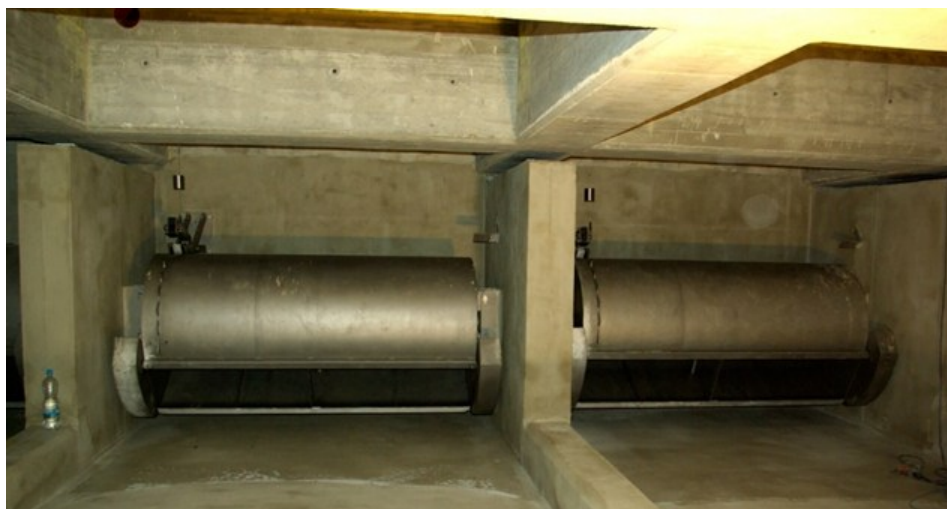
We were contacted by Glanua who needed a flushing system for this very shallow covered tank. We put forward the BGU flushing drum system which is ideal for shallow tank applications where there is minimal freeboard and insufficient supply of external flushing water. Unlike a tipping bucket the flushing drum can be installed below top water level so a lack of freeboard, as on this project, did not present a problem. The tank was divided into 6 almost equal widths and a 700 l/m capacity drum installed in each lane. Although the drums can be supplied with a float system, that does not require any power to operate, this system was hydraulically operated. As Water flows into the tank the drum is filled with storm water and held in position by a hydraulically controlled ratchet mechanism, when the tank is empty the ratchet is release and the eccentric drum tips against the back wall and flushes the tank, Each bucket is flushed in sequence to minimise the size of the receiving sump.

Type of Tank:	Rectangular
Length:	12.4m
Width:	7.3m
No. of flushing lanes/ drums:	6
Depth:	4.6
Fall:	1.6-1.8%
Flushing Volume:	700l/m
Drum model:	SST-B11-100
